RTM322 Engine Bearing Red Substance Contamination and Corrosion Investigation

Aerospace Division
Defence Science and Technology Group

DST-Group-TR-3608

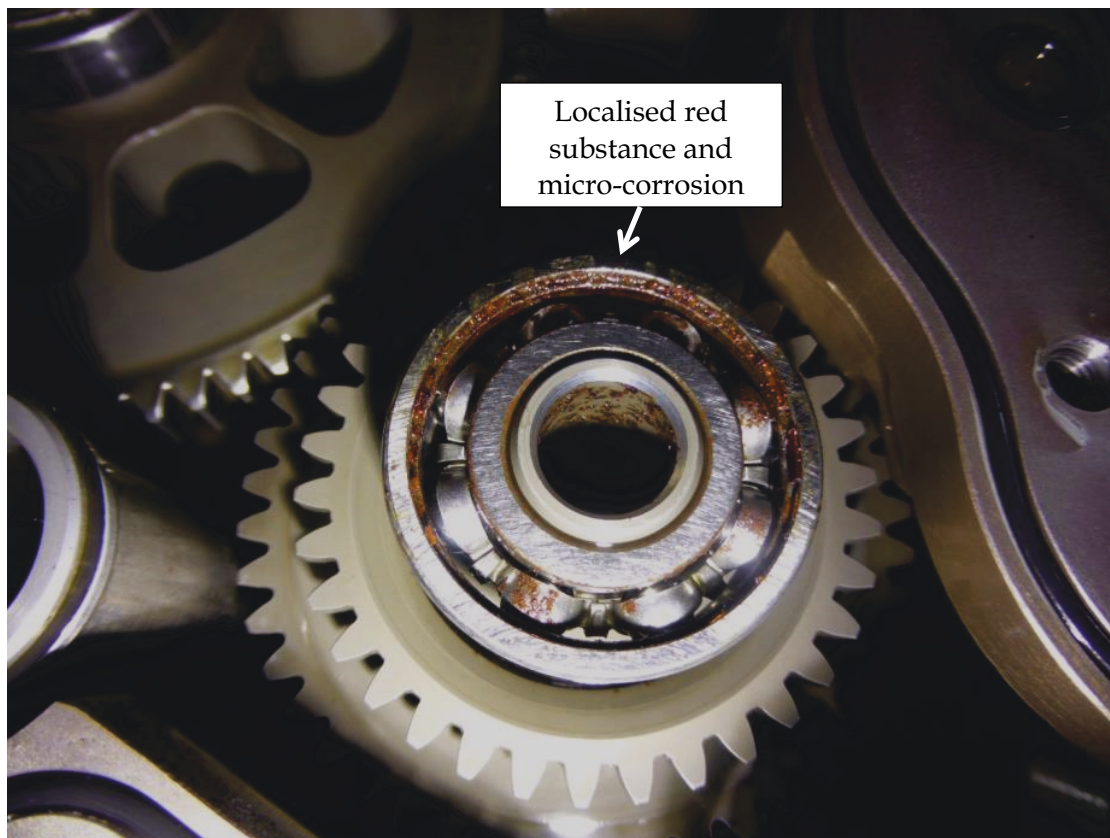
Figure 3: RTM322 accessory gearbox bearing showing the localised nature of the quinizarate and associated corrosion (Image courtesy of Safran HE)

Early in the investigation DST observed that the red substance and associated corrosion regions were exclusively located around rolling element bearings (Figures 3 to 5), although some of the substance had been transported to the filter and magnetic chip detector via the scavenge system. Being localised exclusively to bearings was considered unusual and not consistent with a bulk lubricant contamination issue. A bulk lubricant contamination issue (e.g. high Total Acid Number or high water content) would be expected to affect most low alloy steel components in the lubricated system. Gear, shaft and bearing steels are classified as low alloy steels and have similarly poor corrosion resisting properties due primarily to the relatively low chromium (Cr) content. As can be seen in Figures 3 to 5, the nearby components (e.g. gears, shafts, casing etc.) were pristine and showed no evidence of the red substance or corrosion despite being in the immediate vicinity and exposed to the same lubricant. The localised nature of the red substance and corrosion was a fundamental observation that DST considered critical for determining the likely primary cause.

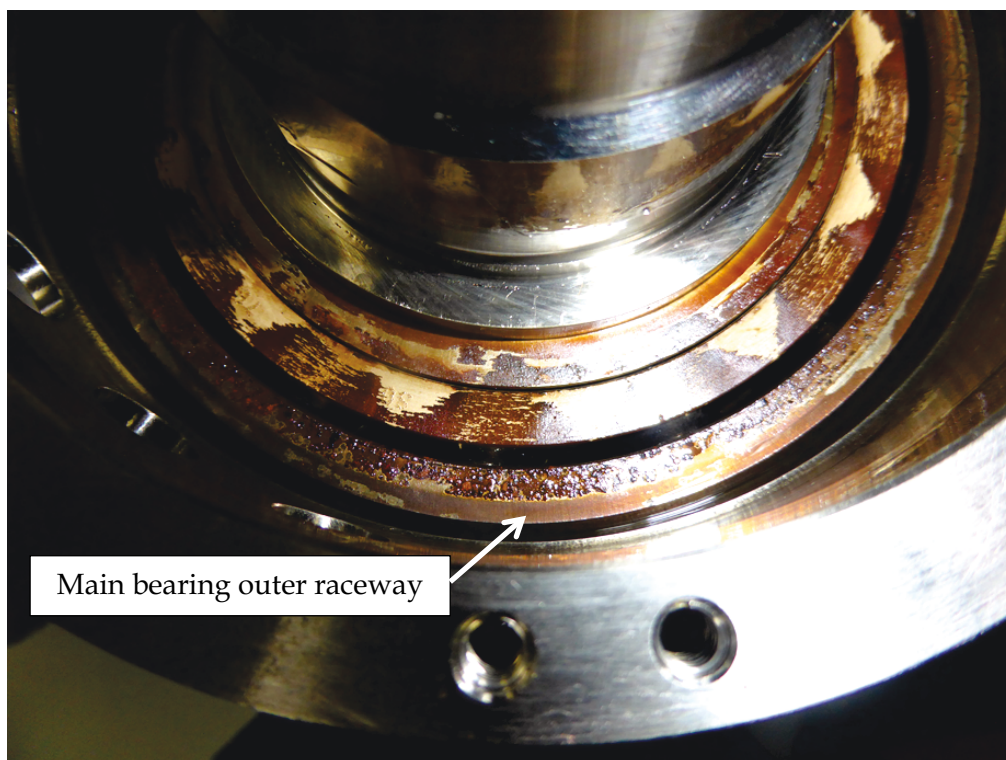
Figure 4: RTM322 main bearing showing localised quinizarate and corrosion (image courtesy Safran HE)

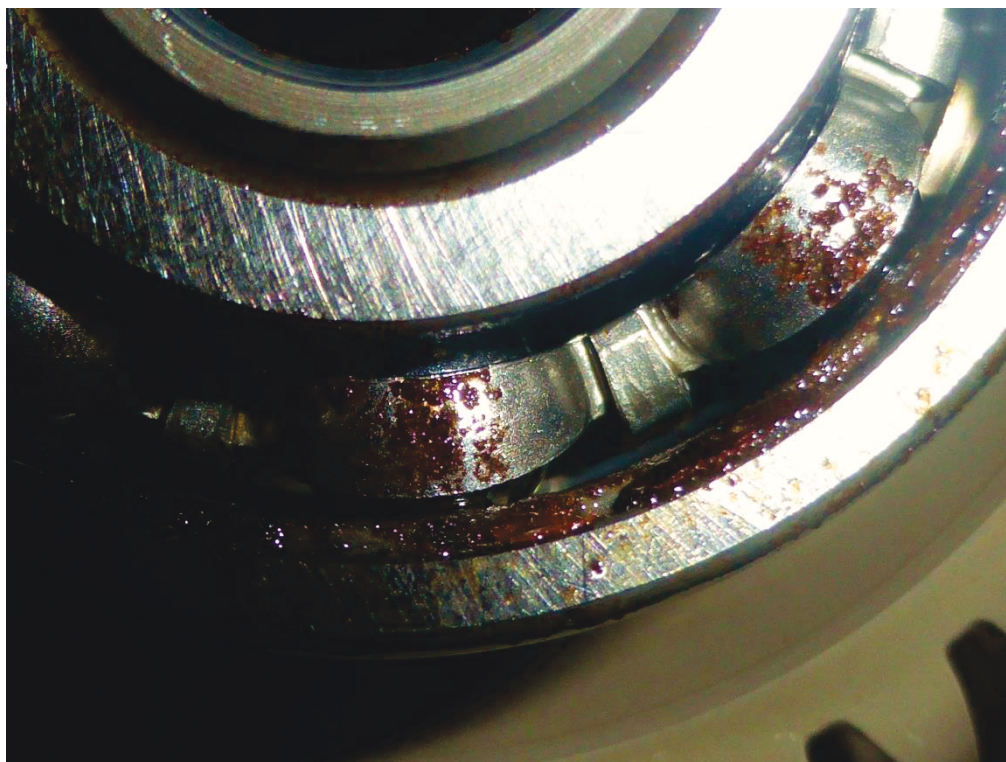
Figure 5: Image of bearing showing red substance on bearing cage and raceways (image courtesy of Safran HE)

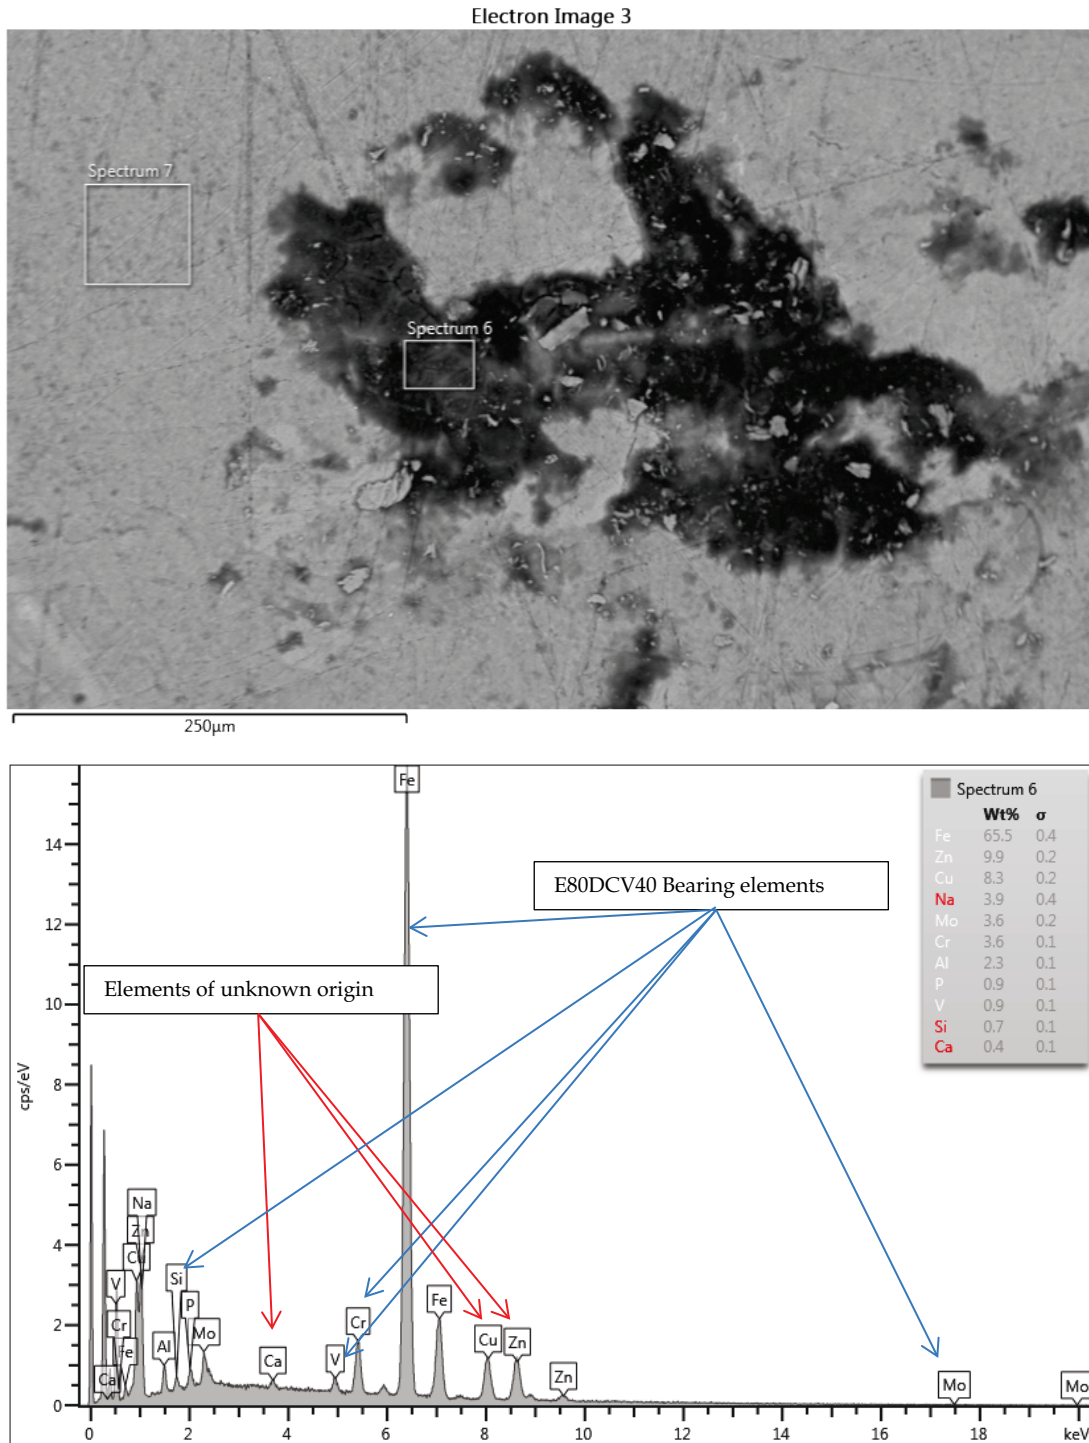
Figure 6: SEM EDS analysis of red substance residue on bearing surface

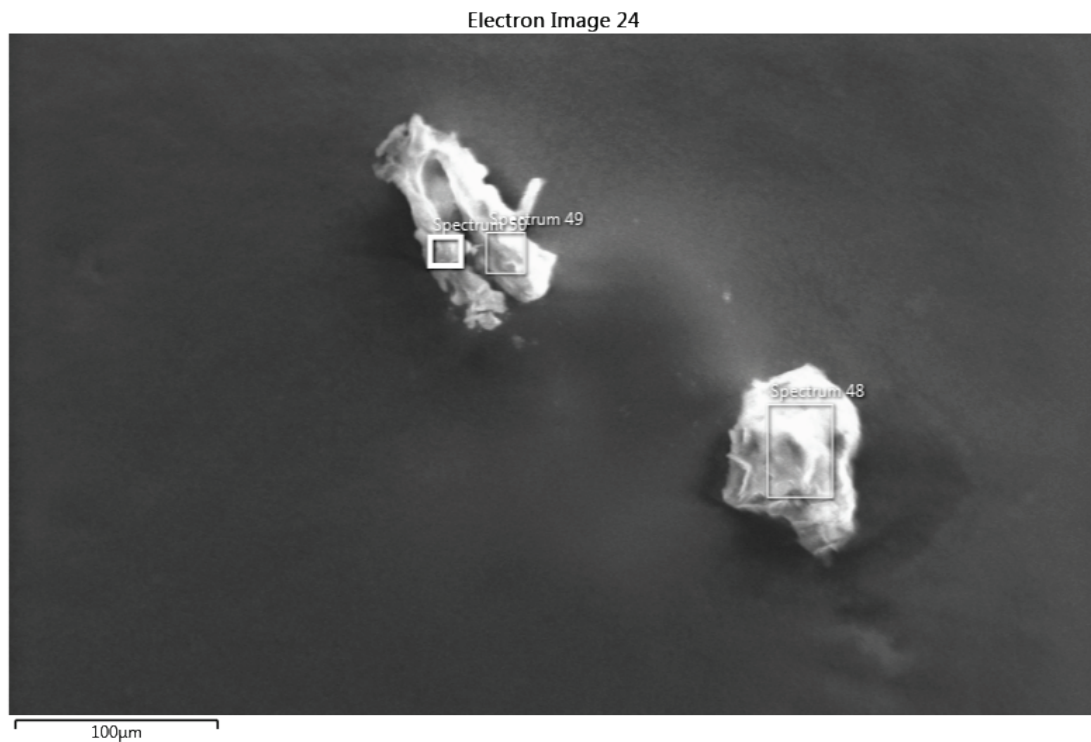
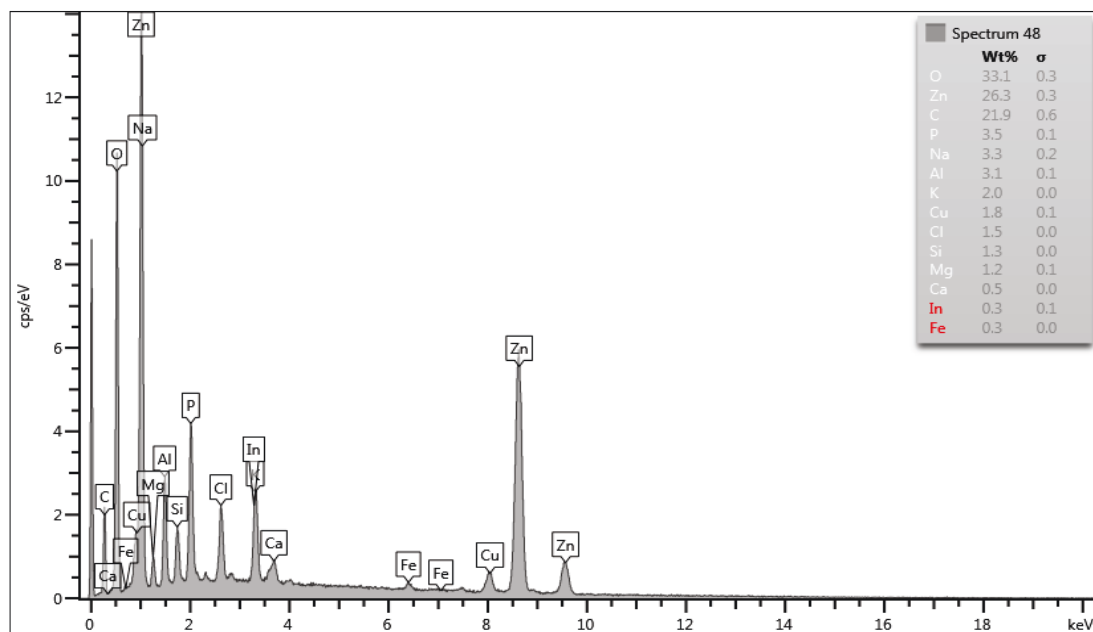
Figure 7: SEM EDS analysis of red substance from A40-016

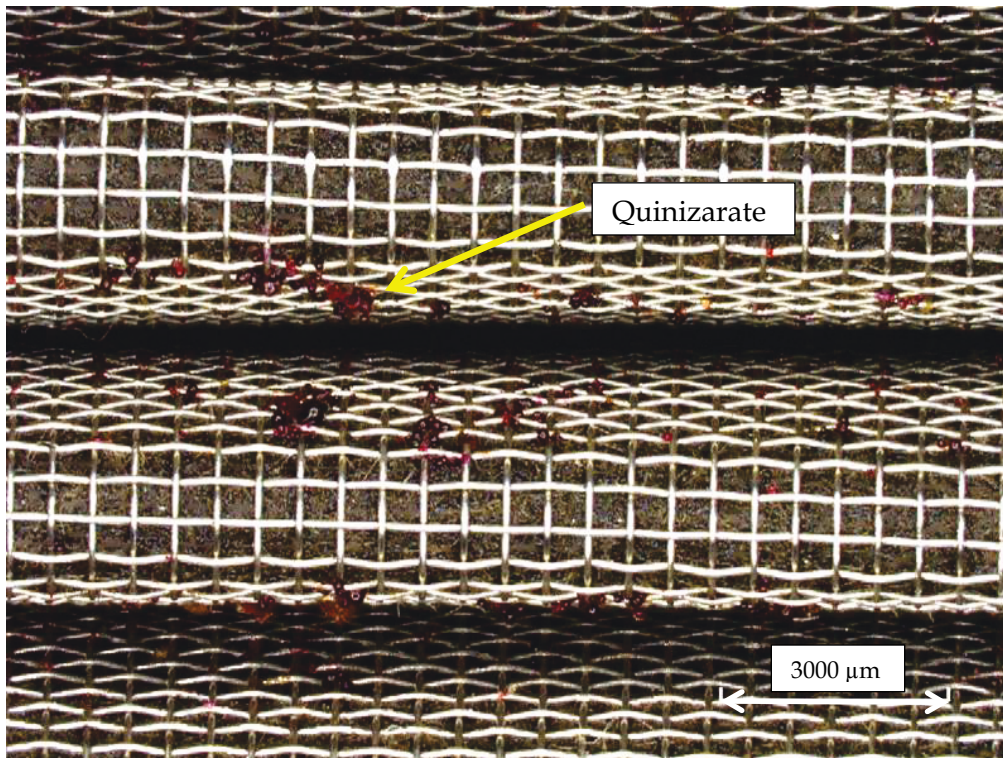
Figure 8: A40-011 filter showing red quinizarate attached to the filter mesh.

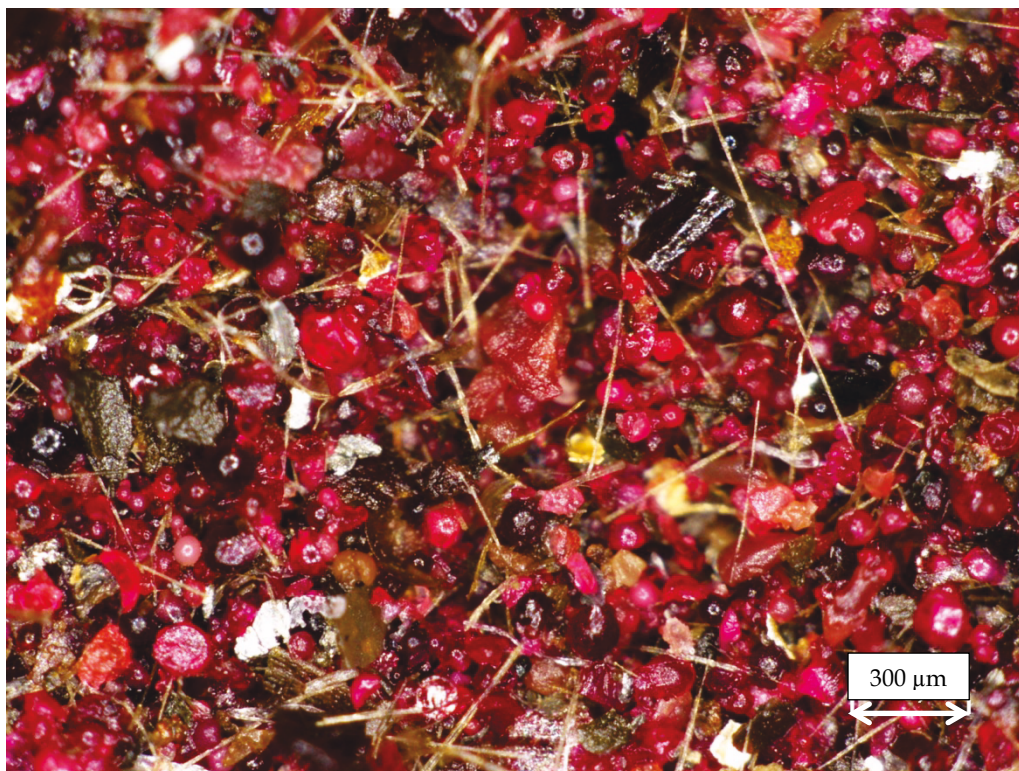
Figure 9: Filter debris extracted from A40-011 ESN 6534 showing extensive Al₂O₃ coated in quinizarate

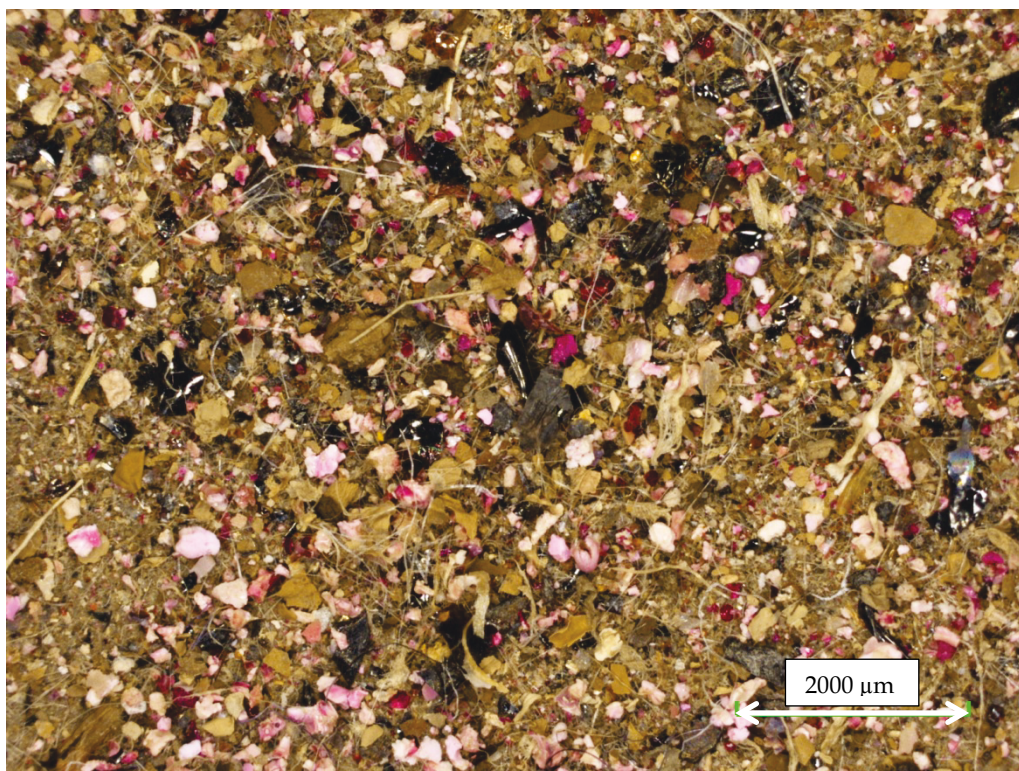
Figure 10: Filter extract from Engine 6500 showing some quinizarate

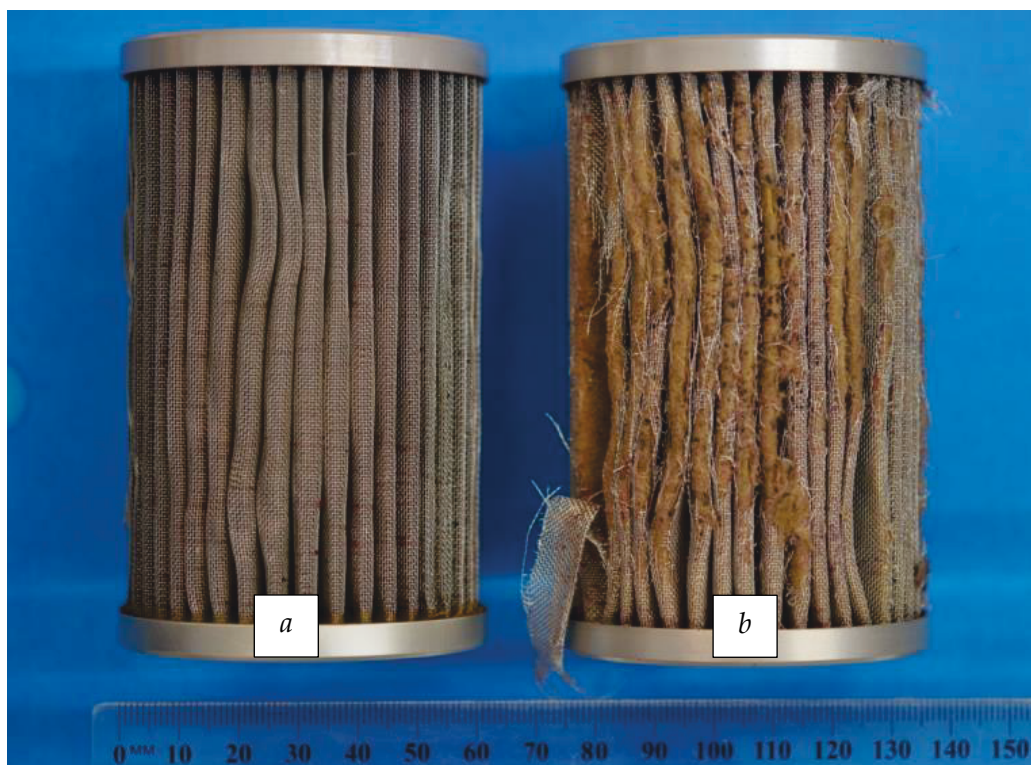
During the analysis of filter debris from one of the affected engines it was noticed that the outer aluminium alloy wire mesh (6000 series or similar) of the filter element had deteriorated and lost its structural integrity. It was observed that simply touching the mesh caused fracture of the wire strands. This observation was unusual and was not observed in all processed RTM322 filters. Figure 11 shows a comparison of two used filter elements following the extraction process. Filter (a) exhibited no structural integrity loss of the mesh (typical) while the degradation of the mesh in filter (b) is evident. The filter extraction process does not cause damage to the filter mesh and DST had not observed this type of deterioration in any previous aircraft lubrication filter analyses. Figures 12 and 13 show magnified views of the filter mesh from the filters shown in Figure 11. Note in Figure 12 that quinizarate persists in the filter near the mesh junctions element even after the extraction process.

Figure 11: Comparison of used RTM322 filter elements following filter debris extraction process.

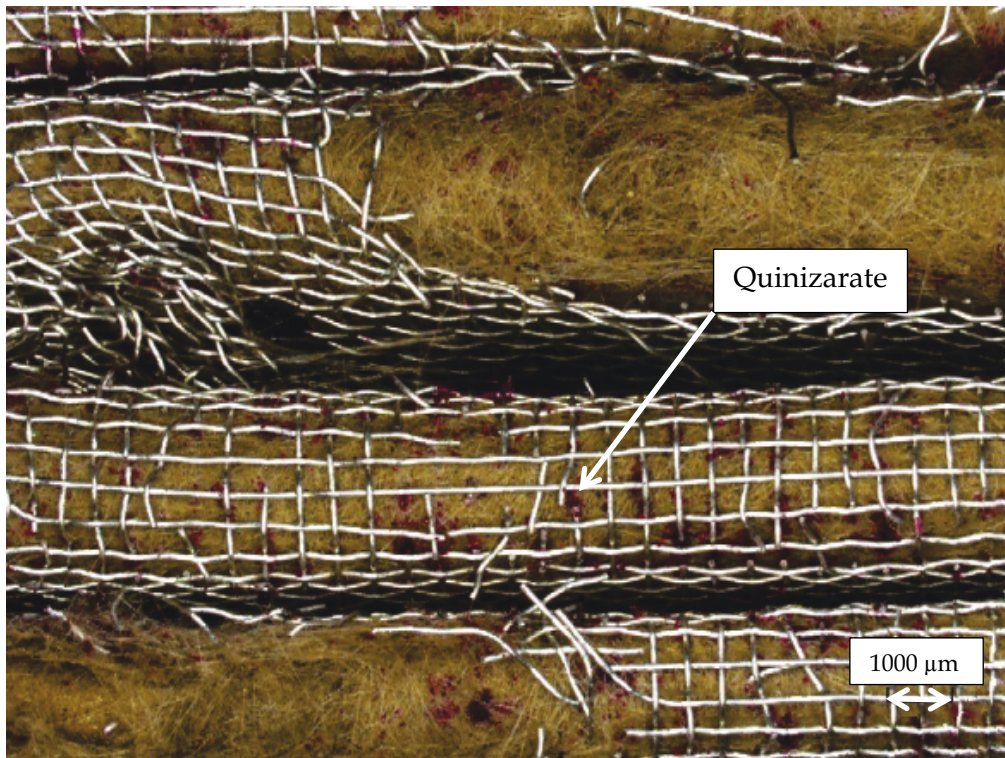
Figure 12: Close up of used RTM322 lubrication filter element (b) from Figure 11 showing the abnormal failed mesh and persistent quinizarate following cleaning.

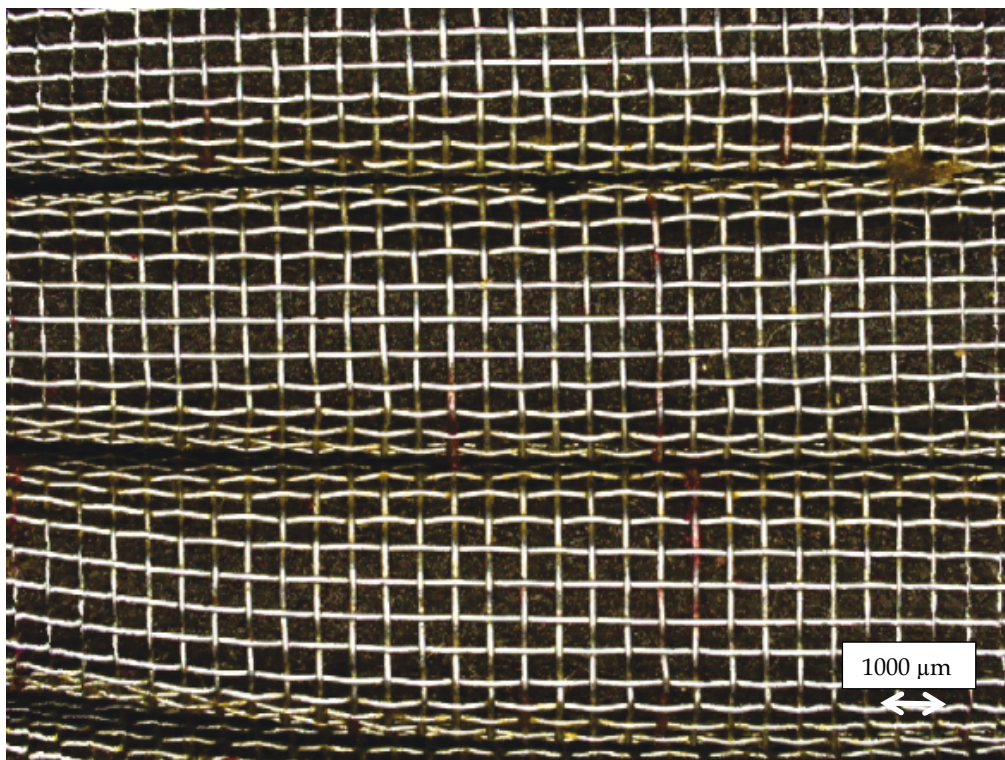
Figure 13: Close up of used RTM322 lubrication filter element (a) from Figure 11 showing mesh intact and appearing as expected.

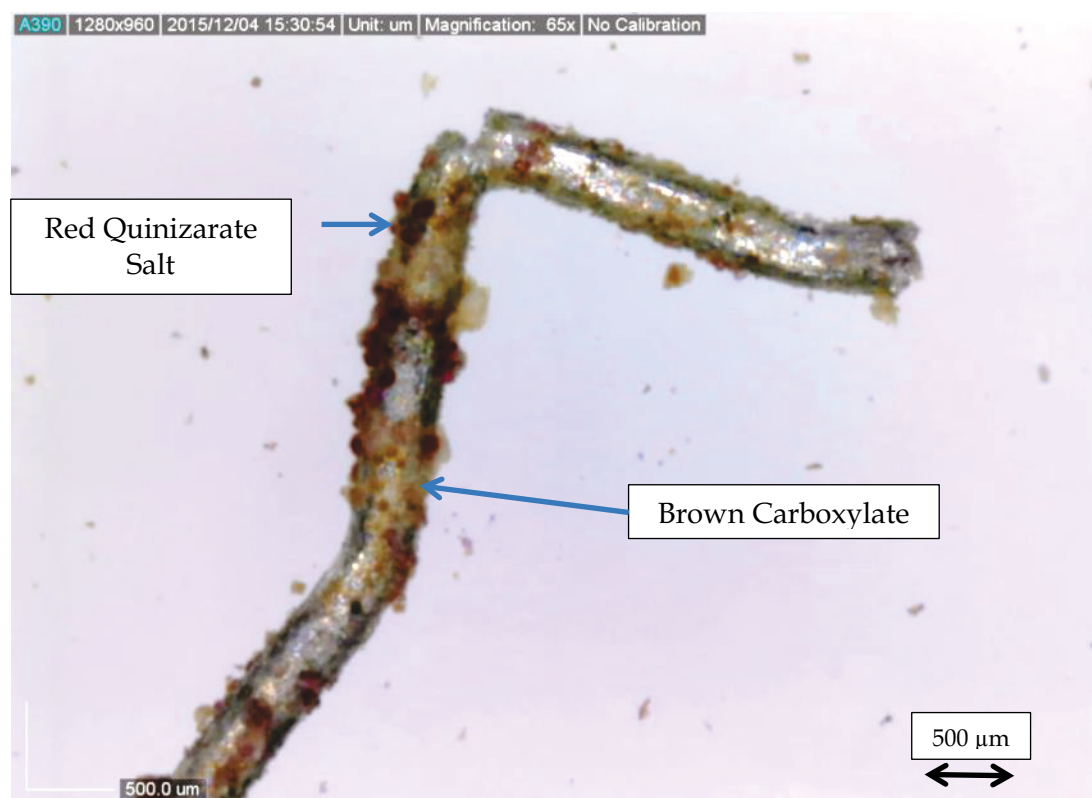
Microscopic examination of the filter mesh strands revealed both the red substance (quinizarate) and another tenacious brown-coloured substance (Figure 14). The brown coloured substance was subsequently identified as a carboxylate salt.

Figure 14: Example of a failed strand of the filter mesh from the degraded filter element showing tenacious brown substance (carboxylate salt) and red substance (quinizarate).

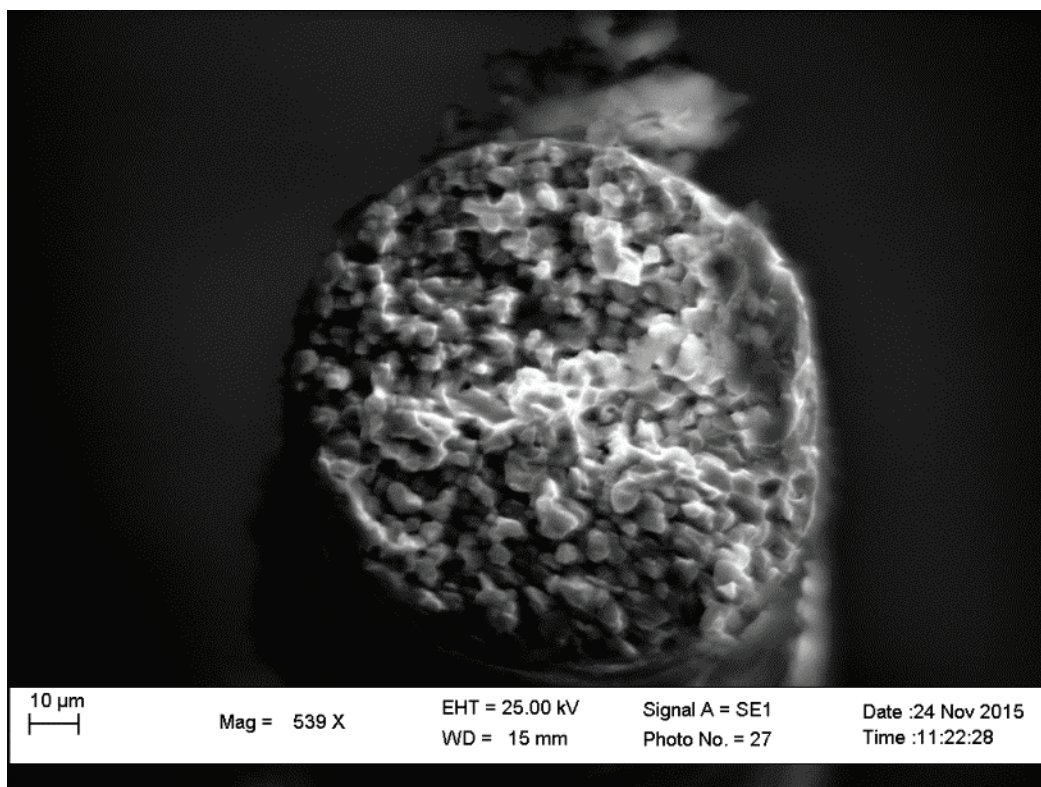
A sample of the wire mesh was further analysed and the fracture surface was assessed as being consistent with intergranular corrosion. Figures 15 and 16 show SEM images of the fracture surface and a strand that has partially broken. This aspect of the investigation caused some concern as it was realised that the attack on the aluminium alloy would not be exclusive to the filter element mesh and may attack other components in this critical system. DST concerns regarding this were passed to Airbus Helicopters and were reportedly noted on the aircraft risk register (See also Section 4.1).

Figure 15: Fracture surface of a wire strand from the filter element outer mesh.

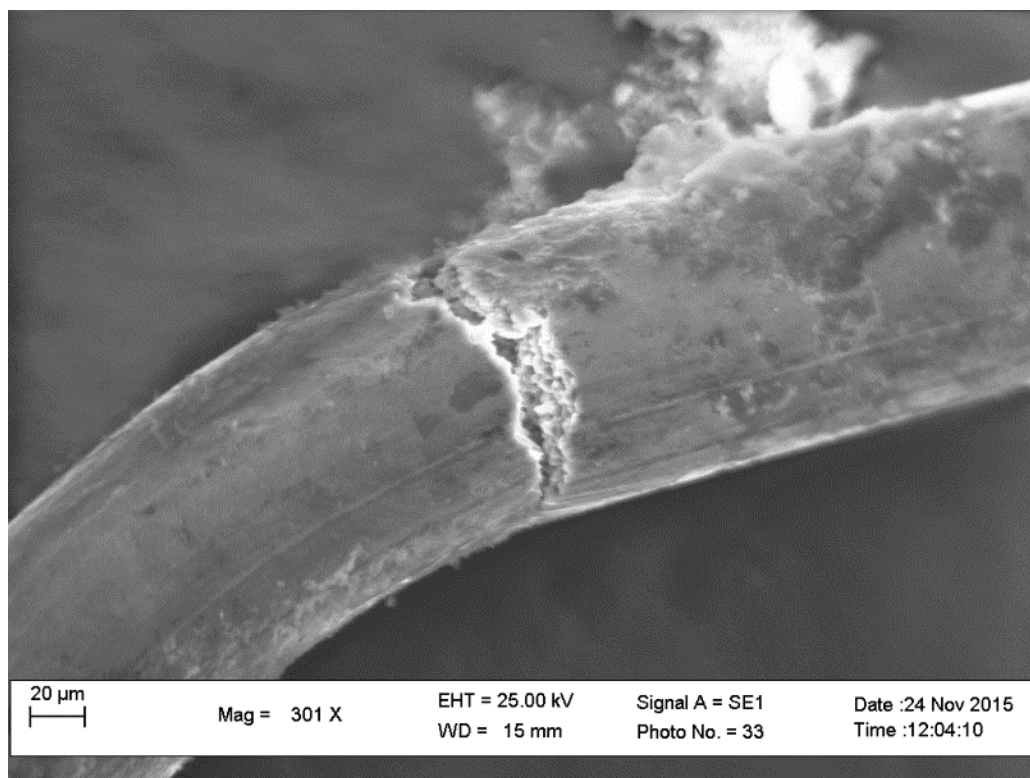
Figure 16: SEM image of filter element wire mesh strand that has partially broken.

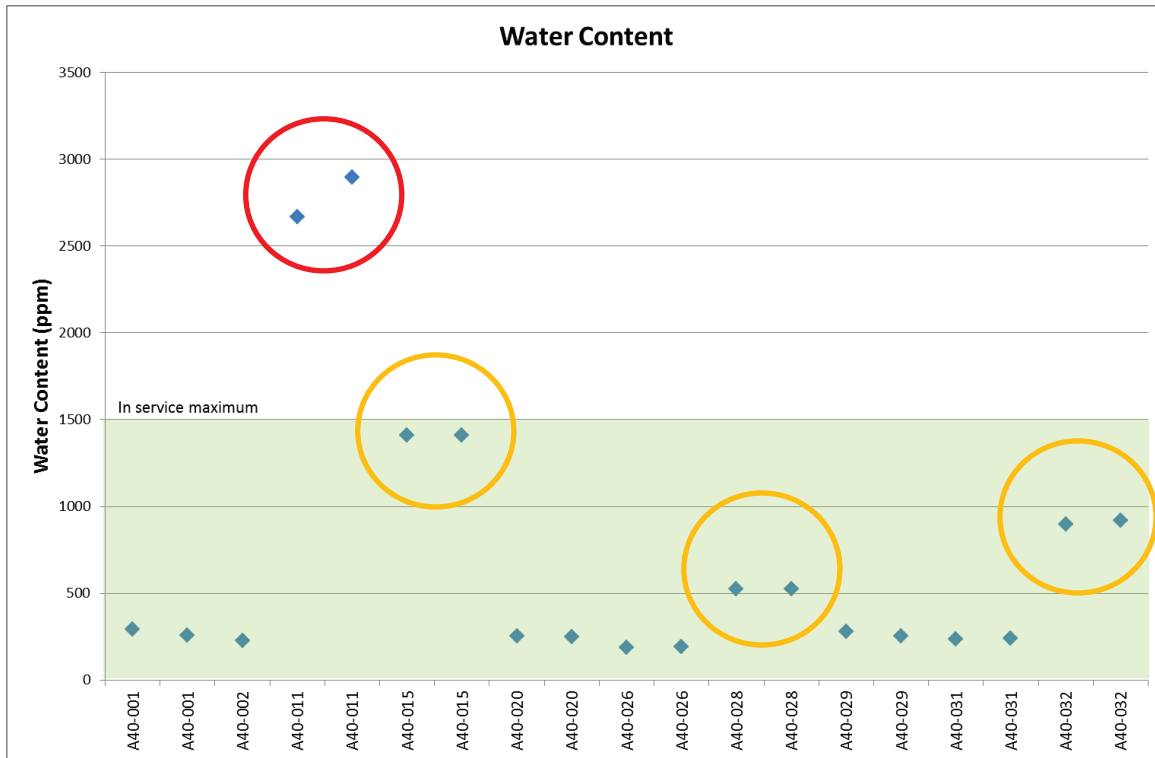
The primary lubricant condition results from the initial tranche of engines affected are shown in Figures 17, 18 and 19. Figure 17 contains a plot of water content (Karl Fischer method). What is clear from this plot is that only one aircraft had an abnormally high water contamination issue (A40-011), one was marginal (A40-015) and two others (A40-028 and A40-032) were considered slightly elevated based on experience with other Navy aircraft using the same lubricant. Only the samples for A40-011 would be considered

Figure 17: Plot of Water Content for MRH90 aircraft. Unserviceable results are circled red, marginal and slightly elevated results are circled yellow.

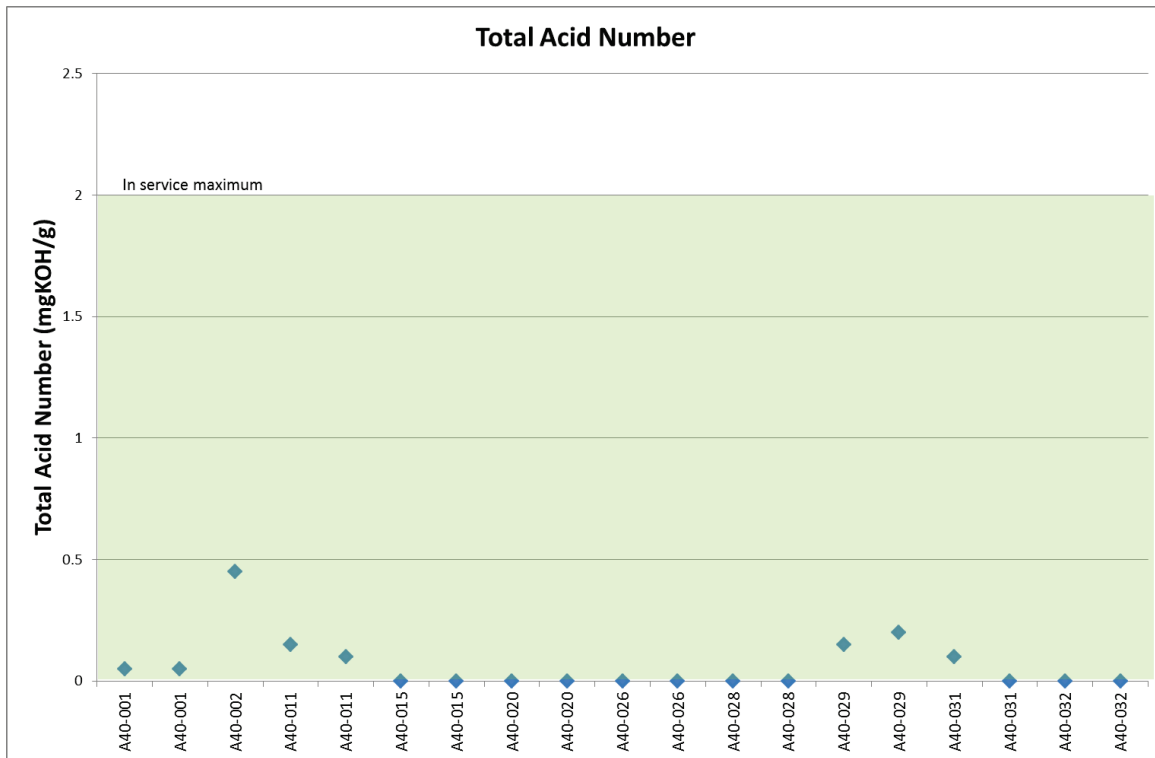
Figure 18 shows the Total Acid Number (TAN) readings for the same group of aircraft. TAN is a measure of the acidity of the lubricant and indicates the propensity of the bulk lubricant to cause corrosion in the system. For polyol ester lubricants such as MIL-PRF-23699, the presence of water can cause the lubricant to revert to its constituent acid and alcohol by the reversible equation (see Figure 20). The TAN results show no significant issue with the acidity of the bulk fluid. This is important to note as the corrosive nature of the bulk fluid had been considered as a possible cause of the internal localised corrosion.

Figure 18: Plot of Total Acid Number (TAN) for MRH90 aircraft

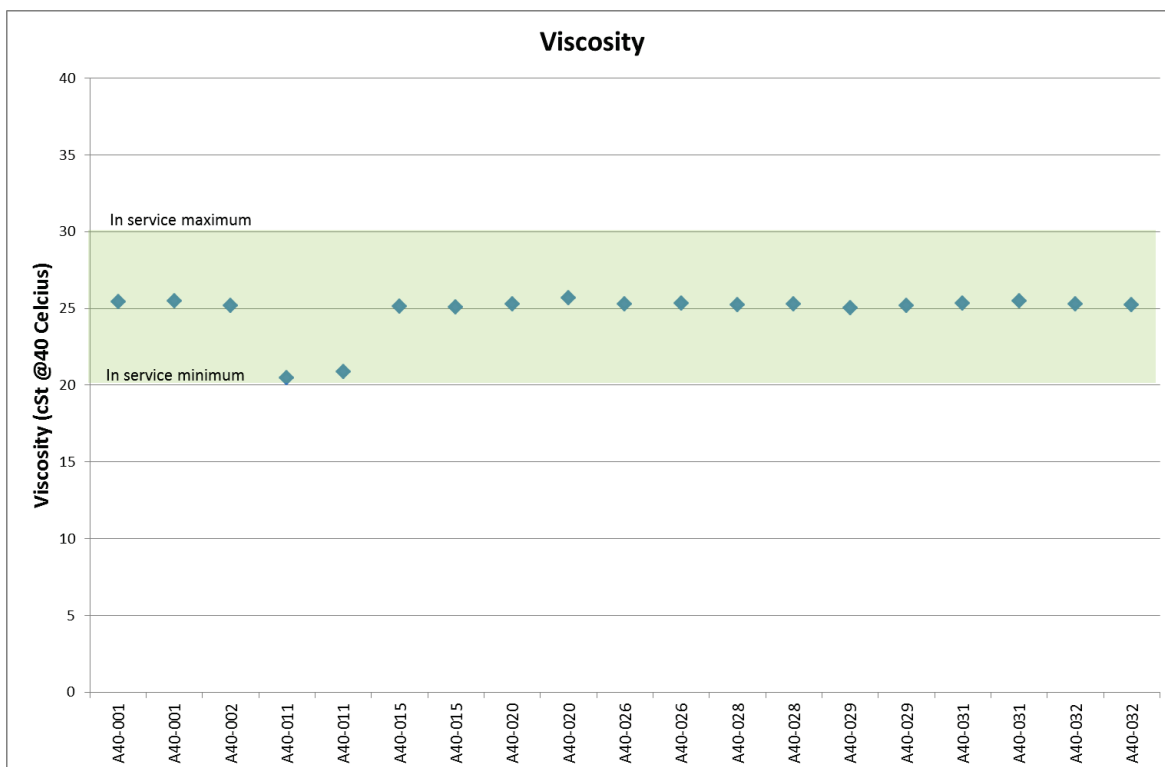
Figure 19 shows the viscosity results with the recommended in-service band limit (i.e. upper and lower limit) overlaid. It can be seen from this plot that there were no significant issues with the viscosity in any of the aircraft tested, however the low viscosity measured for the two samples taken from aircraft A40-011 did coincide with extreme water content readings (see Figure 17). Viscosity is the most important parameter for lubricants and directly relates to machinery health and longevity, however it does not impact the corrosion propensity of the lubricant.

Figure 19: Plot of viscosity results for MRH90 aircraft

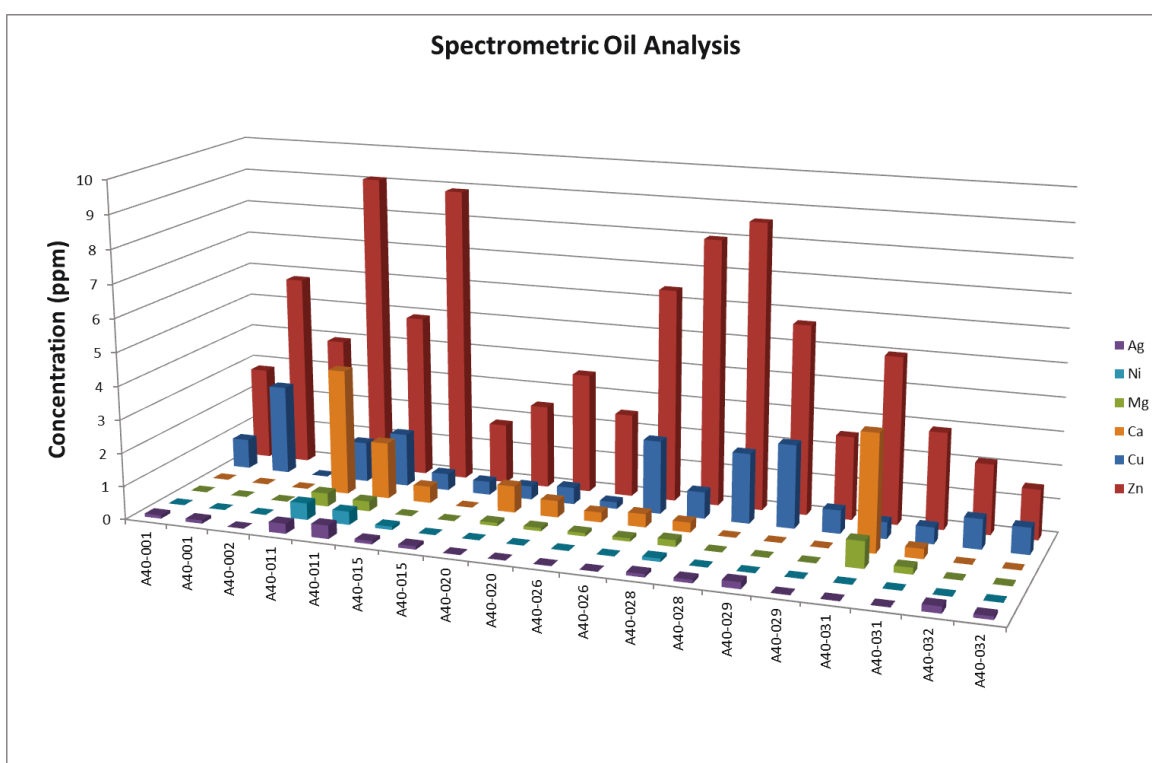
The results in Figure 21 clearly show that copper (Cu), zinc (Zn) and calcium (Ca) are present in concentrations significantly above other trace metals and are consistent with the analysis of the quinizarate being formed around primarily zinc (Zn) and copper (Cu). The source of the zinc (Zn) and copper (Cu) has not been conclusively determined, however DST consider the likely source to be wear from the labyrinth seals which contain a brazing alloy consisting of copper (Cu), zinc (Zn) and silver (Ag). The source of the calcium (Ca) has not been confirmed but is likely to be associated with whatever preservative fluid had

Figure 21: Spectrometric oil analysis results showing copper (Cu), zinc (Zn) and calcium (Ca) well above other elements expected

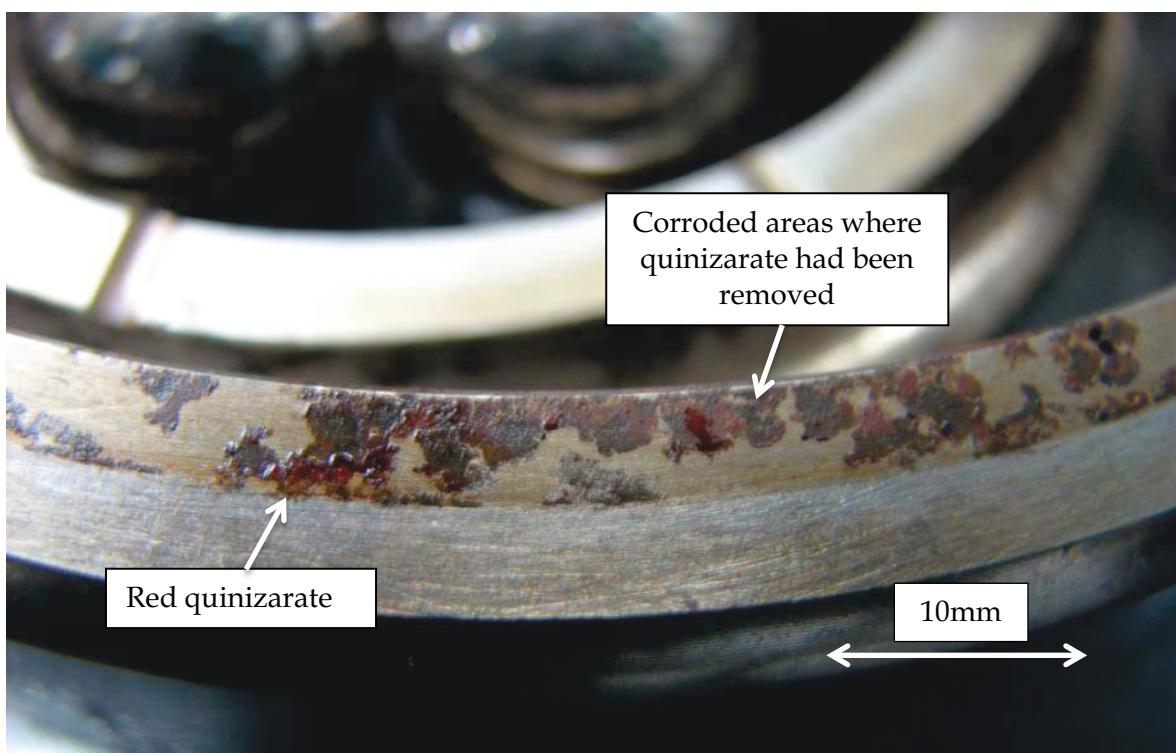
The surfaces of the inner race, outer race, cage and rolling elements showed evidence of the red quinizarate substance. Areas where the quinizarate had been removed revealed localised deep pitting corrosive attack of the bearing steel which had occurred on the outer race (Figure 22), the inner race and the rolling elements. Dark staining of the silver-plated cage by the red quinizarate substance was also observed.

Figure 22 : Outer race of the bearing showing the red quinizarate substance and areas where it had been removed revealing the black coloured localised corrosion

The quinizarate / carboxylate salt mixture is a gelatinous material that forms a tenacious film on the surface of the low alloy steel bearing components. The local environment beneath the substance-steel interface becomes corrosive, typical of a crevice corrosion

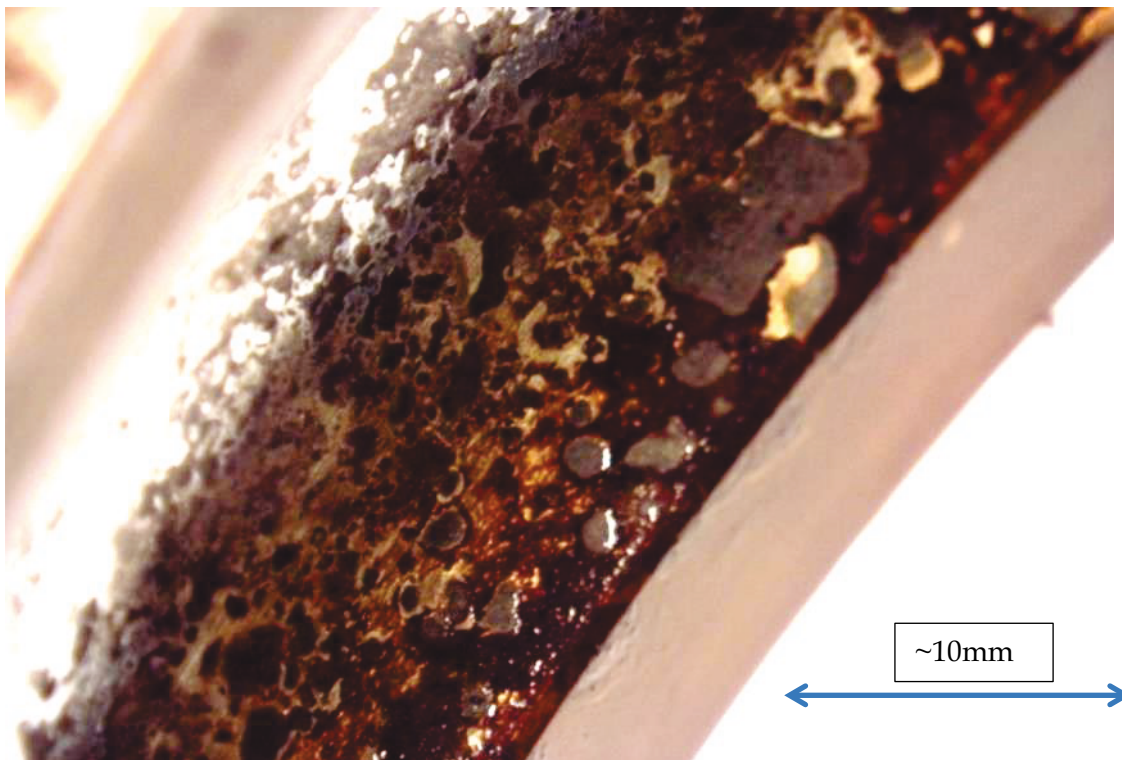
An adverse effect of this type of damage to the ball surfaces is that the sharp edges of the pitting corrosion can lead to mechanical damage of the inner and outer race contact surfaces leading to premature wear and potential failure of the bearing. Figures 23 and 24 show accumulated red quinizarate substances and localised black corrosion product on the inner and outer race of the bearing.

Figure 23: Outer race showing accumulation of red quinizarate substance and corrosion

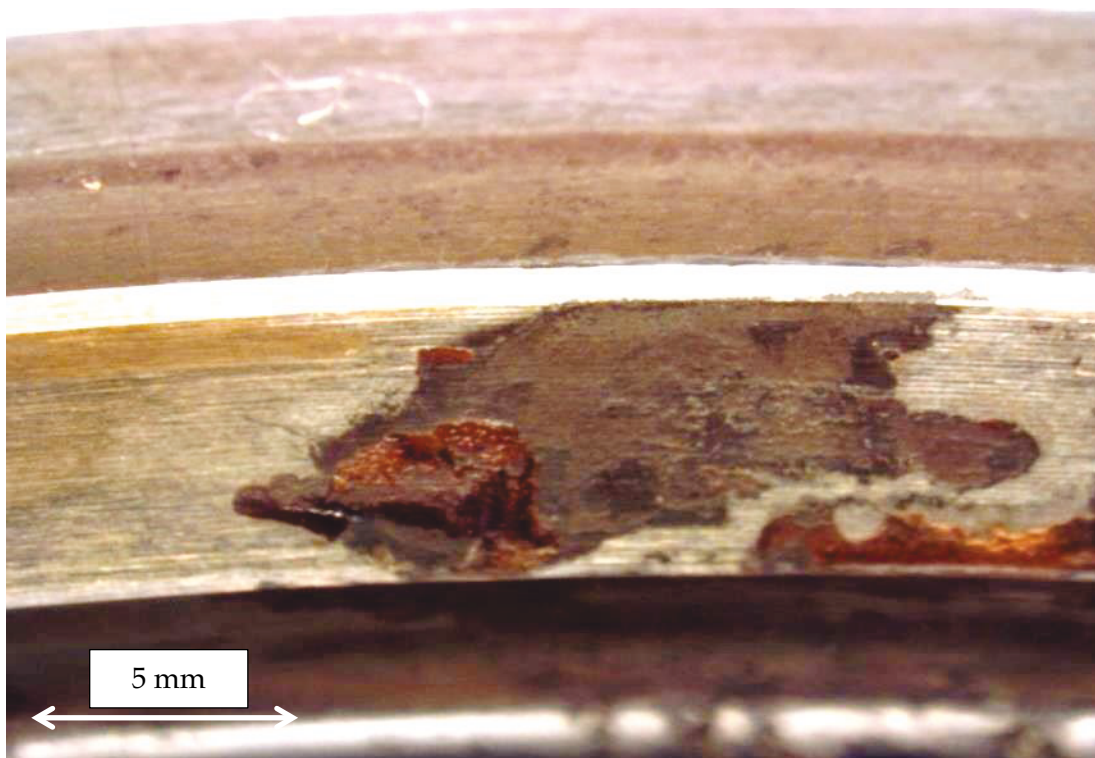
Figure 24: Red quinizarate substance and corrosion damage on the exposed surface of the inner race

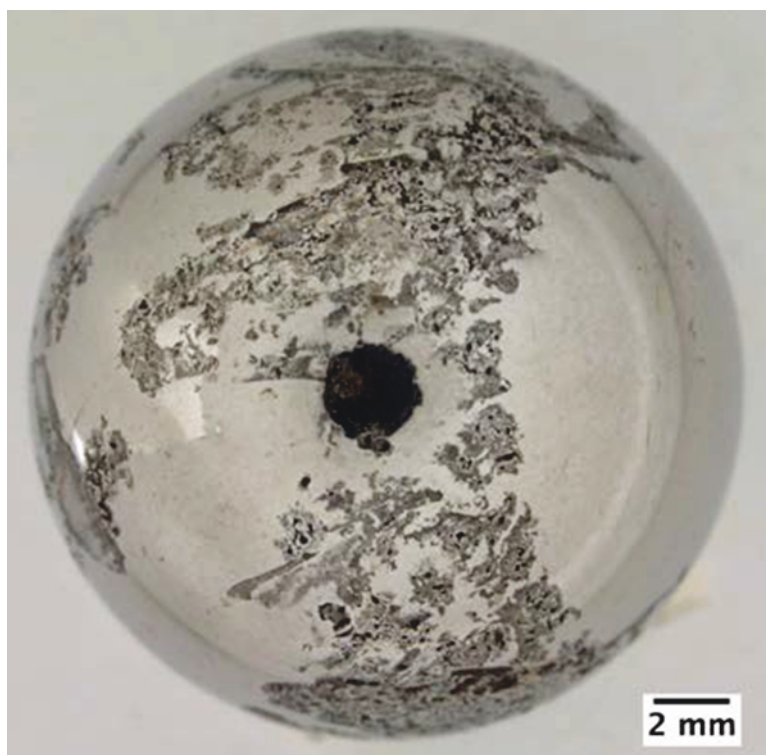
Figure 25: Rolling element from the subject bearing showing extensive pitting and surface corrosion

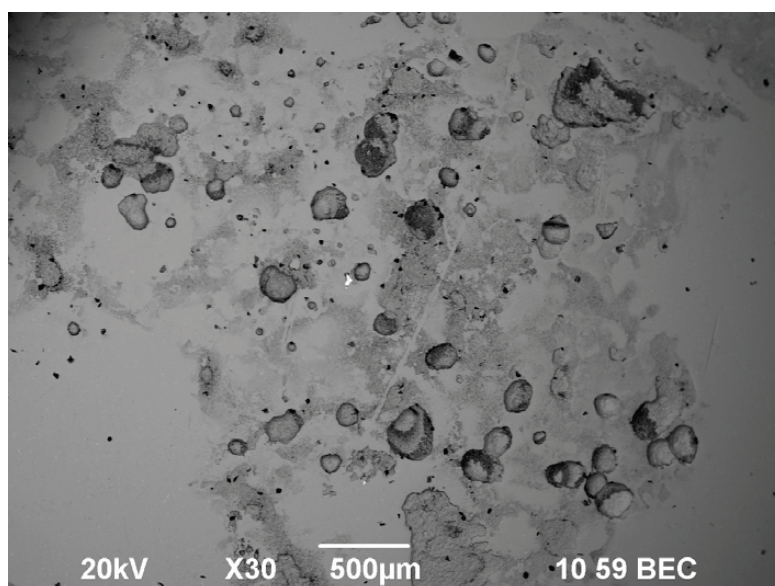
Figure 26: SEM image of the same rolling element from Figure 25 showing the deep pits

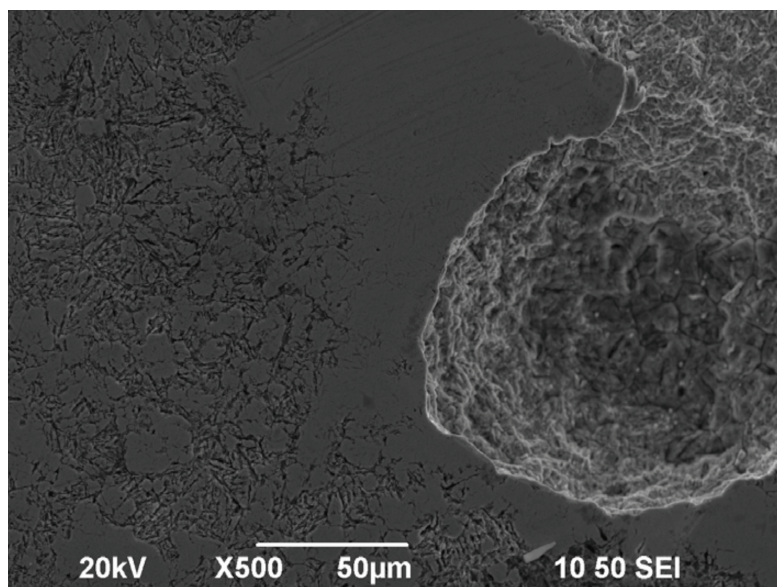
Figure 27: High magnification SEM image of the same rolling element from Figure 25 showing the surface corrosion and deep sharp-edged pitting
