RTM322 Engine Bearing Red Substance Contamination and Corrosion Investigation

Aerospace Division
Defence Science and Technology Group

DST-Group-TR-3608

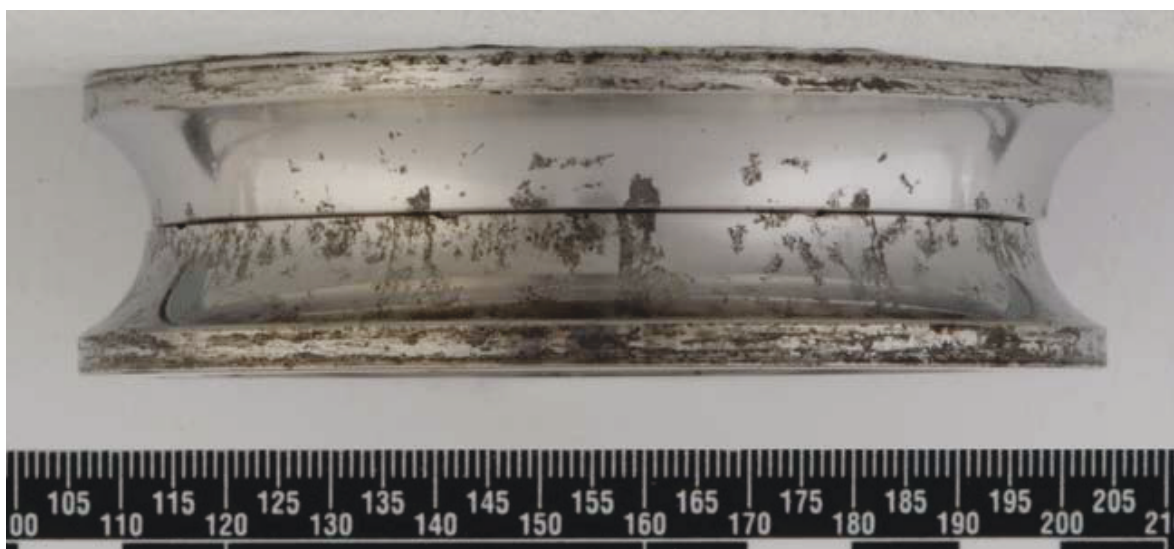
Another RTM322 main bearing² was provided to DST and subjected to a detailed forensic examination [6]. The bearing had been removed from Module 4 (M46526) of engine serial number 6526, with an accumulated life of 538 hours, due to the presence of magnetic chip indications resulting from extensive corrosion. The DST report confirmed extensive deep corrosion on all rolling elements, raceways and staining on cages consistent with the original observations during the Safran HE visit described in Section 3.5.1. Figures 25 to 27 show an example of a corroded ball from this bearing. Figure 25 is a macro image of the ball surface, while Figures 26 and 27 are SEM images at different high magnification showing the sharp edge pits observed. Note that the images of this bearing show it after cleaning and hence do not show the presence of the red substance. The inner and outer raceways also showed similar corrosion features as seen in Figures 28 and 29.

Figure 28: Split inner raceway showing extensive corrosion on the running surface and landings

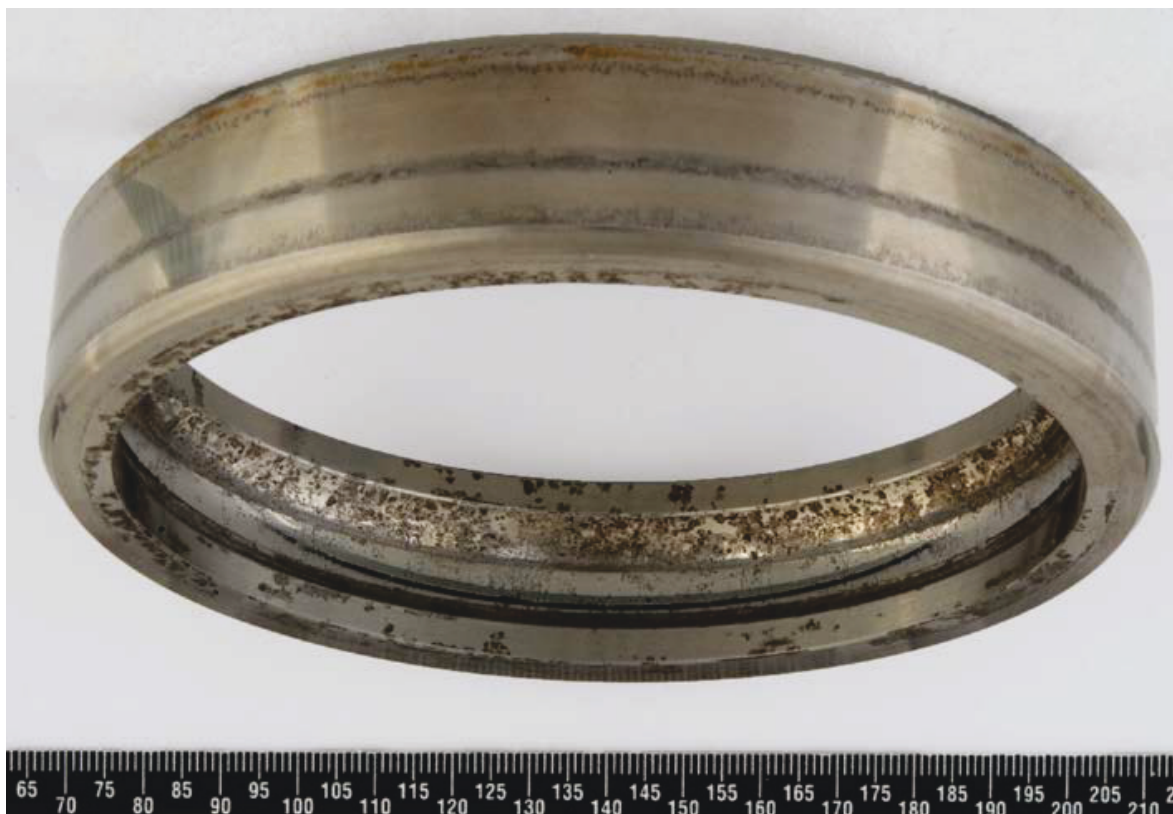
Figure 29: Outer raceway showing extensive corrosion on the running surface and various landings
