Department of Defence

F-111 Adhesive Bonded Repair Assessment Program (FABRAP) - Phase I Testing, Preliminary Results

DSTO-TN-1024

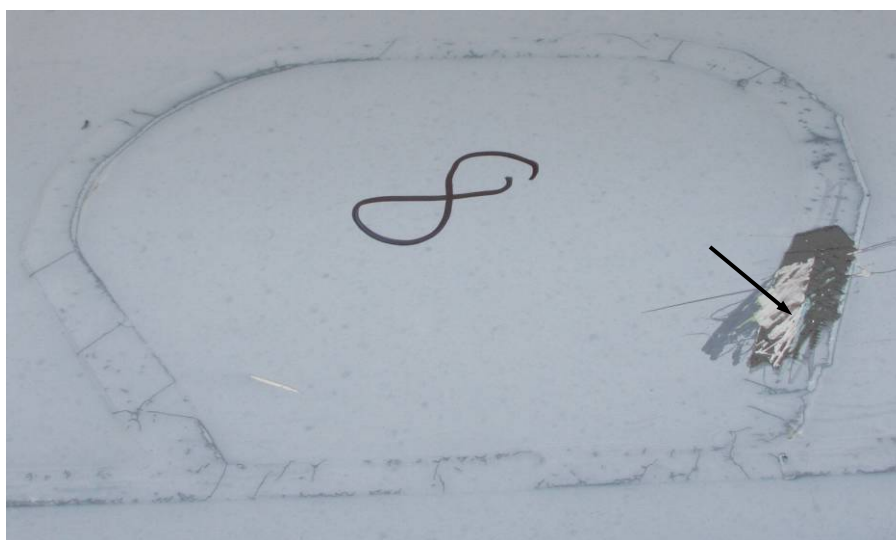
Figure C.2: Photograph of a patch with sufficient sealant removed to identify the blue FM300 adhesive (arrowed)

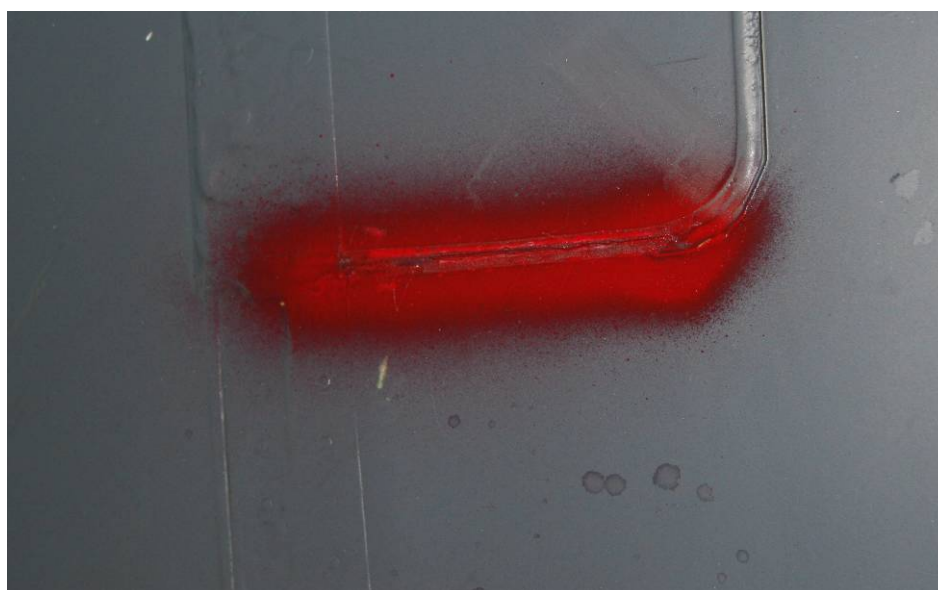
AF130 and AF131 adhesives are brown and contain asbestos. If the adhesive colour is in the yellow to brown range, consult bonding technicians with experience in identification of adhesives containing asbestos. Patches bonded with these adhesives are to be marked with Rust Away red enamel paint as shown in Fig. C.3 and not handled under FABRAP. Any exposed AF130 or AF131 adhesive is to be sealed with a continuous film of Rust Away red enamel spray paint. Where there was any doubt, adhesives were treated as potentially containing asbestos.

Figure C.3: Photograph of a patch containing AF131 adhesive marked with red enamel paint

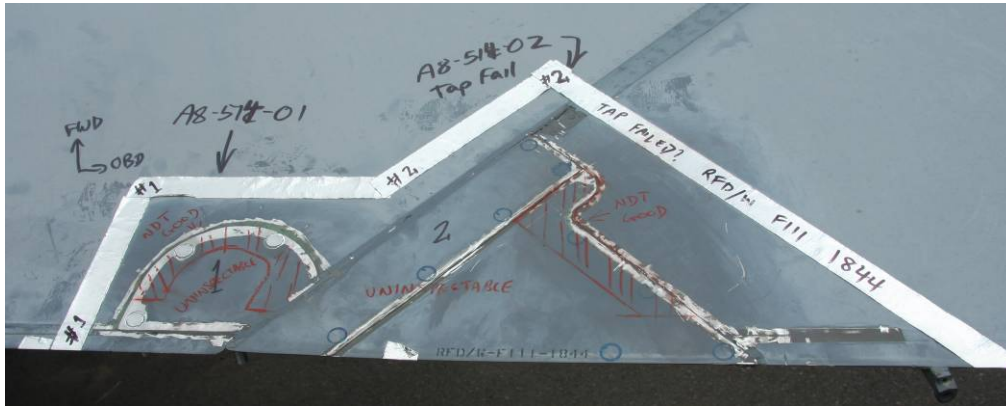
Figure C.4: Photograph of two patches that had been inspected and marked up by 6 Squadron
