Australian Government
Department of Defence
Defence Science and
Technology Organisation

Helicopter Transmission Oil Discolouration

Air Vehicles Division
Defence Science and Technology Organisation

DSTO-TR-2672

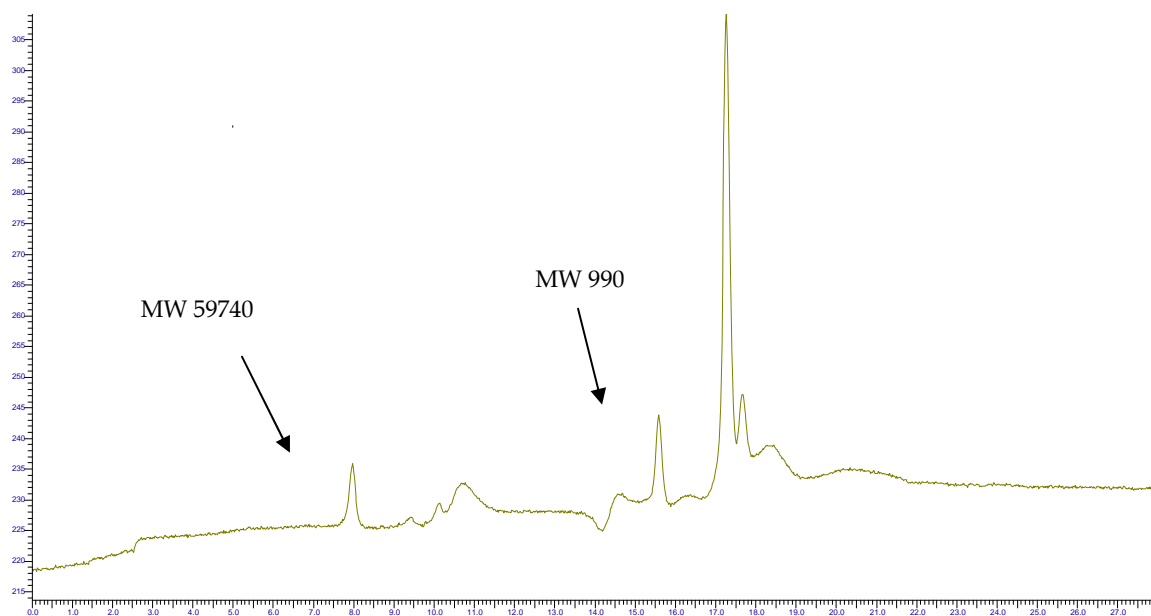
The molecular weights of the isolated purple precipitate and the metal quinizarate standards were examined to determine if the precipitate was due to the formation of insoluble polymers, (Table 3, Figure 5. It was observed that the purple precipitate did contain a range of high

molecular weight components that were similar in weight range to the three metal chelates indicating that metal quinizarate polymers had been formed.

Figure 5. GPC-Refractive Index chromatogram of Black Hawk purple precipitate.

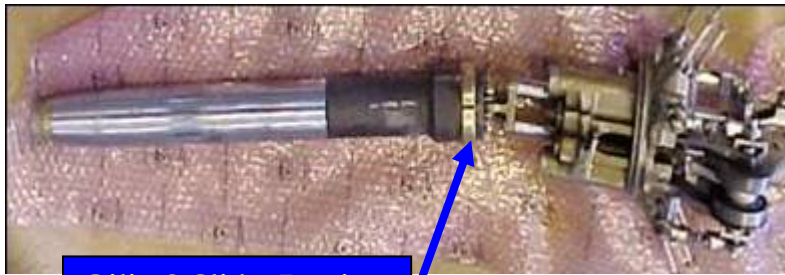
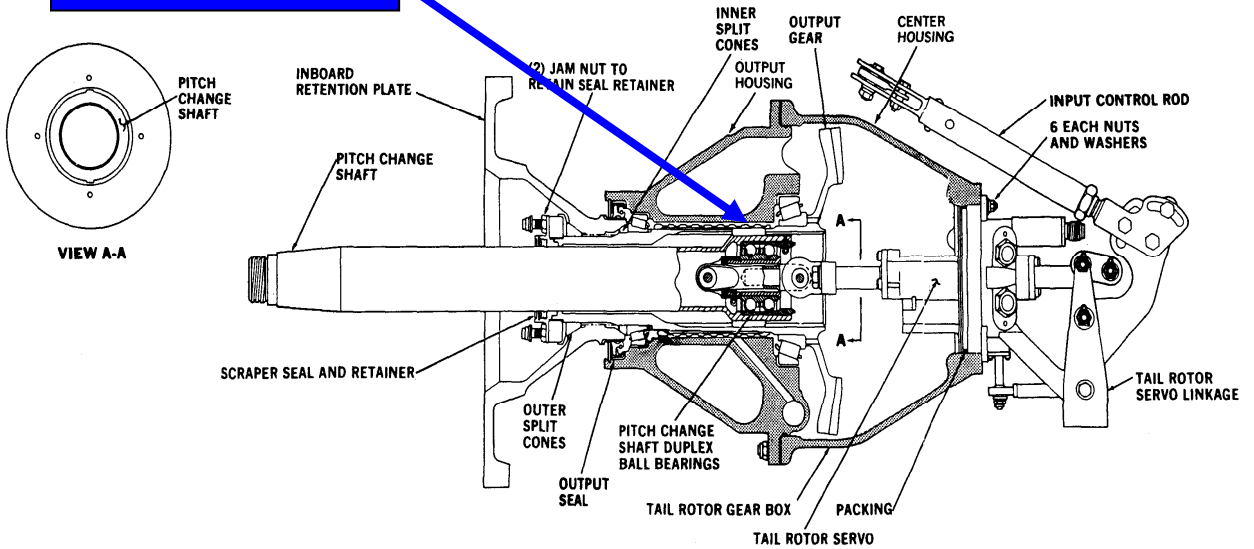
Figure 7: Cross-section of Seahawk/Black Hawk TRGB showing location of Oilite® slider bearing

The pitch change shaft for the tail rotor blades passes through the oil-wetted section of the gearbox and is fitted with an Oilite® bronze slider bearing to accommodate sliding of the shaft (see Figure 1). It is expected that this bearing will wear in service and that the particles generated from that wear will also accumulate in the oil. At present, the degree of slider bearing wear is assessed by one of the following methods:

There is currently no indication that the Oilite® slider bearings are experiencing any abnormal wear. Wear particles accumulating in the oil due to normal in-service wear of the slider bearing would be expected to react directly with the quinizarate and form the purple discolouration/deposit since the bronze bearing material is copper-rich. The serviceability check for the TRGB specifically states that purple discolouration is not a reason for rejecting the gearbox [14].

3. The TRGB Bronze bushing should be checked for excessive wear if the TRGB oil continues to discolour significantly after an oil change out.

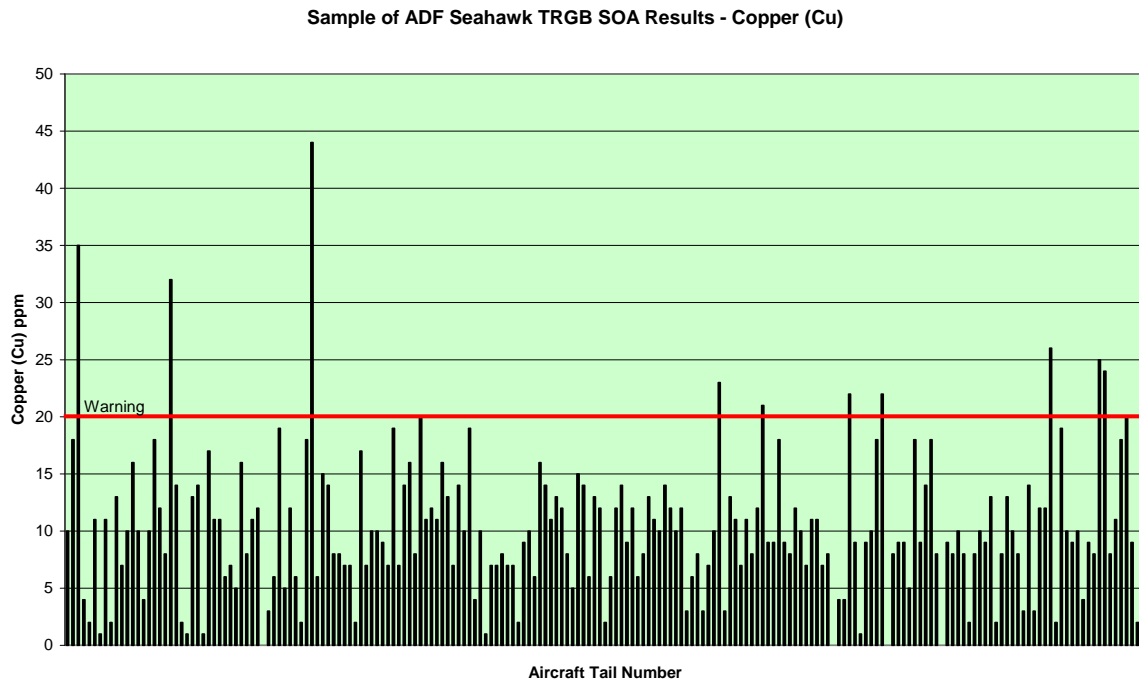
1. By measuring the level of copper in the Spectrometric Oil Analysis (SOA) reports. This oil analysis technique is currently only applied to ADF Seahawk aircraft. The technique is limited to detecting particles less than 8 micron (approximately), however it should detect slider bearing wear. The relative movement of the Oilite® bearing is exclusively sliding and therefore any debris generated is expected to be within the detectable range of SOA. Historical SOA results from Seahawk confirm that copper is being detected (see Figure 2).
2. By visual inspection and dimensional check as part of the routine flight controls inspection. This inspection specifically contains limits for nicks, dents, scratches and outer diameter wear [18].

Figure 8: Sample of ADF Seahawk TRGB SOA Results for Copper (Cu)

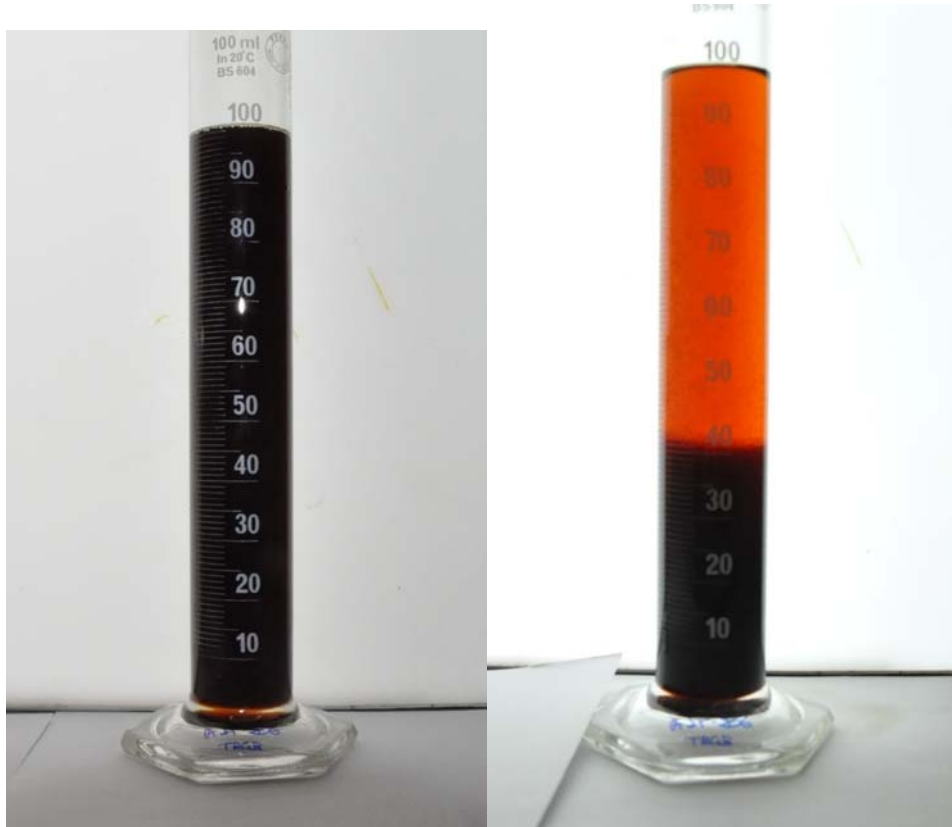
Figures A1 and A2. A25-206 TRGB oil before and after 48 hours standing

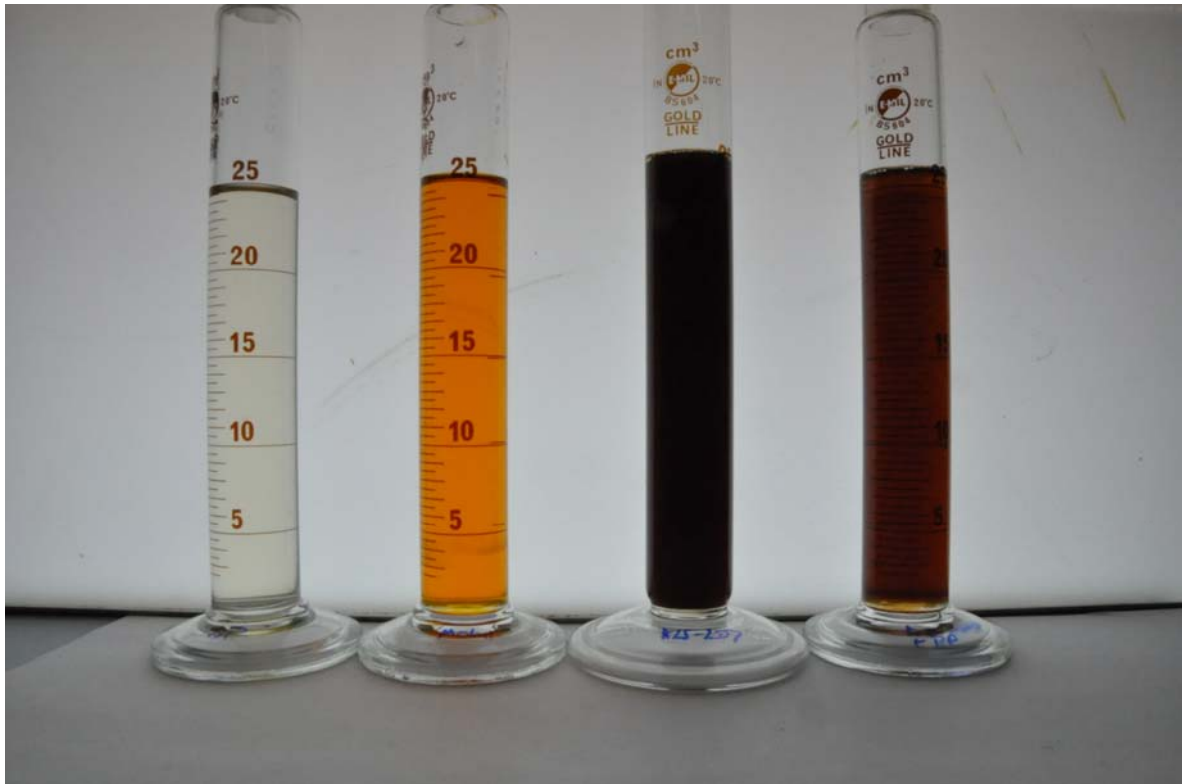
Figure A3. MIL-PRF-23699 Fluids

Left to right: Fresh BP Turbo oil 2380, fresh Mobil Jet Oil 2, Discoloured A25-207 TRGB oil. 50% A25-207 TRGB oil mixed with BP Turbo oil 2380.

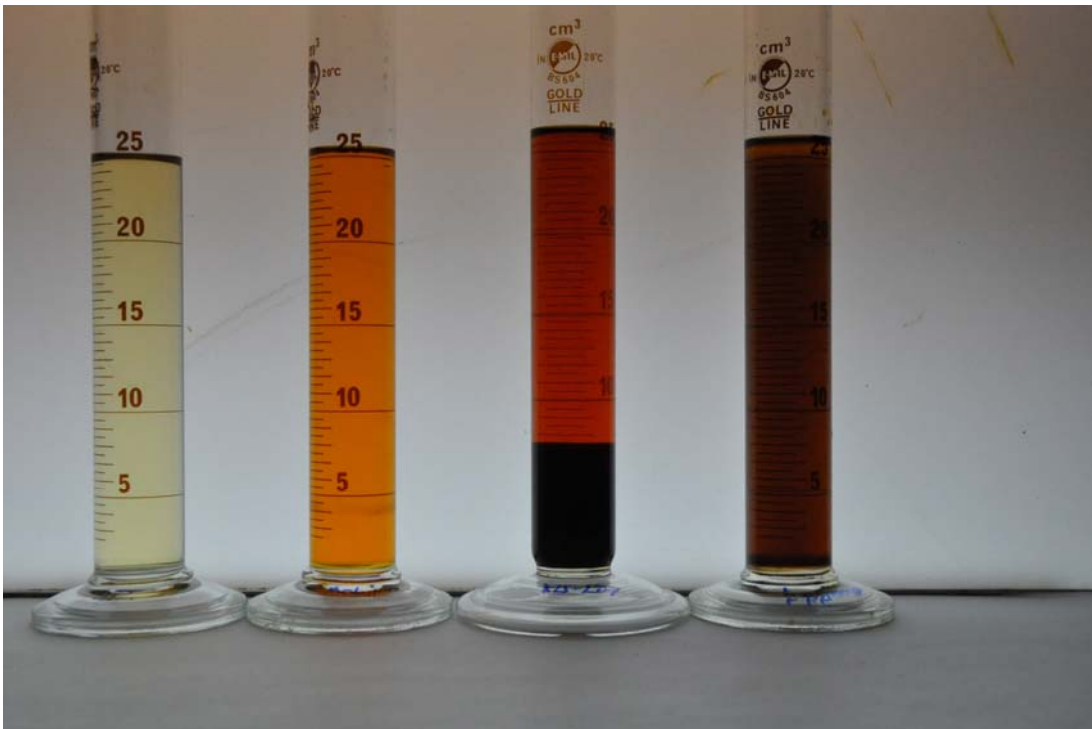
Figure A4. MIL-PRF-23699 Fluids after 48 hours standing.

Left to right: BP Turbo oil 2380, Mobil Jet Oil 2, Discoloured A25-207 TRGB oil. 50% A25-207 TRGB oil mixed with BP Turbo oil 2380. Note the BP Turbo oil 2380 was observed to darken in colour after 48 hours.

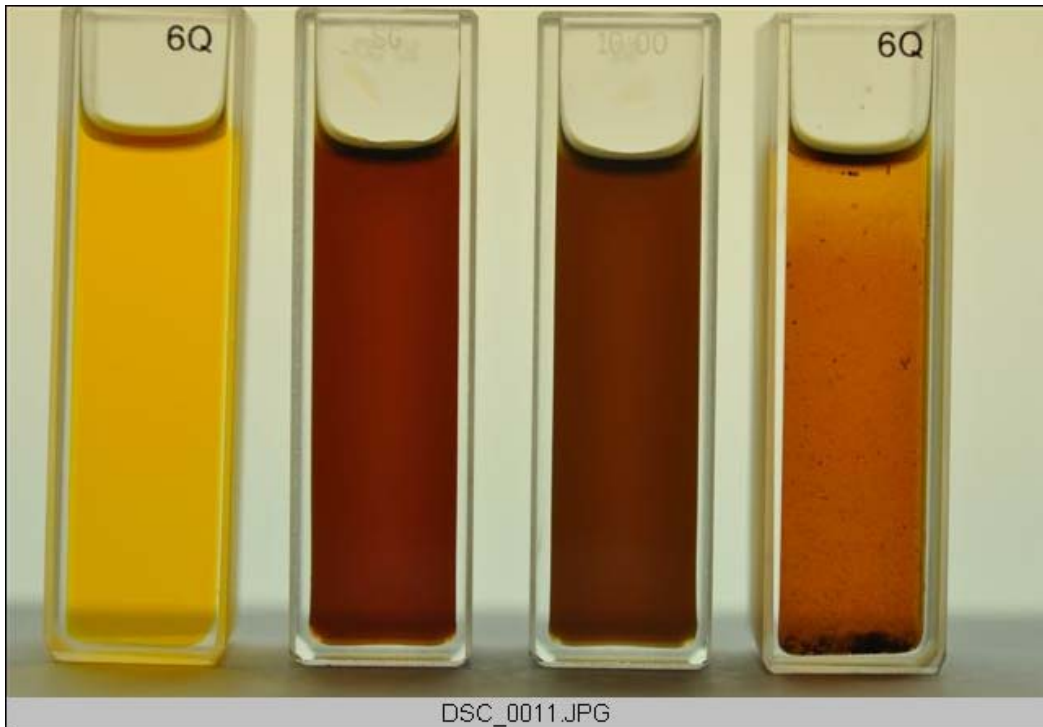
Figure A5. Oil samples from left to right: Fresh Mobil Jet Oil II; A25-107 TRGB; A25-204 TRGB; A25-107 TRGB with precipitate (samples from 2005 archive photo)

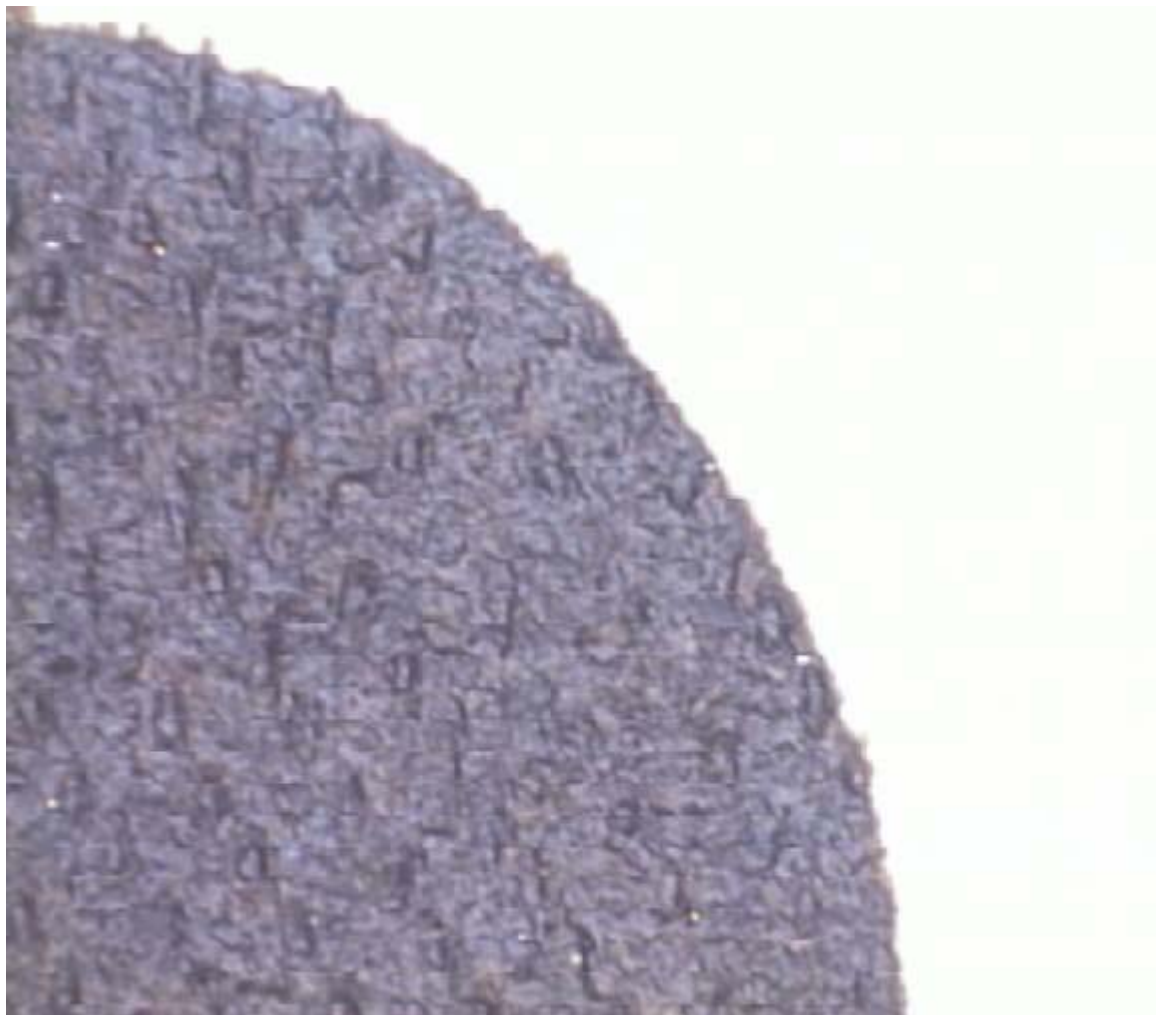
FigureA 6. Filtered and methanol washed "purple" precipitate

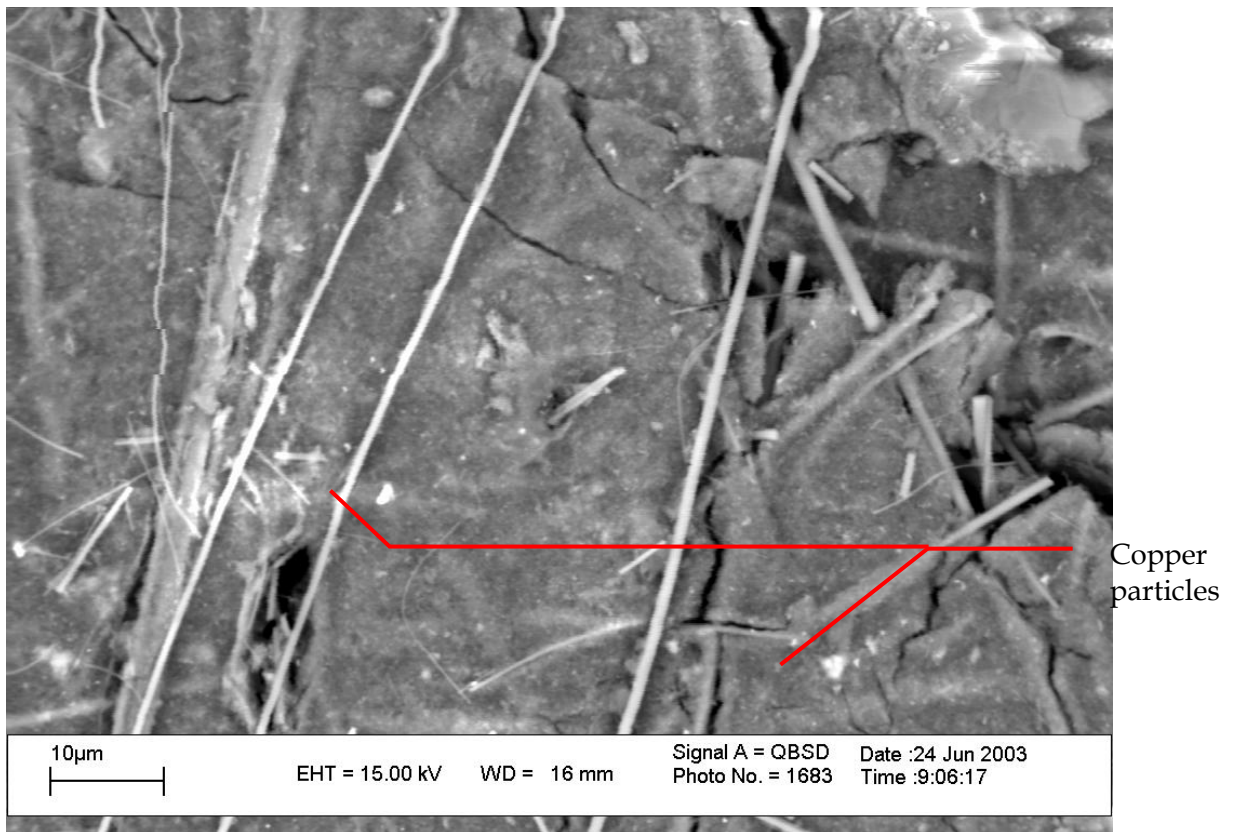
SEM analysis of the precipitate found a significant quantity of copper rich particles entrained in the bulk precipitate, (Appendix A). The metal particles may provide evidence for continued depletion of the quinizarin additive as they dissolve in the oil and may be the cause of the observation that once the oil has begun to show a colour change it will tend to darken with time.

Figure A7: Backscatter Electron Image of purple precipitate

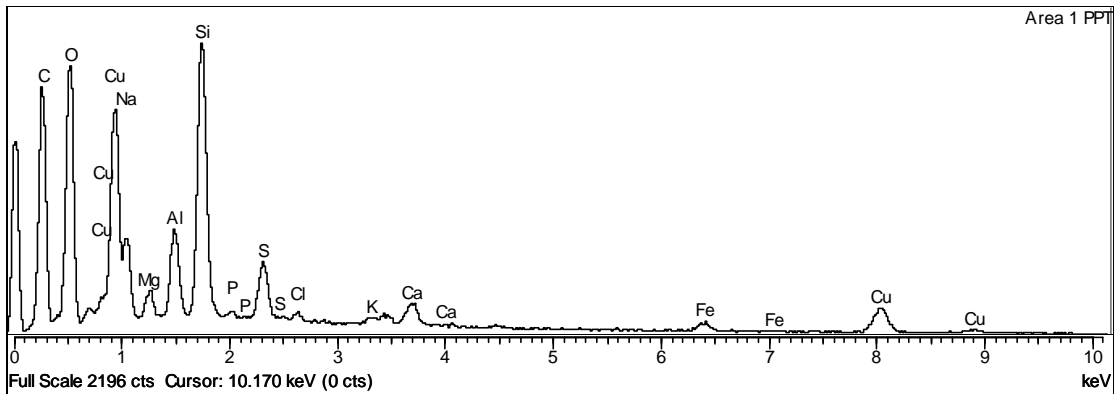
FigureA8: X-ray Scan of MTRG Oil Precipitate, from Figure A7.

(Note the peaks associated with Si, Na, Al, Ca, O and K are at least in part due to the filter media). The C, Cu, Mg, S and Fe is associated with the precipitate

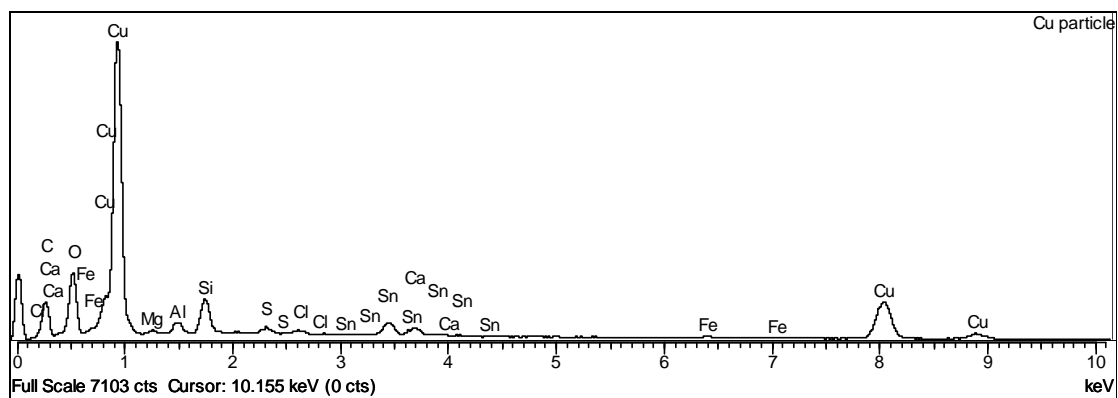
Figure A9: EDS scan of Cu/Sn Rich Particle, from Figure 7

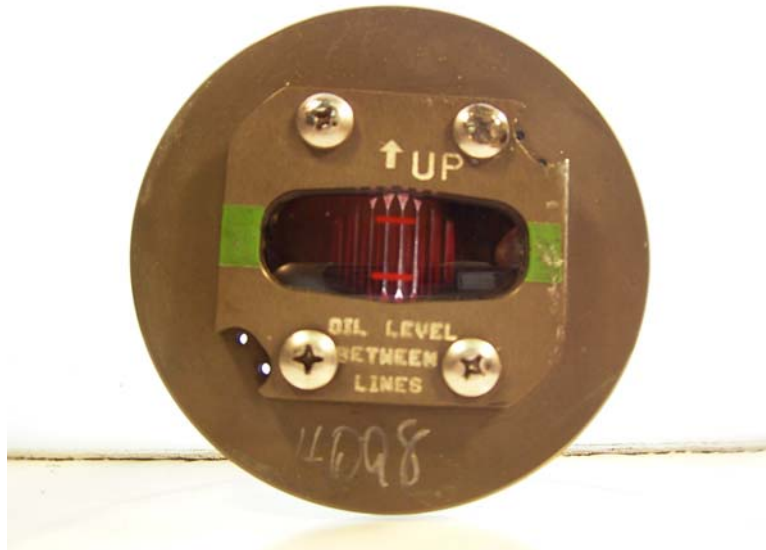
Figure B1. Sight glass from a Black Hawk, rear lit showing obscuration with red stain

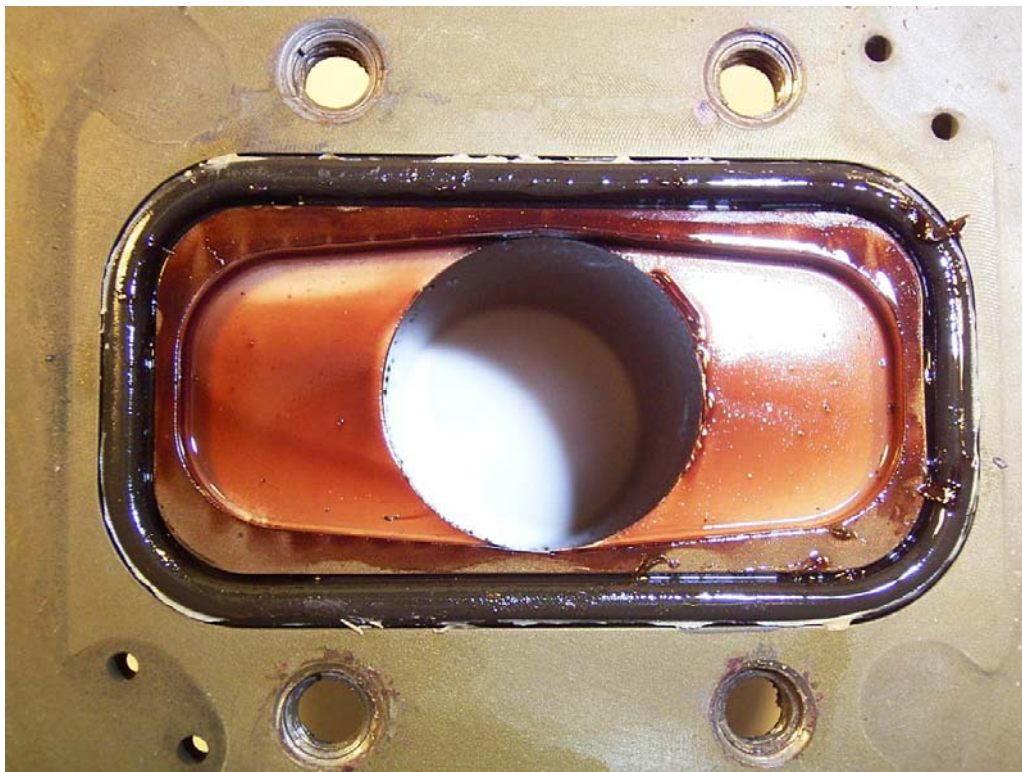
Figure B2. Sight glass, rear plate

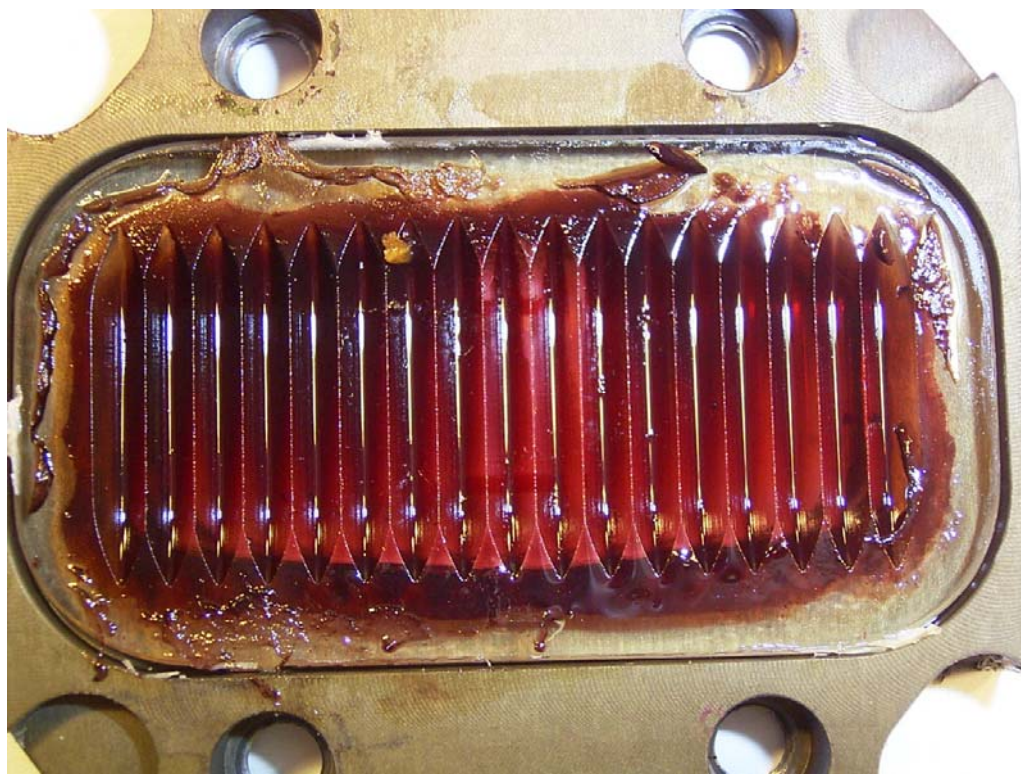
Figure B3. Sight glass inside face showing red stain and white grease like deposit
