75 Years of Scientific Air Accident Investigation Support at the Bend

L. Molent and N. Athiniotis

July 2016

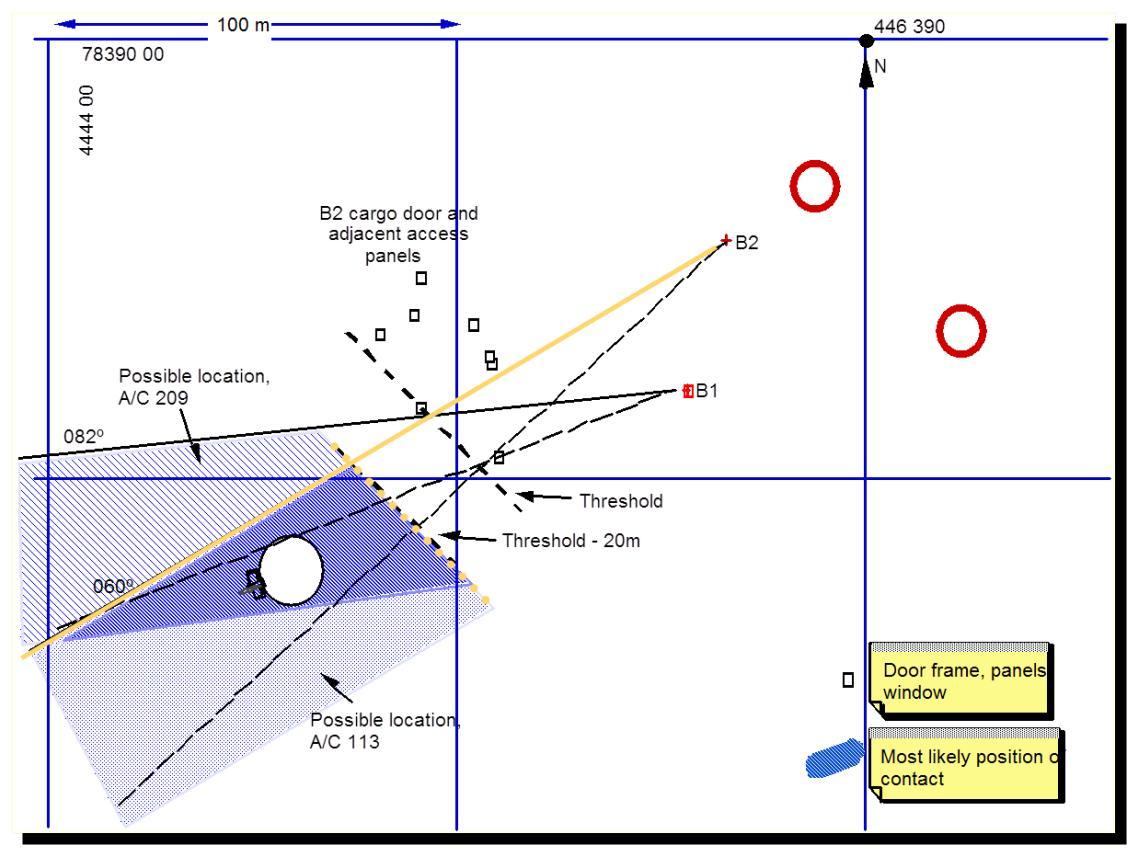
of the two aircraft was made. By conducting individual trajectory analyses of each of the various component groups identified (e.g. rotor blades, light materials, major components) and considering their measured spread on the ground (e.g. Figure 6), the overlapping common areas was considered the most probable area of aircraft contact (see Figure 7). These two technical aspects were critical in postulating a credible scenario to explain the collision.

Figure 6: Debris trajectory analysis of cargo door parts from B1 and B2, indicating most likely location of impact.

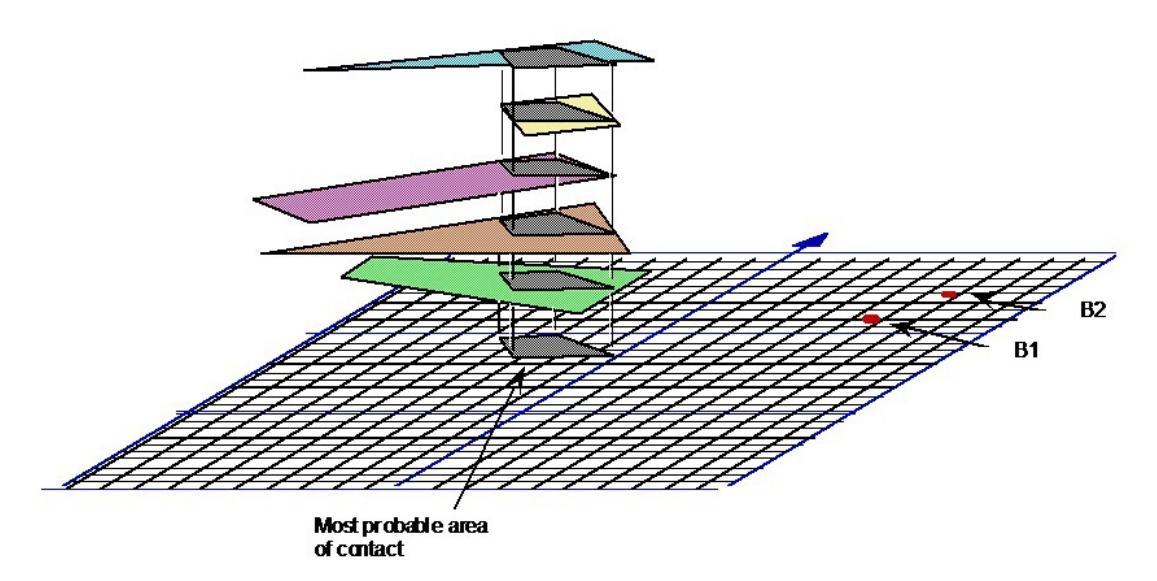
Figure 7: Most likely location of impact (grey shaded area). Each other colour represents the estimated projection of a component group (separated in height dimension for illustration purposes).

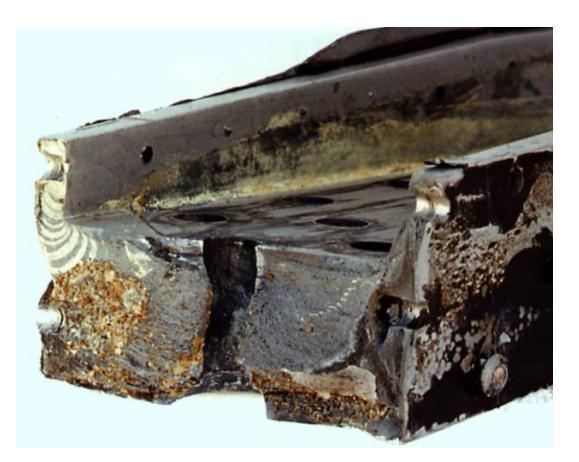
On 22 November 1990 RAAF Macchi aircraft A7-076 was observed by other pilots in the vicinity to suffer a wing failure during an air combat manoeuvre. Examination of the wreckage recovered from the sea disclosed that the port wing had failed when the aluminium alloy 7075-T6 lower spar boom broke as the result of a large fatigue crack [8,9]. The cracking was found to have initiated from a machining detail in the base of a flange fastener hole, Figure 8. This defect had the effect of introducing a severe notch into the fastener hole. Examination of the recovered starboard wing revealed further fastener hole cracking. All spars in the RAAF fleet had been replaced in a life extension program however a fatigue test of the new configuration had not been conducted. Examination of the Deutsch[™] fastener hole from which the fatigue crack initiated revealed that the hole had been drilled though the flange to a depth where the drill tip had just penetrated the rear surface of the flange. This penetration had occurred in the central region of the hole and corresponded to the centre of the tapered end of the drill used to machine the hole. The cracking had initiated at the resultant tapered base of the hole between where the hole penetrated the back face of the flange, and the main bore of the hole. Cracking had occurred

on either side of the penetration, roughly in the plane perpendicular to the length of the spar boom with the cracking on either side being slightly offset. Providence dictated that the step produced by the fastener hole drilling was aligned at the worse possible orientation, namely approximately perpendicular to the principal loading direction. The depth of the notch-step produced was estimated to be approximately 0.22 mm (i.e. a large flaw, see [10]). It was postulated that the stress concentration effect of this notch, coupled with that of the hole and low interference of the fastener, contributed to the rapid crack growth rate. Further,

Figure 8: Fracture surface of A7-076 lower spar cap after recovery from the ocean. Note the fatigue progression marks propagating from the upper (nominally) blind fastener hole (upper left hand side)

teardown inspection of the recovered starboard wing revealed the presence of other fatigue cracks, including at the mirror location to the port wing failure site; generally these cracks could also be attributed to poor hole machining quality. With the aid of the load history from the aircraft's Nz meter, the growth pattern on the fatigue fracture surfaces of two holes was determined via quantitative fractography. The largest of the cracks were investigated to establish their growth rates which, coupled with assistance of the non-destructive inspectors, enabled the RAAF to conduct a safetyby-inspection program which helped to recover their training capability.

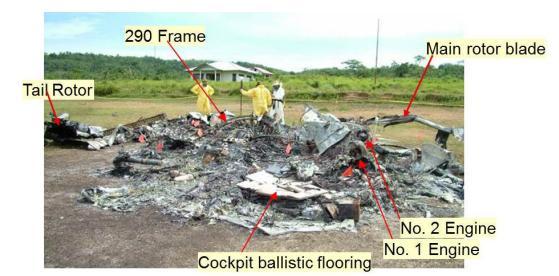
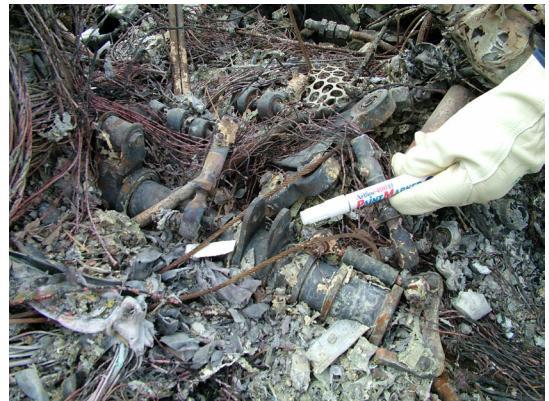
The most significant evidence found suggested that a flight control system failure occurred due to disconnection of the fore/aft bellcrank from the flight control's Mixing Unit (see Figure 10). The physical evidence indicated that an unsecured castellated nut detached from the end of a bolt holding the fore/aft bellcrank onto the Mixing Unit lugs. The bolt then slid out of the lugs, permitting the bellcrank to separate from the Mixing Unit. The Sea King flight modelling developed at DST indicated that the forward motion of the bellcrank and its detachment from the fore/aft lugs of the Mixing Unit would, in less than a second, cause the aircraft to pitch forward rapidly, leading to a nosedive towards the ground. Any fore/aft inputs made by the pilot with the cyclic stick would have been ineffective because the disconnection of the fore/aft bellcrank from the Mixing Unit prevented fore/aft cyclic stick motions from being transmitted to the swashplate. There was no possibility of recovering the aircraft.

Figure 10: Sea King Accident Site, and disconnected fore/ aft bellcrank (below)

The last known maintenance activity on the fore/aft bellcrank occurred on HMAS KANIMBLA, 40 flight hours before the accident, by Sea King detachment personnel on 4 February 2005. The fore/aft bellcrank was removed due to suspected lateral play in the pivot point of the Mixing Unit.

Due to the difficulty in re-installing the item, the maintenance activity carried out by the early watch handed over the task to the late watch with the fore/aft bellcrank loosely secured at the pivot point, with the castellated nut not torqued and with no split-pin fitted. Whilst those undertaking the maintenance were aware of the activity, no aircraft maintenance documentation existed that recorded the removal, serviceability assessment, reinstallation or final inspections of the fore/aft bellcrank. This meant that there was no documented record of a critical maintenance operation task to act as a prompt for the necessary associated maintenance and inspections. It was considered that this lack of documentation and therefore prompt to inspect the critical item which may have noticed the missing split pin, that ultimately led to the unwinding of the castellated nut, extraction of the bolt and separation of the fore/aft bellcrank from the Mixing Unit pivot point.

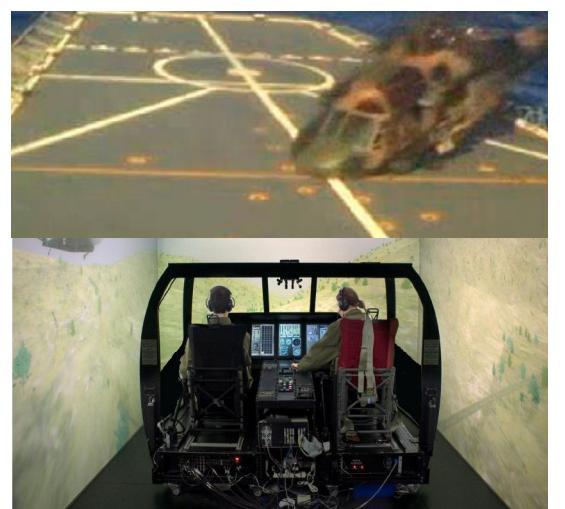
Figure 11: Black Hawk impact on HMAS Kanimbla, and DST Simulator with 'roll-in' Black Hawk cockpit

DST presented its evidence alongside DDAAFS at the subsequent BoI. The BoI determined that "The principal and overarching finding of the BoI was that the cause of the crash was pilot error by the aircraft captain," and "this accident was the regrettable result of a number of factors coming together which culminated in this tragic incident. There was a gradual adoption of approach profiles which, on occasions, exceeded the limits of the aircraft. Other factors included a 'can do' culture in the Squadron, inadequate supervision, the pressures of preparing for operations, the relocation of the Squadron and a high operational tempo".

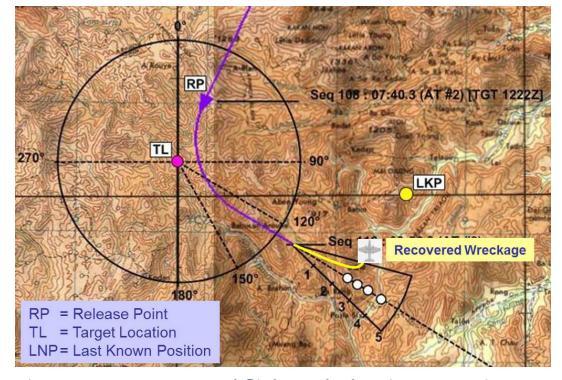
The DST reconstruction provided a refined area of interest for the Principal Investigator (see Figure 13), which assisted in discovery of an aircraft. DST forensic examination of items recovered from the wreckage site confirmed that this aircraft was the missing RAAF Canberra and its crew.

Figure 13: Reconstructed flight path showing approximate location of recovered aircraft. RP =Release Point, TL=Target Location, LKP= Last Known Position based on radar 1970. DST predicted quadrants including possible in-flight breakup (debris field based on fragmentation size).

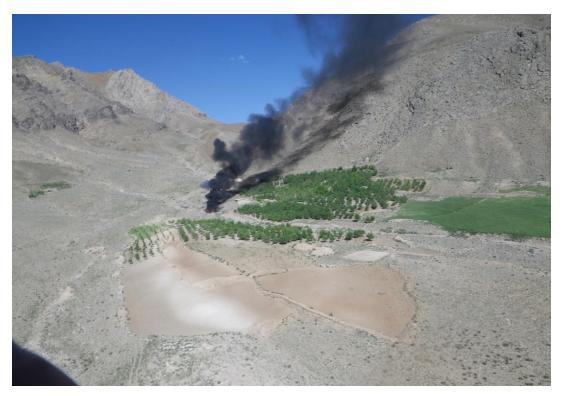
Figure 15 - Graphic illustration of possible crash site

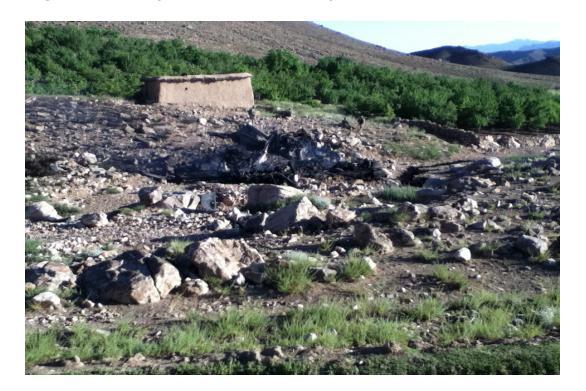
Figure 16: Remaining debris at crash site
