Australian Government Department of Defence Defence Science and Technology Organisation

Fatigue Crack Initiation from Pitting Introduced during the Anodising Process

DSTO-TR-2729

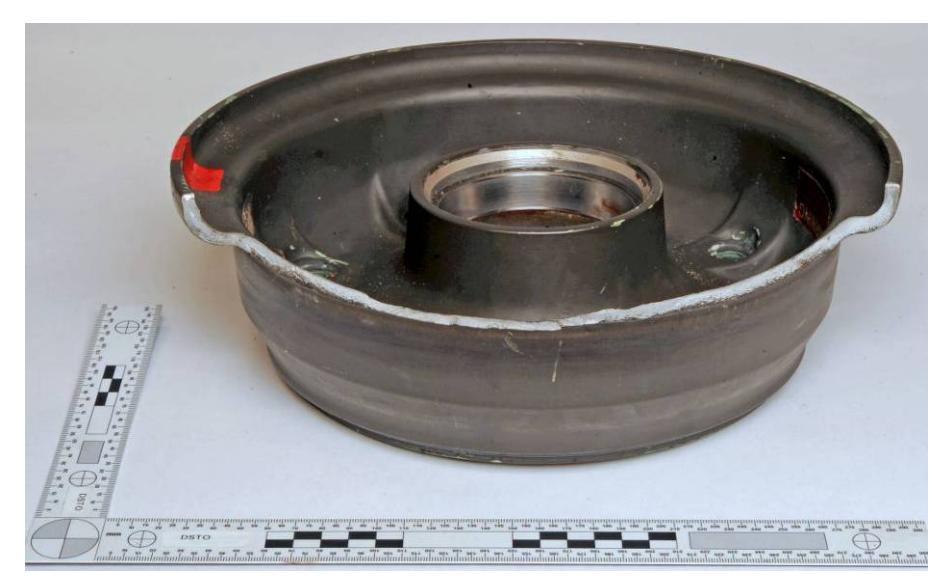
The left hand forward inboard wheel from an ADF rotary wing aircraft was found to be fractured during scheduled Daily Flight Servicing [8]. Figure 1 shows the wheel following removal of the tyre. A section comprising approximately one third of the circumference of the rim had broken away from the wheel at the bead seat and was located on the taxiway. The wheel had been in service for 1798 airframe hours (AFHRS) and was manufactured from aluminium alloy 2014-T6 with a sulphuric acid anodising surface treatment.

Figure 1. Photograph of the wheel following removal of the tyre. A section comprising approximately one third of the circumference had separated from the wheel at the bead seat.

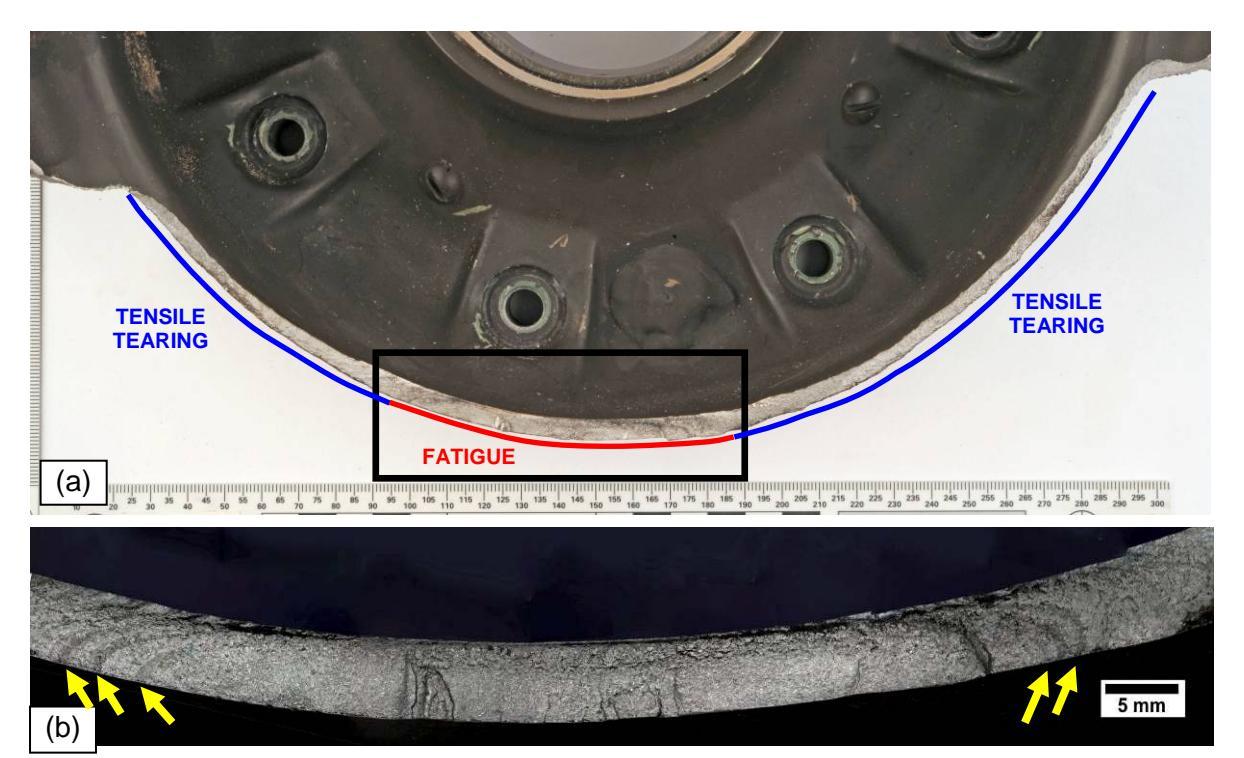
Examination of the fracture surface revealed the presence of progression marks and tear bands, indicative of fatigue cracking, see Figure 2. The area of fatigue cracking extended approximately 85 mm around the circumference of the wheel before final tensile failure occurred. It was observed that numerous fatigue cracks had initiated on the outer surface of the wheel and propagated inwards. Higher magnification examination revealed surface etch pits up to 40 μ m diameter and 40 μ m depth, and corrosion pits up to 300 μ m in diameter and 100 μ m in depth, at the origins of the fatigue cracks. Paint was observed within these pits, see Figure 3.

Figure 2. Photographs of (a) the fracture surface of the wheel with the areas of tensile tearing indicated with blue lines and the area of fatigue indicated with a red line, and (b) a higher magnification image of the fatigue region (area boxed black in (a)). Tear bands at the outer edges of the fatigue region are indicated with yellow arrows.

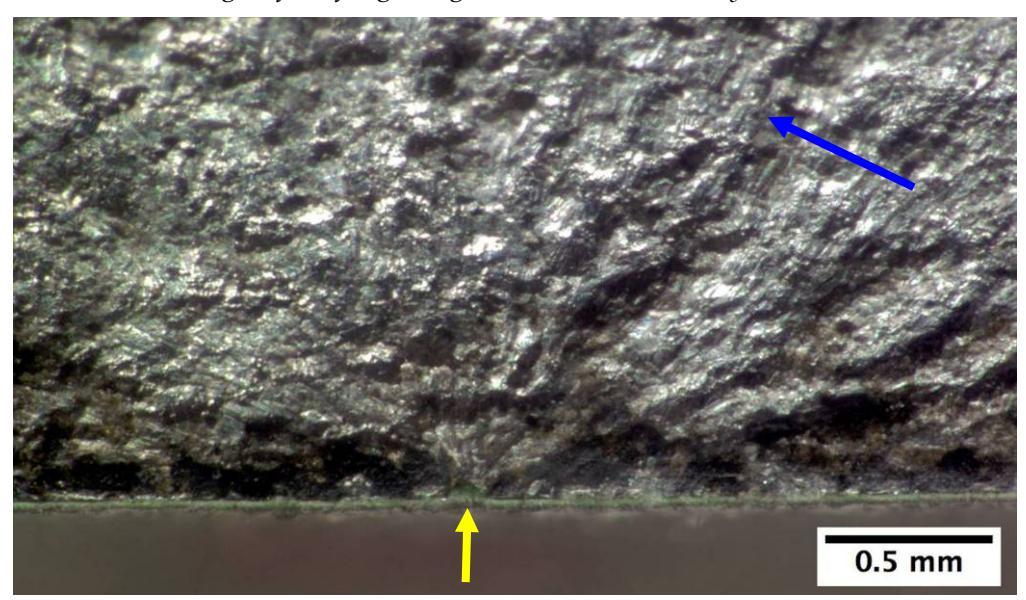
Figure 3. Photograph of a fatigue crack observed on the fracture surface. A fatigue progression mark is indicated with a blue arrow. The pit at the origin of the crack (approximately 40 µm in depth), which was observed to have been painted, is indicated with a yellow arrow.

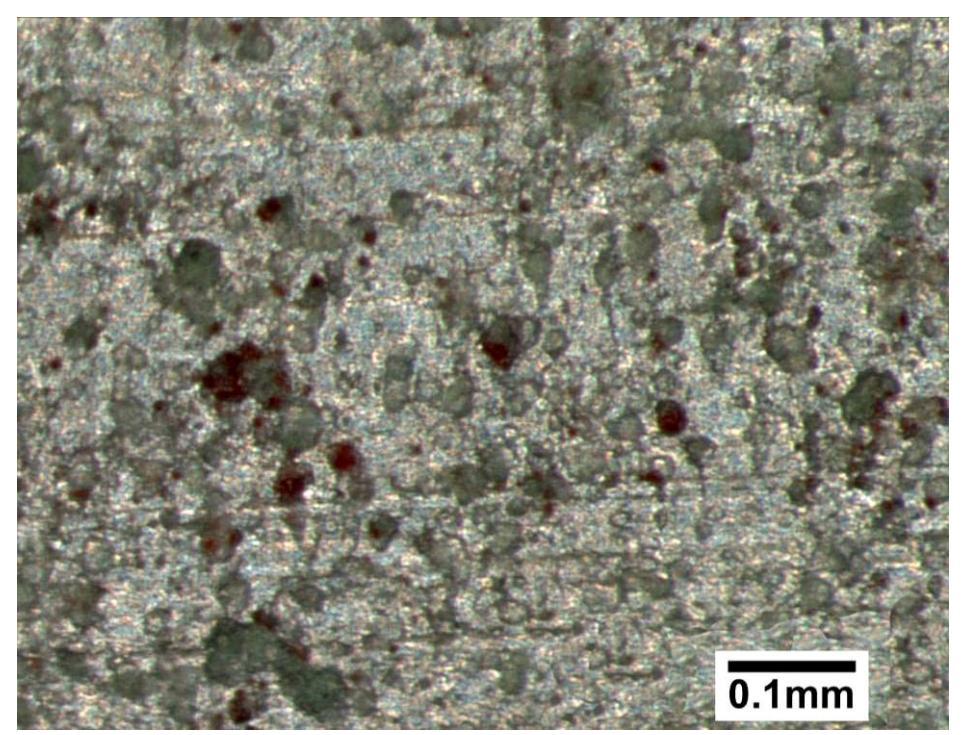
Following removal of the paint from a section of the wheel, it was observed that the surface of the wheel was extensively pitted, with smaller rounded etch pits and larger corrosion pits present, see Figure 4 and Figure 5. The size of these pits was consistent with the pits observed at the fatigue crack origins.

Figure 4. Photograph of the outer surface of the wheel following paint removal. The surface exhibited extensive rounded etch pits up to 40 µm diameter.

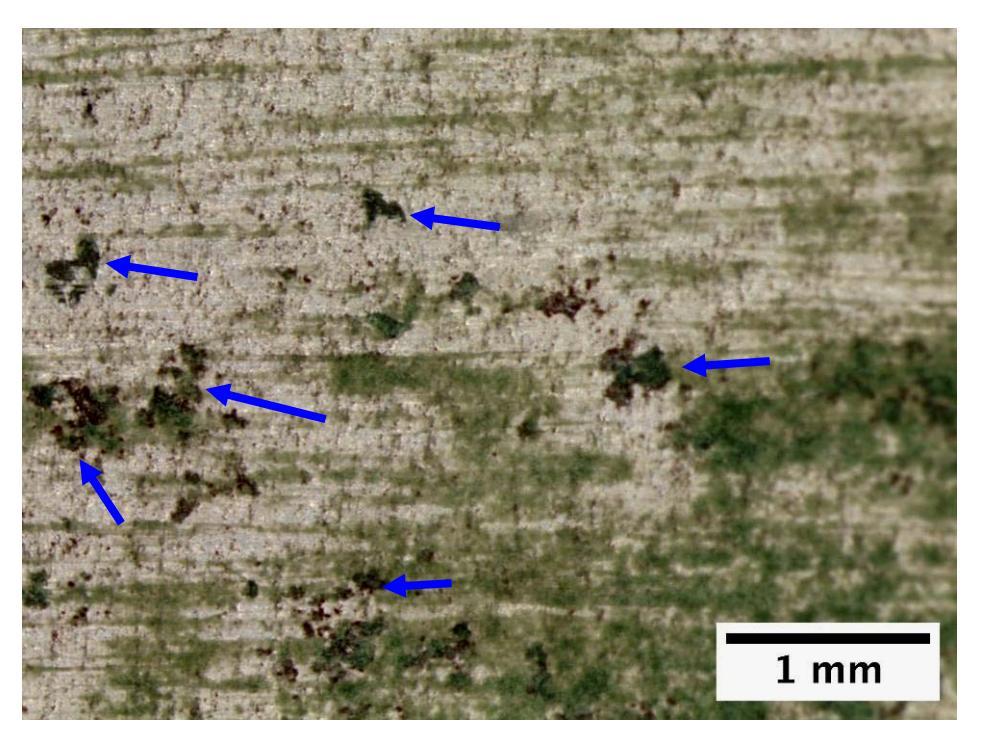
Figure 5. Photograph of the outer surface of the wheel following paint removal showing dispersed corrosion pits, indicated with blue arrows.

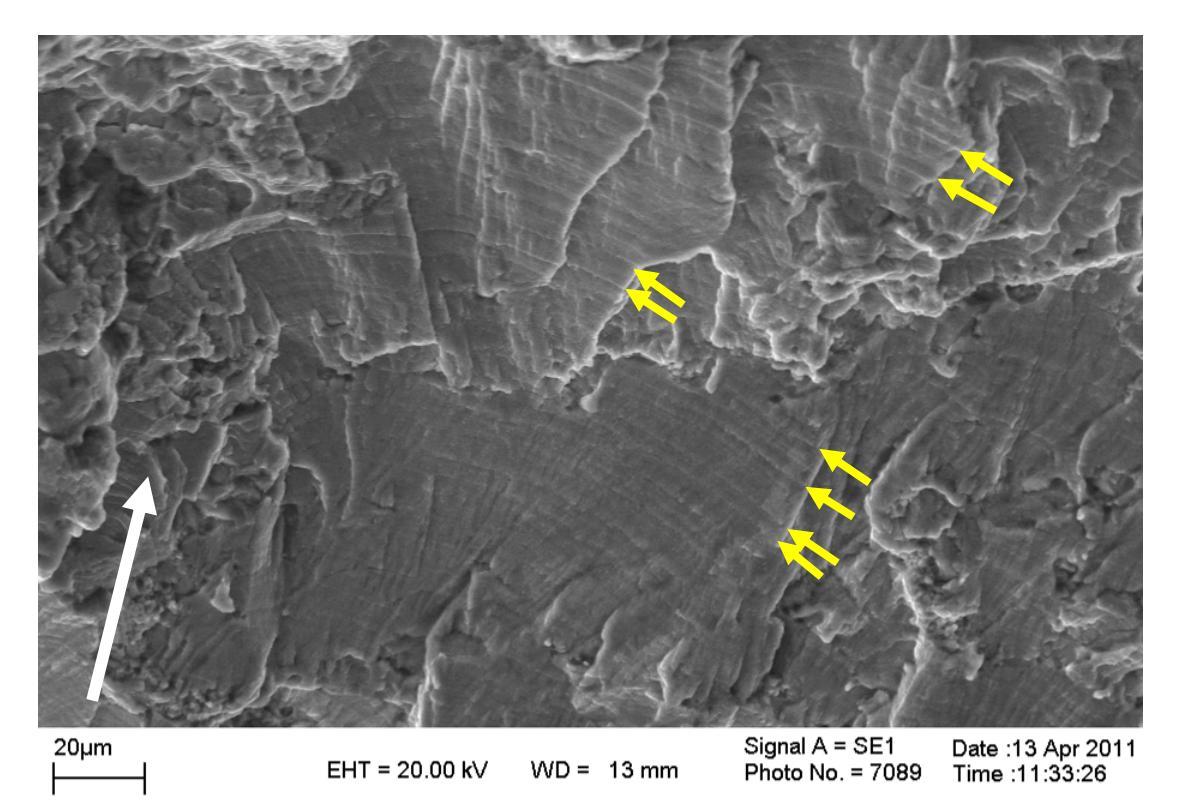
Scanning Electron Microscope (SEM) examination of the fracture surface confirmed that the failure mode was consistent with fatigue, with progression marks present over the fracture surface, see Figure 6. Examination of the corrosion and etch pits present at the crack initiation sites revealed that they had been anodised and painted, see Figure 7 and Figure 8, which indicated they were present at production.

Figure 6. SEM photograph of the fracture surface on which numerous progression marks were observed, examples indicated with yellow arrows. Crack growth direction is indicated with a white arrow.

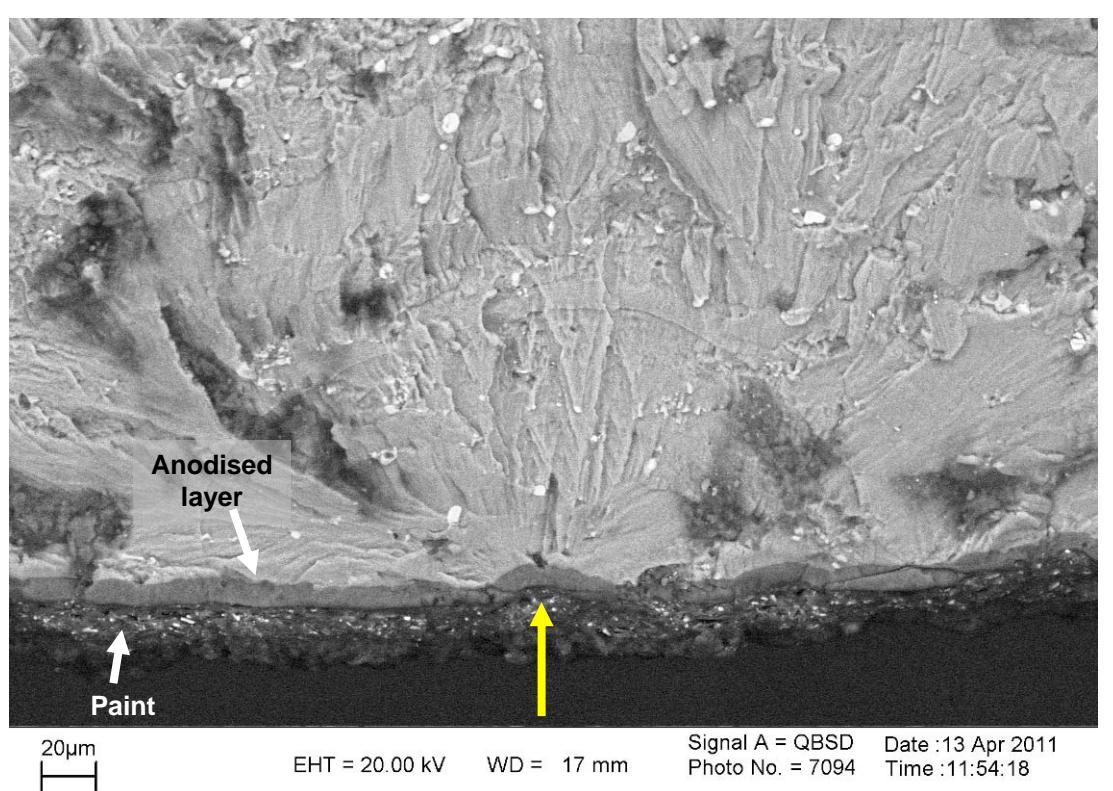
Figure 7. SEM photograph showing a fatigue crack that initiated from a surface pit (8 µm depth), indicated with a yellow arrow. The pit was observed to be both anodised and painted.

Fatigue cracking had initiated from etch and corrosion pits present on the wheel's external surface. The etch and corrosion pits were anodised and painted, indicating that they had formed prior to anodising. The existence of etch pits over all surfaces suggests that they likely formed when the wheel was immersed in a bath during a pre-anodising process. The corrosion pits likely grew from etch pits due to environmental exposure prior to surface finishing.

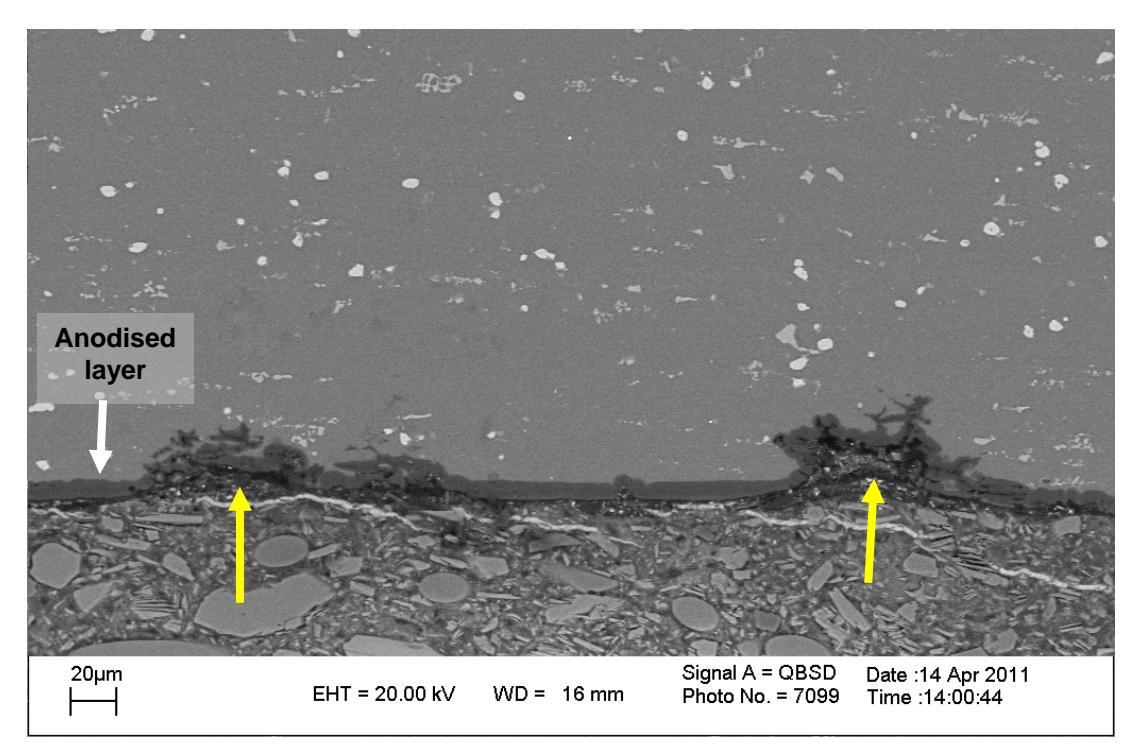
Figure 8. SEM photograph showing two corrosion pits in cross-section, indicated with yellow arrows. The surfaces of the pits were found to have been anodised.

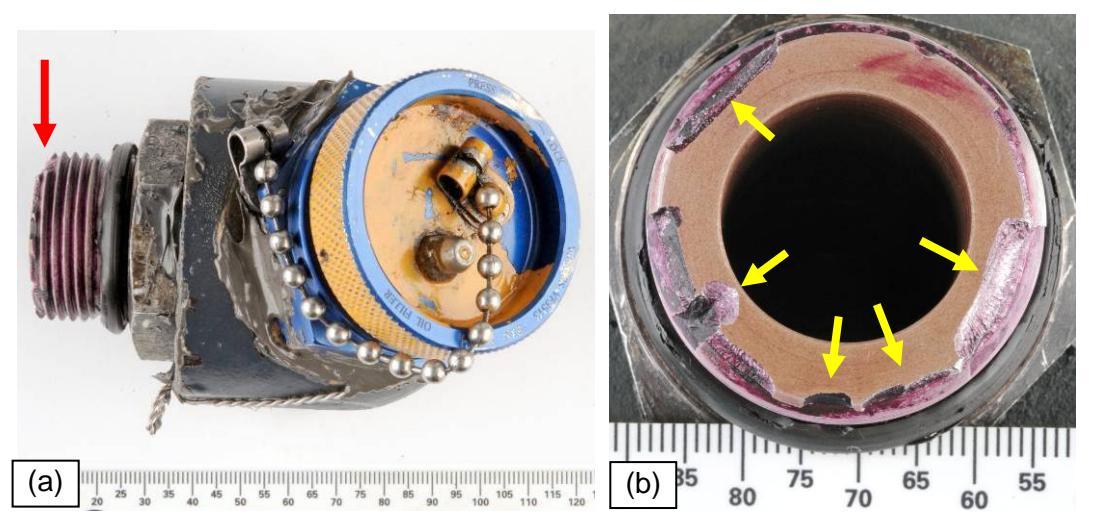
During removal of the gearbox oil filler assembly from an ADF rotary wing aircraft, the first thread of the oil filler adapter was found to have fractured [9]. Two failures of this type had previously occurred. The adapter, shown in Figure 9, was manufactured from aluminium alloy L168-T6 (equivalent to AA 2014) with a chromic acid anodising surface treatment.

Figure 9. Photographs of the oil filler adapter as received. The first thread was fractured, as indicated with a red arrow in (a). Fracture occurred in several locations, examples indicated with yellow arrows in (b).

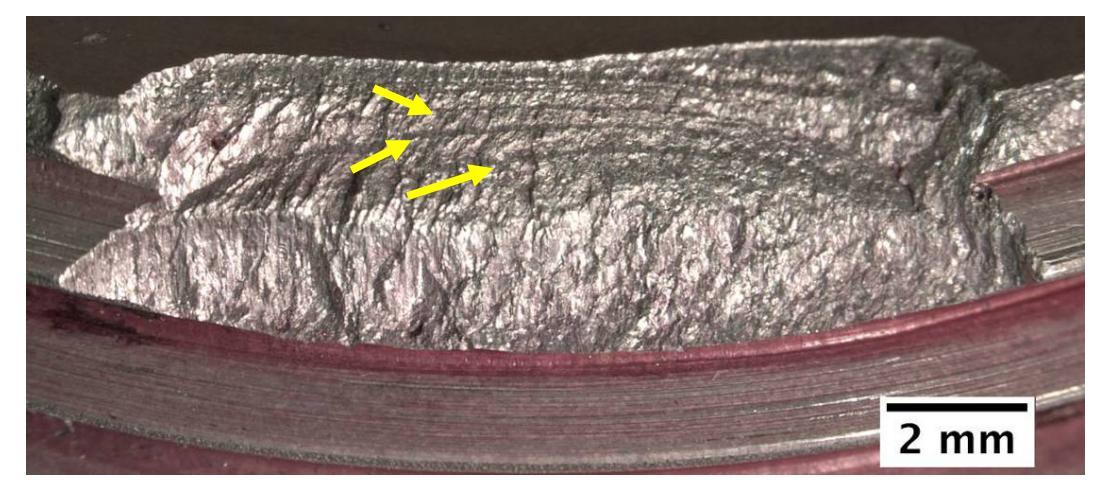
Following cleaning, the fracture surfaces on the first thread were examined and found to be consistent with fatigue cracking, see Figure 10. The cracks had initiated at corrosion pits up to 80 μ m diameter and 30 μ m depth at the thread roots, see Figure 11. SEM examination of the fracture surfaces confirmed cracking was via fatigue, with numerous progression marks present, see Figure 12 for example, and corrosion pits present at the crack initiation sites, see Figure 13.

Figure 10. Photograph of the cracking present on the first thread. The cracking originated at the thread root and was consistent with fatigue. Examples of progression marks are indicated with yellow arrows.

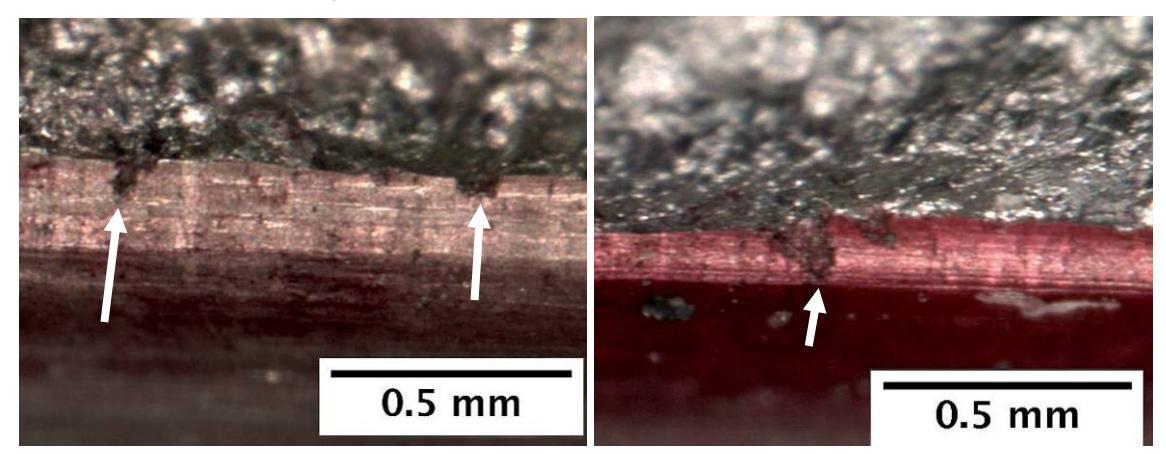
Figure 11. Photographs of pitting (arrowed white) observed at the initiation sites of the fatigue cracks. Corrosion pits up to 80 µm diameter and 30 µm depth were observed.

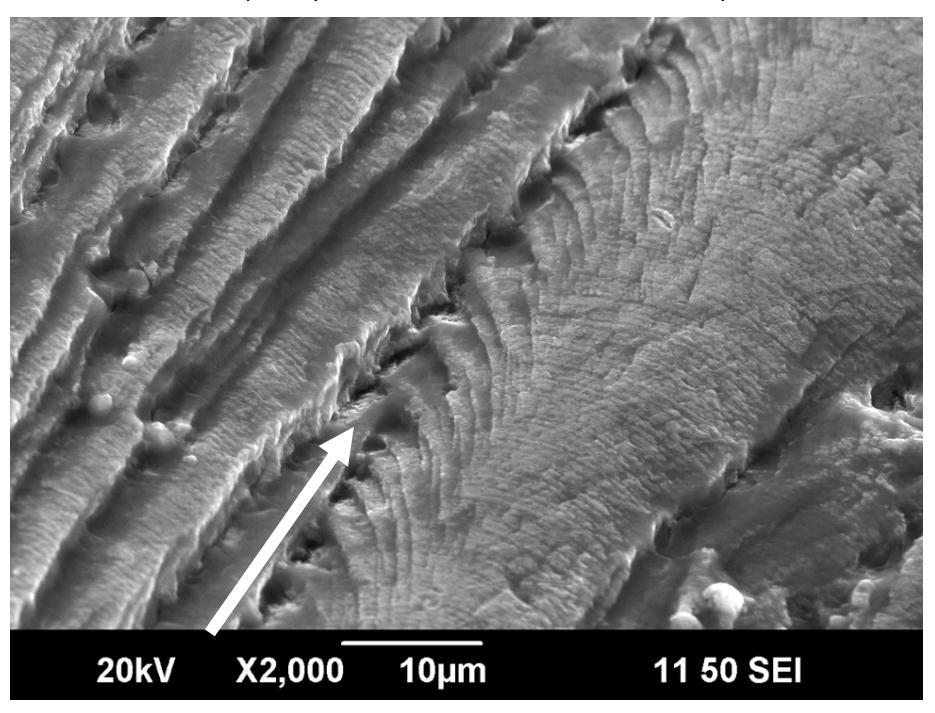
Figure 12. SEM photograph of the fracture surface showing the numerous progression marks, appearing as a series of curved bands on the surface. Crack growth direction is indicated with a white arrow.

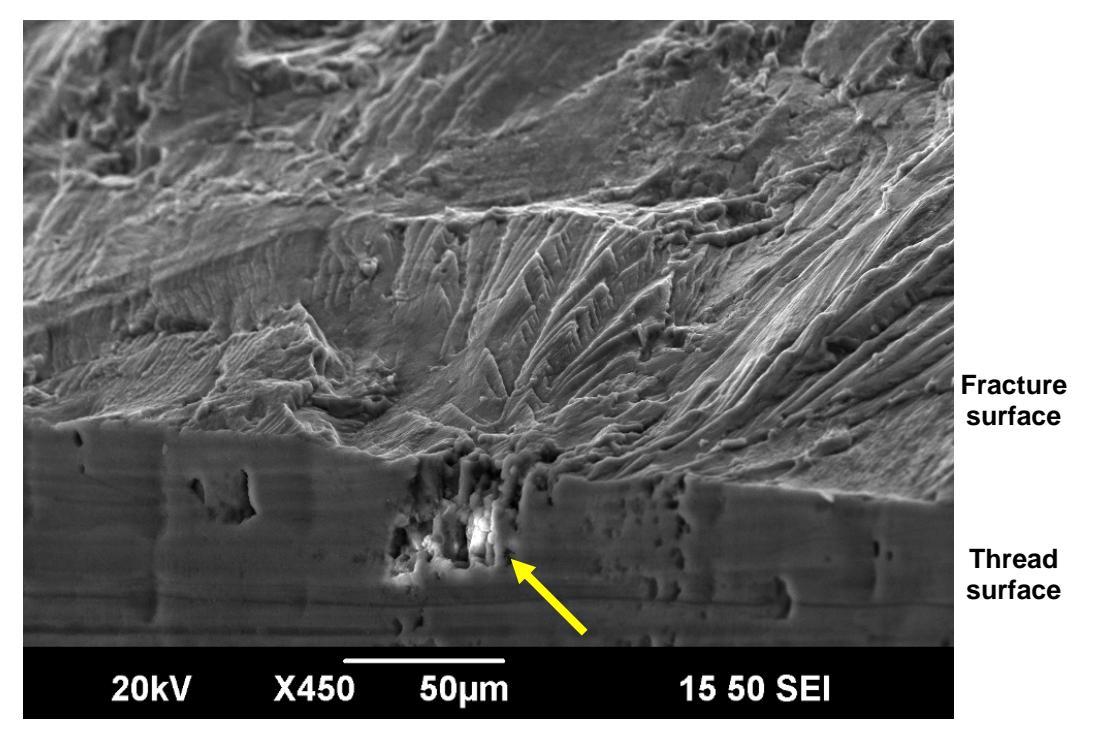
Figure 13. SEM photograph showing fatigue crack initiation from a surface pit (arrowed yellow).

The pits acted as stress concentrators for crack initiation, with stresses arising from normal operations providing the driving force for crack growth. As the component was supplied by the manufacturer in the anodised condition, other oil filler adapters from the same batch were likely to suffer from significant etch and corrosion pitting.

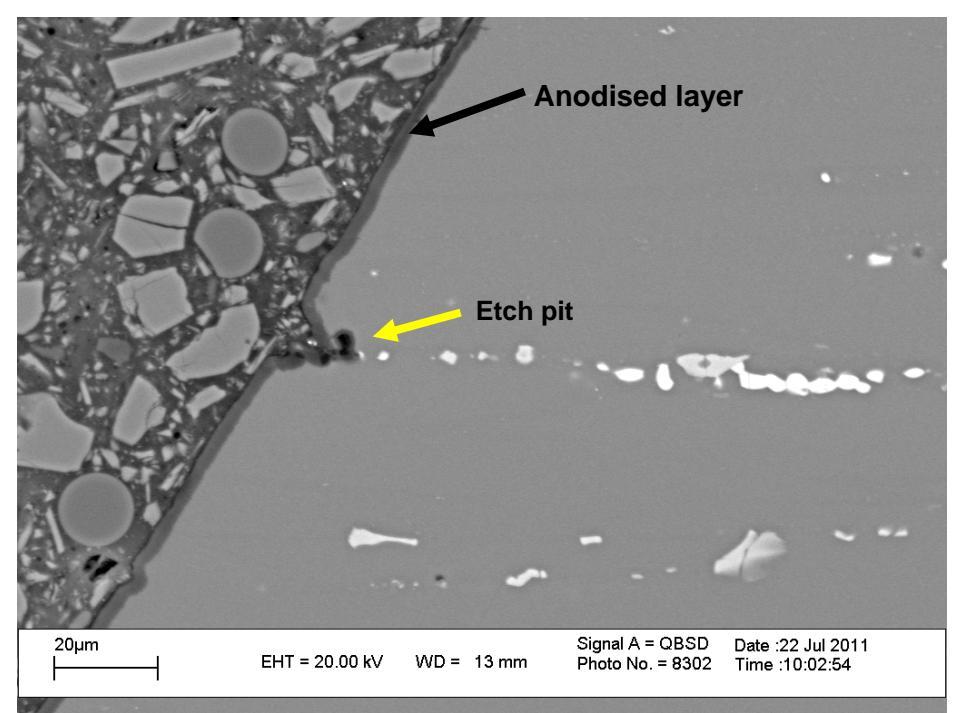
Cross-sections cut through the threaded section of the oil filler adapter revealed the presence of fine etch and larger corrosion pits on the threads, see Figure 14 and Figure 15. The surfaces of the etch pits were anodised while the corrosion pits were only partially anodised, which indicated that further corrosion and growth of the pits had occurred following anodising.

Figure 14. SEM photograph of etch pitting observed in a polished metallographic cross-section through the oil filler adapter. The surfaces of the pits were anodised. Pits were observed to be up to 12 μ m in diameter and 10 μ m in depth.

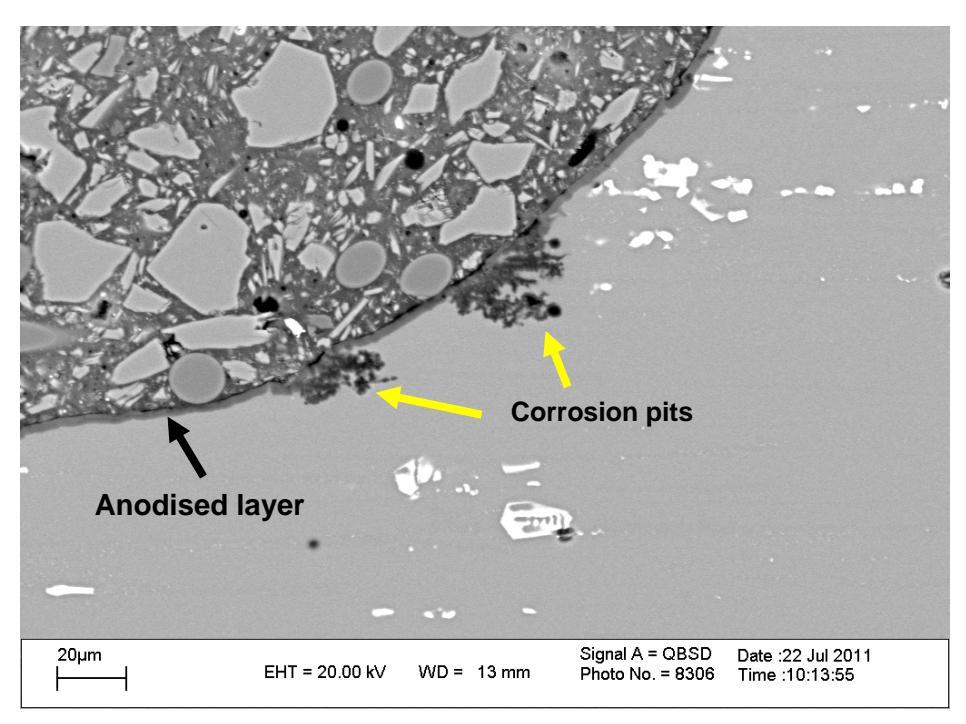
Figure 15. SEM photograph of corrosion pitting observed in a polished metallographic crosssection through the oil filler adapter. An anodised layer was present at the surface and within the pits.

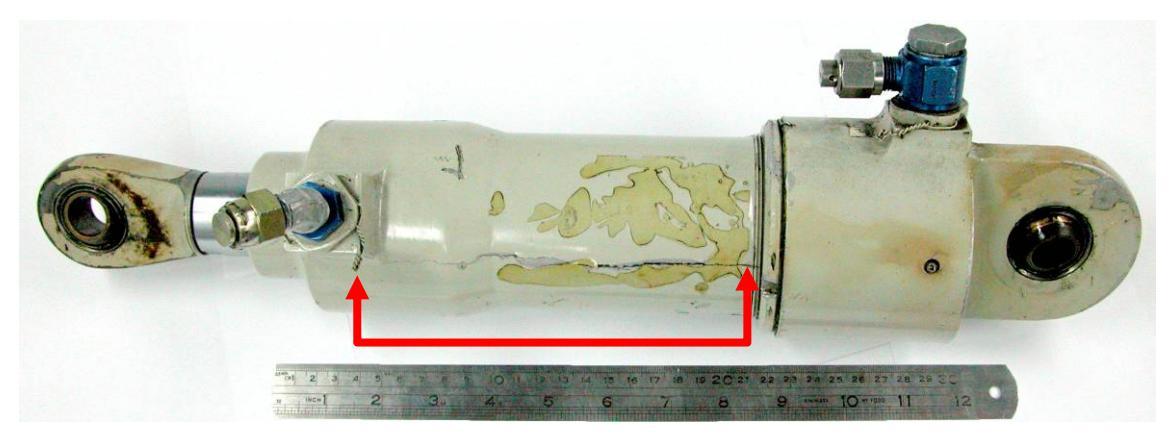
Cracking was observed on the hydraulic cylinder of the left hand retractor actuator from the main landing gear of an ADF fixed wing aircraft [10]. The crack ran along the length of the cylinder and was found to be 163 mm long, see Figure 16. The hydraulic cylinder was manufactured from aluminium alloy 2014 in the T6 condition.

Figure 16. Photograph of the main landing gear hydraulic cylinder. A 163 mm crack was present along the length of the cylinder, as indicated with a red arrow.

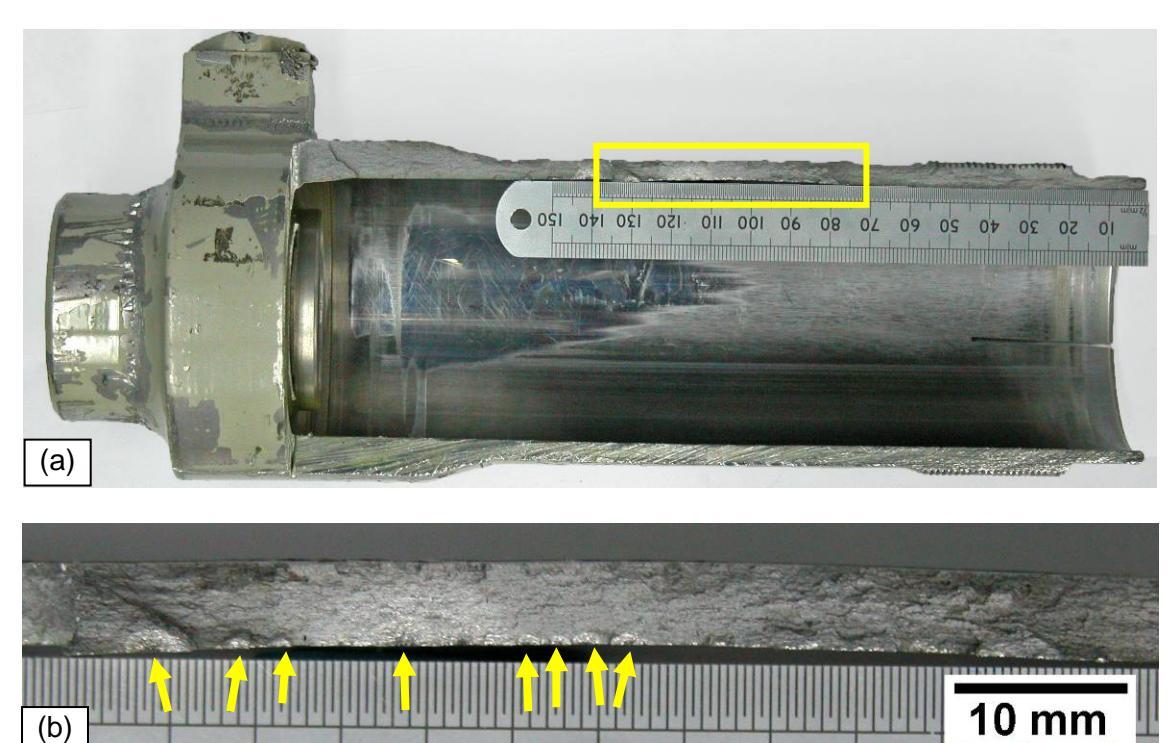
Examination of the fracture surfaces revealed the presence of multiple cracks in the wall of the cylinder, see Figure 17. Progression marks were present on the fracture surfaces indicating that the cracking had propagated via fatigue. Based on the orientation of the progression marks, the crack originated from the bore of the cylinder and propagated towards the outer surface.

Figure 17. Photographs showing the fracture surface of the hydraulic cylinder. The area marked with a yellow box in (a) is shown at higher magnification in (b). Multiple crack initiation sites were observed, with examples indicated with yellow arrows.

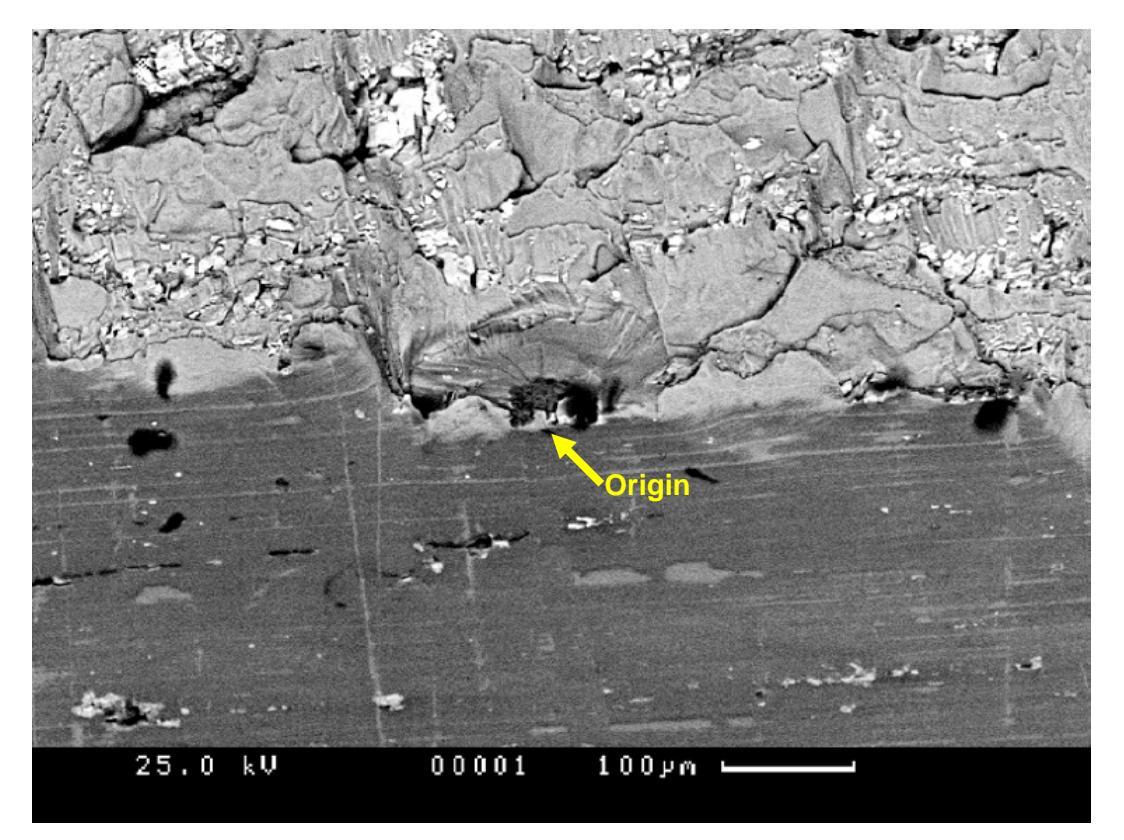
SEM examination of the fracture surface revealed that multiple cracks had propagated from pits in the surface of the bore of the cylinder, see Figure 18. The pits were measured to be between 20 and 80 μ m in depth. Pitting was observed over the entire surface of the cylinder bore.

Figure 18. SEM photograph showing one of the crack origins. Cracking had initiated at a pit, which appears as a dark area at the origin.

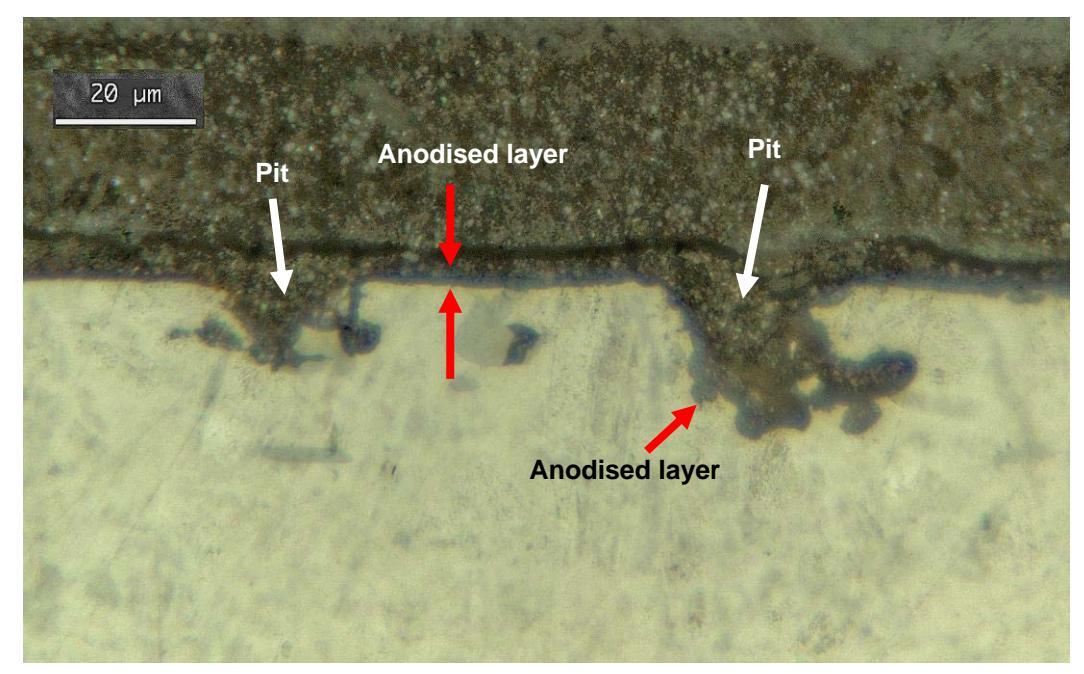
Metallographic examination of cross-sections from selected areas of the cylinder confirmed the presence of pitting damage to the bore of the cylinder. The surface of the pits exhibited evidence of anodising, see Figure 19. This indicated that the pits were present in the cylinder when the cylinder was last anodised, being either at manufacture or overhaul. The pits provided crack initiation sites and the cracks grew undetected from the inside of the bore.

Figure 19. Photograph of pitting (depths of 11 µm and 20 µm) in the surface of the cylinder bore. Note that the anodised layer is present within the pits.

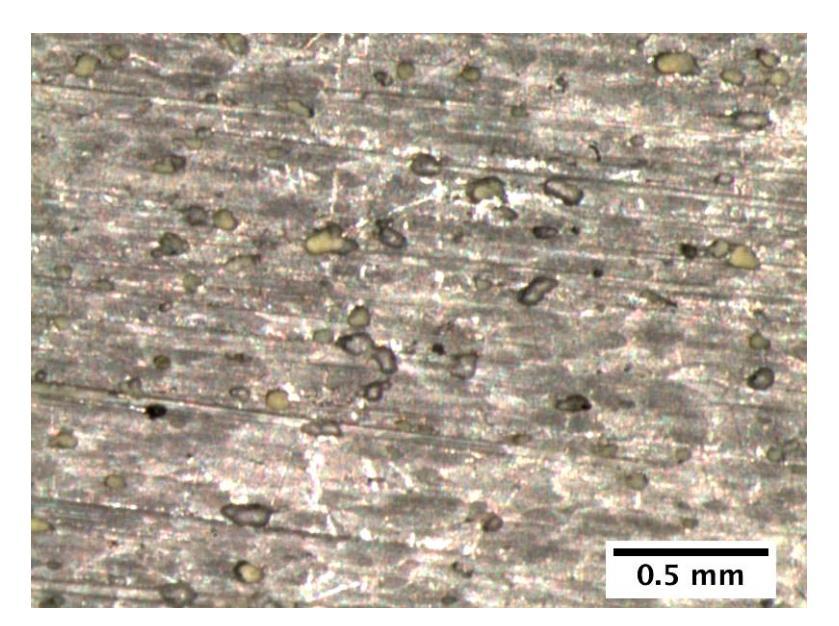
Examination of the two rescue hoist arms revealed the presence of fine etch pits on all surfaces. The pits were typically $50 - 100 \,\mu\text{m}$ in diameter, see Figure 21. In addition to the fine etch pitting, a distribution of larger corrosion pits was observed on the outer surfaces of the rescue hoist arms, see Figure 22. The locations of the corrosion pits were generally consistent between the two rescue hoist arms, see Figure 23. The corrosion pits were up to 5 mm in length, with some containing dark coloured deposits and others being filled with paint or containing paint particles that were consistent in size and shape with the paint observed within the etch pits, see Figure 24.

Figure 21. Photograph of fine etch pits observed on the body of the rescue hoist arms. Etch pits on the body were typically $50 - 100 \ \mu m$ in diameter.

The two rescue hoist arms were from the same manufacturing batch and both had fine etch pits present over their entire surfaces. These etch pits were found to be both anodised and painted, indicating that they formed prior to anodising. The existence of etch pits over all surfaces suggested that they formed when the parts were immersed in a bath during the pre-anodising process.

Due to the presence of significant surface etch pits and localised corrosion pits, the rescue hoist arms were considered no longer fit for purpose. The presence of the etch pits and, in particular, the larger corrosion pits introduced unquantifiable stress concentrations that could initiate cracks during subsequent in-service loading, both cyclic and sustained. As such, all rescue hoist arms from the same manufacturing batch were rejected.

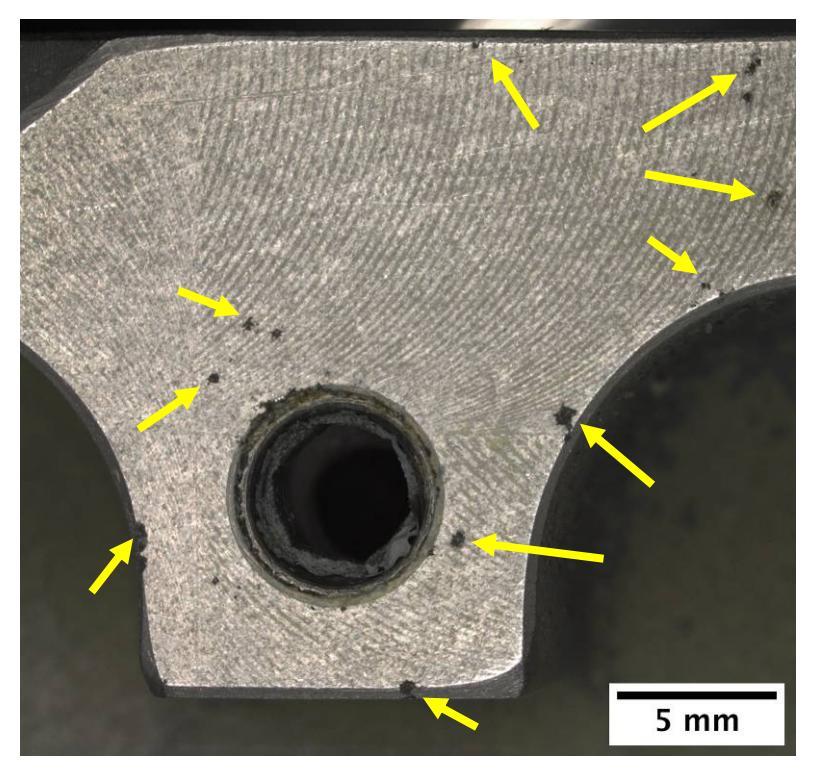
Figure 22. Photograph showing examples of the corrosion pits observed on the body of the rescue hoist arm, indicated with yellow arrows. Corrosion pits up to 5 mm in length were observed.

Corrosion pits were also present on both rescue hoist arms. The large size and localised nature of the corrosion pits suggested that they formed due to exposure to a surface contaminant. As the locations of the corrosion pits were consistent between the two rescue hoist arms and limited to the exterior surface of the body, it is likely that contamination occurred during a process which all parts were subjected to during manufacture or storage, for example parts handled with contaminated gloves or equipment, or stored on contaminated racks.

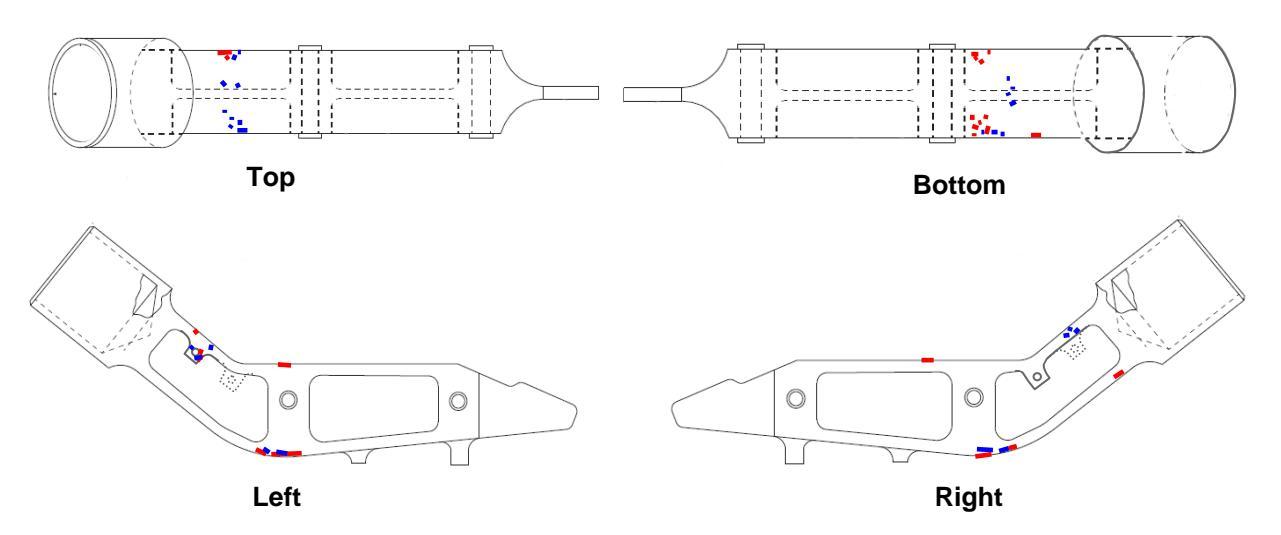
Figure 23. Diagrams showing locations of corrosion pits on each face of the rescue hoist arms. Red points indicate corrosion pits on rescue hoist arm 1 and blue points indicate corrosion pits on rescue hoist arm 2. Locations were generally consistent between the two rescue hoist arms.

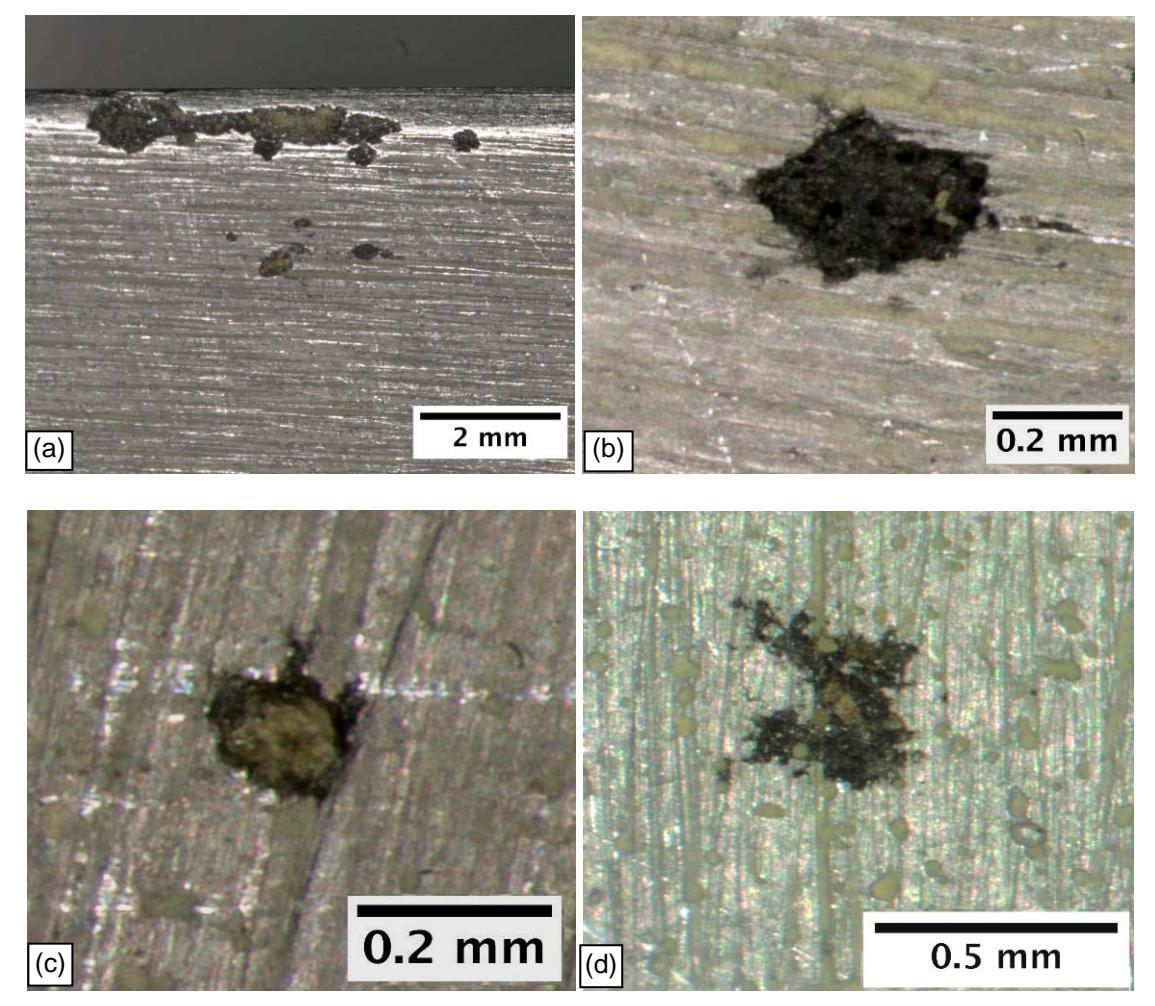
Figure 24. Photographs showing (a) corrosion pits up to 5 mm in length. The pits were observed to contain (b) dark coloured deposits, or (c) residual paint. In some cases (d) the paint within the corrosion pits consisted of particles that were similar in size and shape with the paint observed in the finer etch pits.

The corrosion pits formed some time after anodising. The surface etch pits may have caused discontinuities in the anodised surface layer, making the alloy susceptible to localised corrosion. It is also possible that the rescue hoist arms were stored for some time following anodising and prior to painting, during which time the corrosion pits began to form due to surface contamination. Following painting, the corrosion pits continued to grow undetected beneath the paint layer.

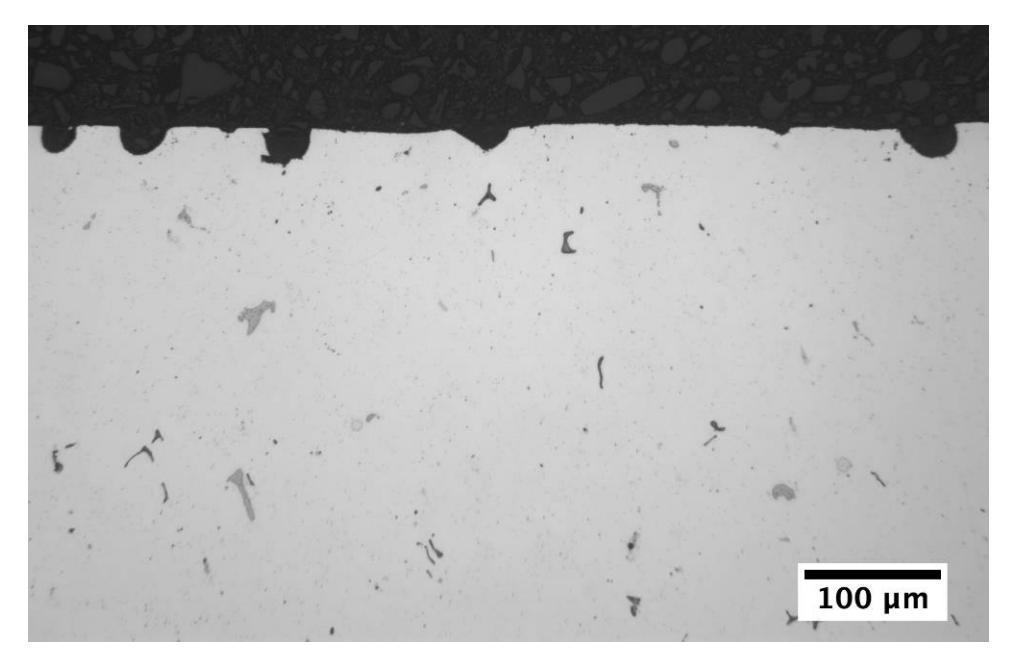
Cross-section examination of the etch pits revealed they had a rounded shape and a typical depth of approximately $25\mu m$, see Figure 25. An anodised layer was observed on the surface of the etch pits, see Figure 26. Examination of the corrosion pits in cross-section revealed that the pits were in the order of 300 μm in depth and had a branched, irregular structure, see Figure 27 for example.

Figure 25. Micrograph of a cross-section from a rescue hoist arm showing the etch pits were up to 25 µm in depth.

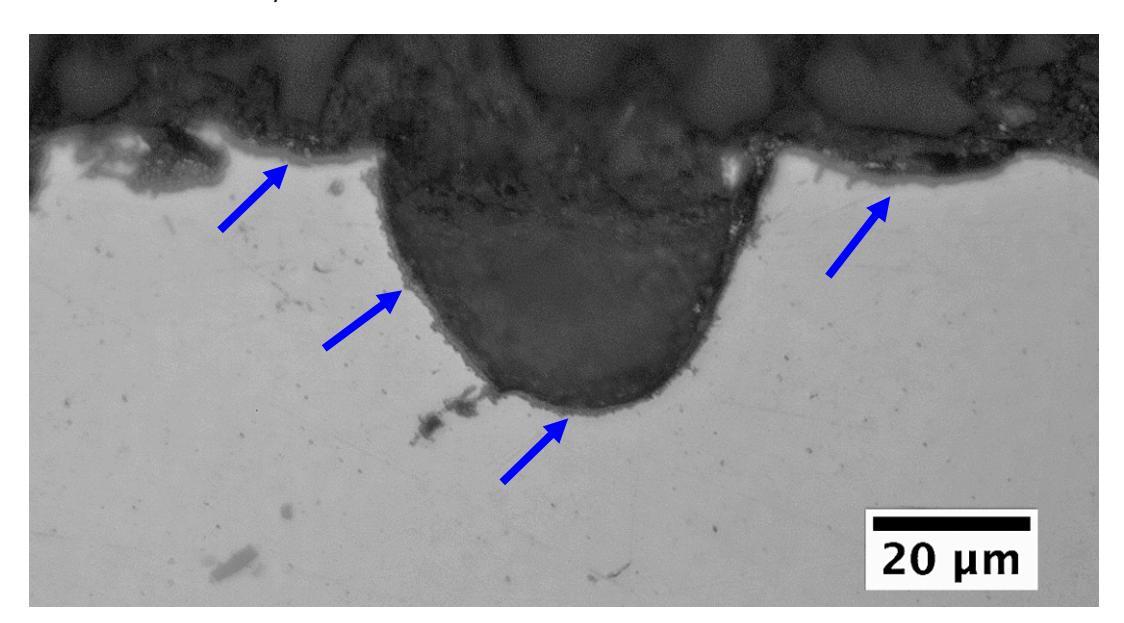
Figure 26. Micrograph of a rescue hoist arm in cross-section showing the presence of an anodised layer on the surface of the component and within the etch pits, as indicated with blue arrows.

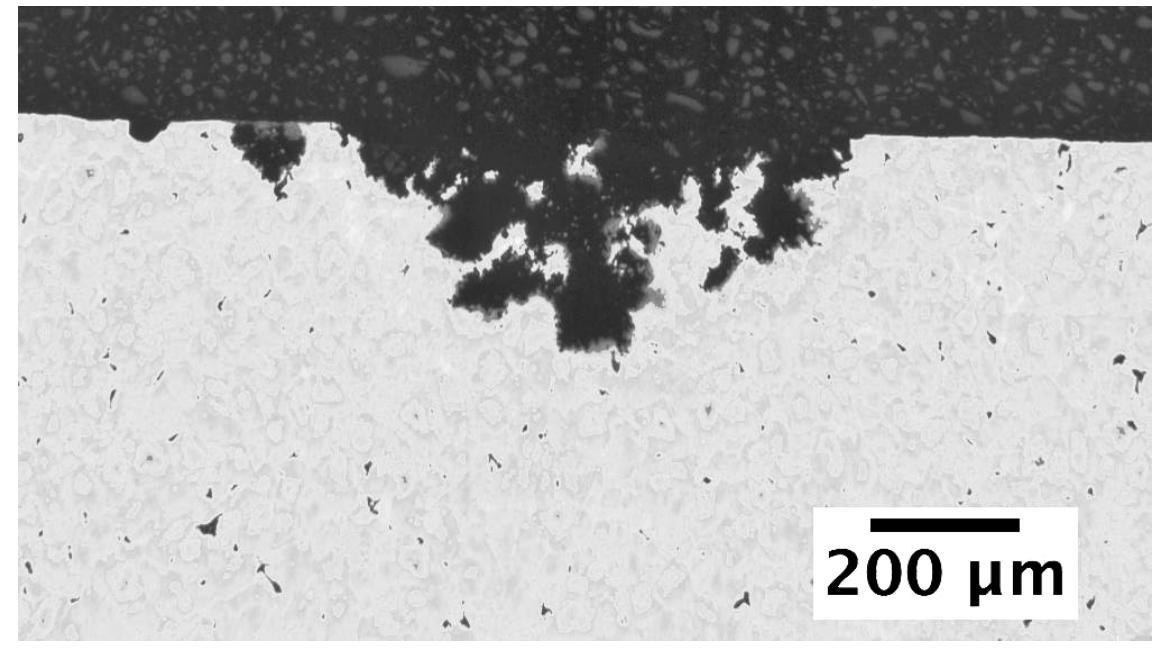
Figure 27. Micrograph of a rescue hoist arm in cross-section showing the corrosion pits had a branched and irregular structure.
