Improvements to Filter Debris Analysis in Aviation Propulsion Systems

Air Vehicles Division
Defence Science and Technology Organisation

DSTO-TR-2773

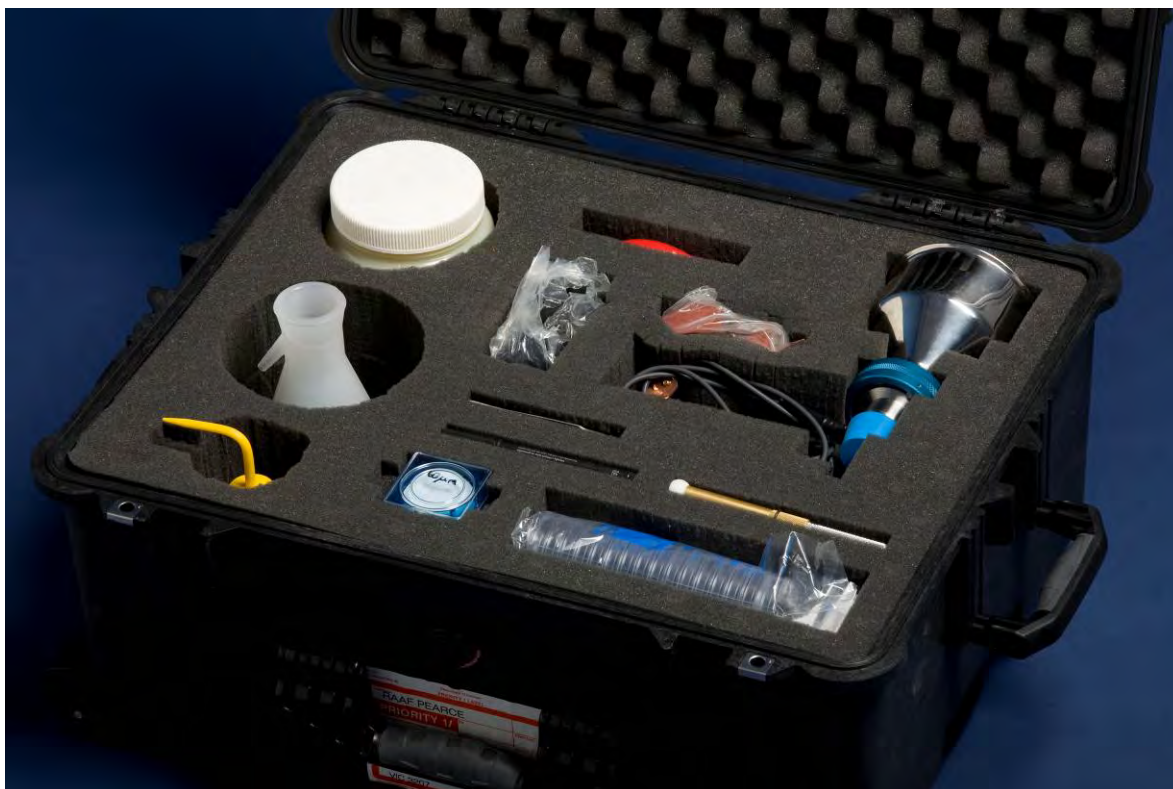
Figure 1: Filter Debris Extraction Kit

The kit developed for the PT6A-62 engine (powering the PC-9/A aircraft) routine oil filter analysis [3] has also been applied to RAAF F117-PW-100 (hereafter referred to as the F117) engine oil filter debris examinations. The previous guidance for examining metallic debris captured by the oil filter in this engine required maintenance staff to visually identify and count particles captured in the numerous pleats of the filter element. This procedure was considered to be inaccurate due to the difficulty of reliably identifying metallic particles located in the metal-woven filter pleats as well as tedious and unnecessarily time-consuming for maintenance staff. A 12-month trial was conducted using a kit based on the DSTO-developed PC-9/A filter extraction kit to assess its suitability for the F117 engine. Figures 1 and 2 show the test kit and contents respectively.

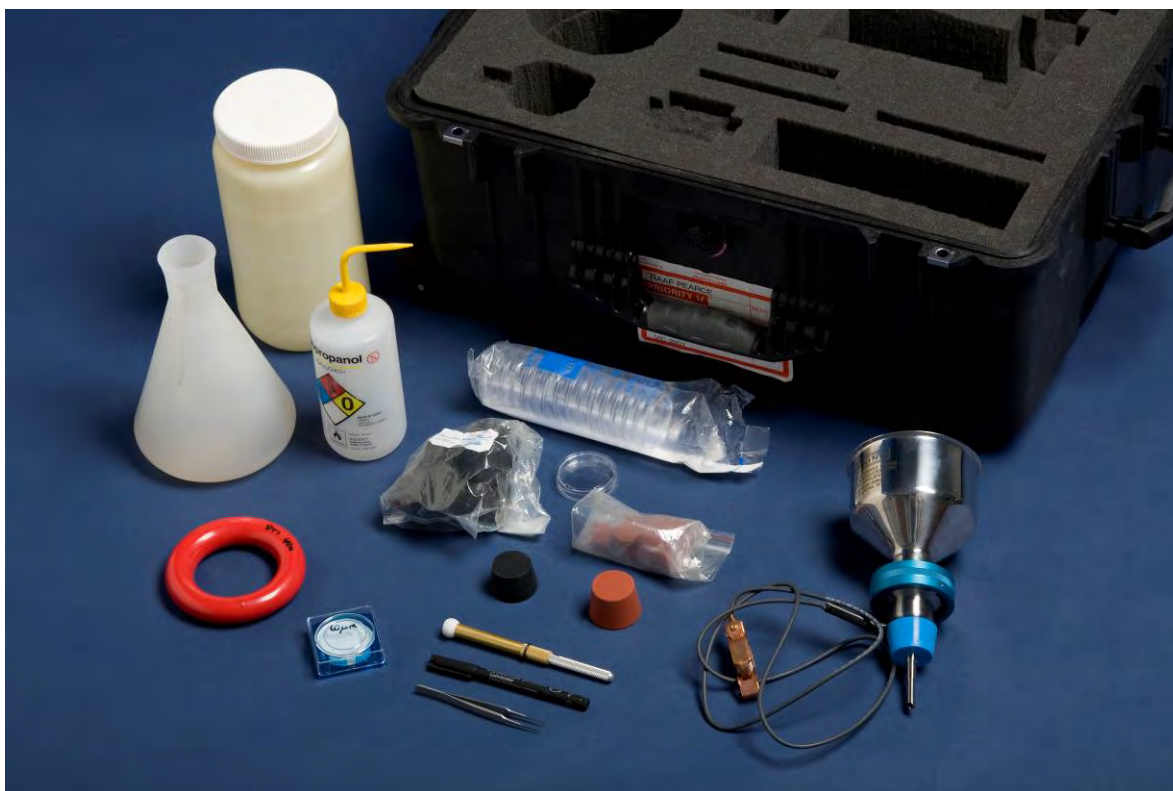
Figure 2: Contents of Filter Debris Extraction Kit

The kit provides some simple tools (Appendix A) that enable the filter debris to be extracted into a slurry and then deposited on a 60 micron filter patch in the field. Once deposited on the filter patch the magnetic particles can be separated from the bulk debris for counting or further analysis. Whilst the majority of the kit is identical to that used for RAAF PC-9/A aircraft, the F117 filter element is physically bigger and required a modified plugging device. Figures 3 and 4 show the combined plug and handle device that was manufactured to block the filter element outlet and enable it to be inserted into the cylindrical extraction container. For the manual method of debris extraction, it is essential that the clean (outlet) port of the filter element is blocked so that the debris entrained into the slurry does not migrate back into the filter and become trapped. Figure 5 shows the plugged filter element being lowered into the cylindrical extraction container. The details of the combined plugging and handling fitting are contained in Appendix B.

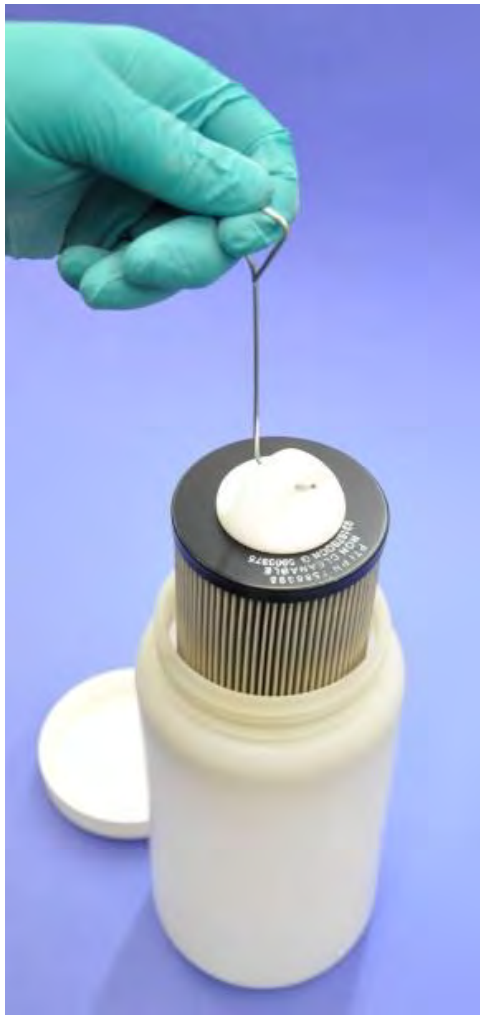
Figure 5: Plugged filter element being lowered into the cylindrical extraction container.

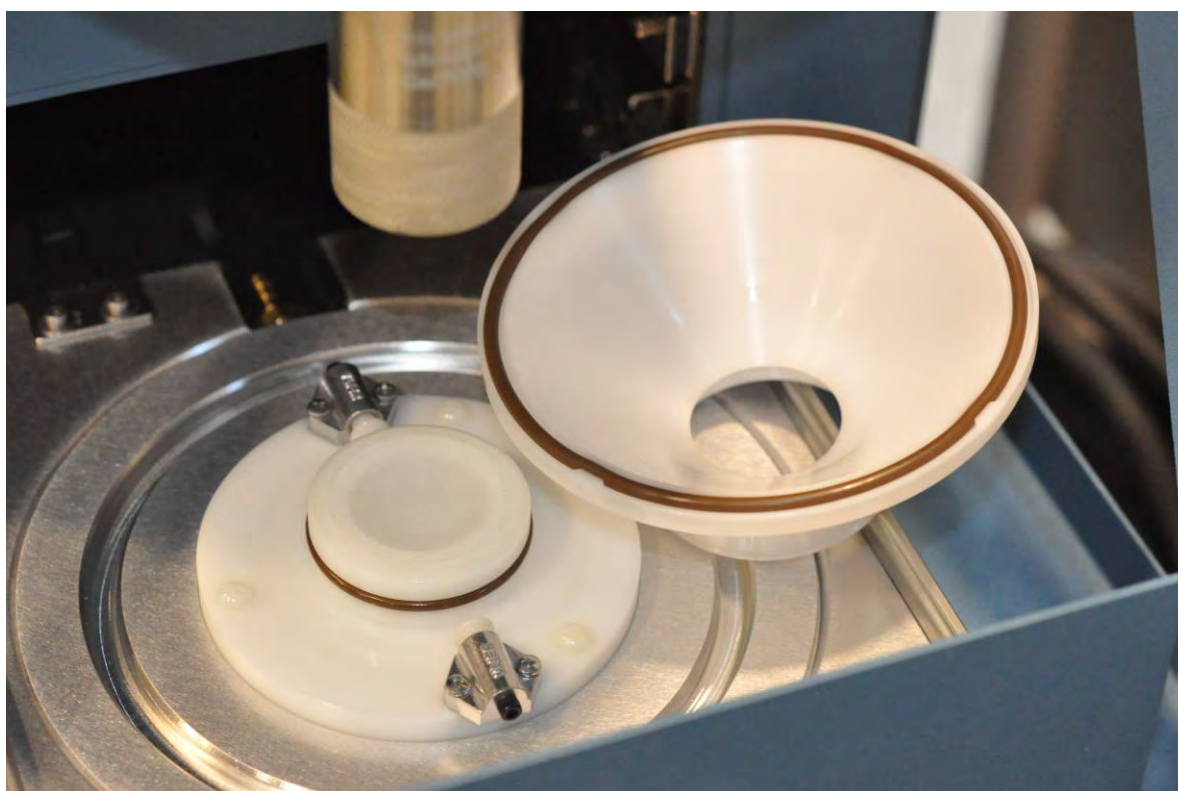
Figure 24: Sample filter patch holder as delivered.

press fit over the base and this was assessed to be insufficiently robust for the expected RAAF usage. Additionally, the filter patch support gauze was considered to be too light-weight for repeated usage. DSTO incorporated a stainless steel filter patch holder manufactured by Millipore that uses a simple cam-lock method of attaching the funnel to the base. This provides a better mechanism for securing the filter patch that is both easier to use and more robust. It is important to note that the use of stainless steel prevents the FC290 models currently owned by ALSPO being upgraded to include the XRF capability, however this upgrade is not anticipated and DSTO recommends the use of external XRF units should that be desired in the future.

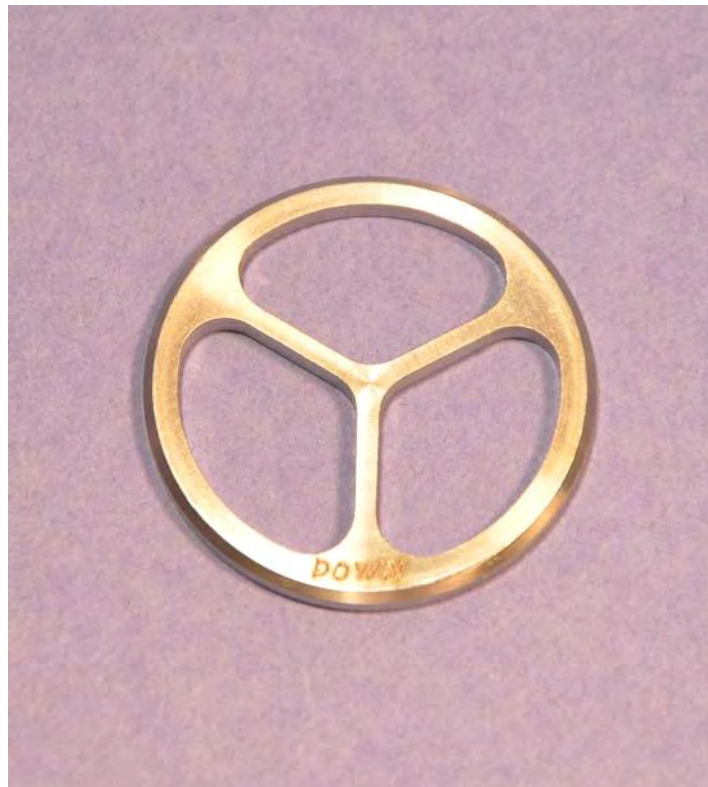
Figure 26: Stainless steel replacement filter patch support

A thin gauze disc is supplied with the FC290 in order to support the filter patch during the sample phase. This item was also assessed as being sufficiently robust to meet the RAAF expected usage and a replacement was made from stainless steel (Figure 26). The cam-locking mechanism of the Millipore funnel enables the nylon filter patch to be locked in place around the periphery of the filter patch. This also allows the supporting ring to be a simple design that minimises resistance to flow of the slurry. The support ring has the word "DOWN" engraved on one side to ensure it is inserted with the bevelled edge facing down and hence allows it and the filter patch to be locked in securely. Appendix F contains details of the support ring.

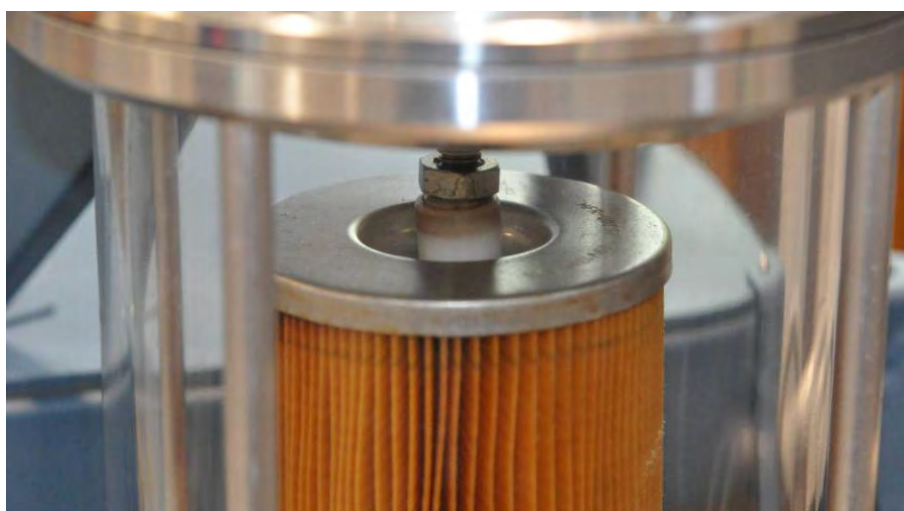
Figure 28: Top of T56 ESF in the FC290 showing the Wash Housing plunger bearing directly onto the solid top of the filter element.

Adapters are required to secure the filter element to the wash housing connection (see Figure 21). Most modern filter elements have an open clean oil exit port at the top and bottom; these type of filters require an upper and lower adapter to ensure the slurry does not re-enter the filter element and result in particles not being detected. The top adapter is completely solid and the lower adapter has an opening to allow it to fit onto the Wash Housing hub and allow the wash fluid and compressed air to enter the bore of the filter element. The T56 external scavenge filter is different to most conventional filter elements in that the bore of the element is only open at one end. This means that the upper adapter is not required for the T56 ESF and the wash housing lid simply bears down on the solid end of the filter element (see Figure 28).

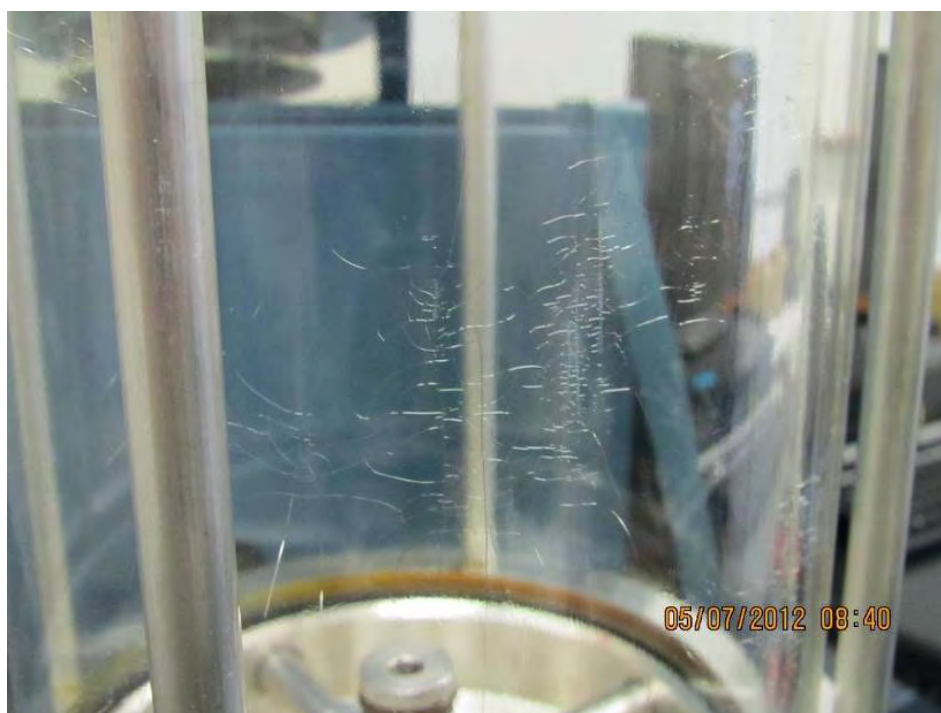
Figure 34: Wash Housing showing crazing

During the trial of the FC290 crazing of the wash housing was identified by operators along with an abnormally low level of wash fluid in the wash housing during the processing of filters (Figure 32). A further symptom was the pooling of wash fluid on top of the mist filter which is fitted to the wash housing lid assembly (Figure 33). After initial troubleshooting by the operators and discussions with the OEM, it was determined that the mist filter had become blocked and subsequently caused an artificially high pressure in the wash housing; this had also caused the low wash fluid level. The blocking of the mist filter with wash fluid was not categorically determined, however it was likely to have been caused by the regulated air pressure which had initially been set at 60 psi (420 kPa). The regulated air pressure was subsequently reviewed and was lowered to 40 psi (280 kPa) following testing by RAAF operators. Initially crazing observed on the wash housing wall (Figure 34) was thought to be related, however further advice from the OEM suggested it was benign wear and tear. The mist filters will be replaced on condition (based on observed pooling of fluid on the mist filter) to avoid further issues.

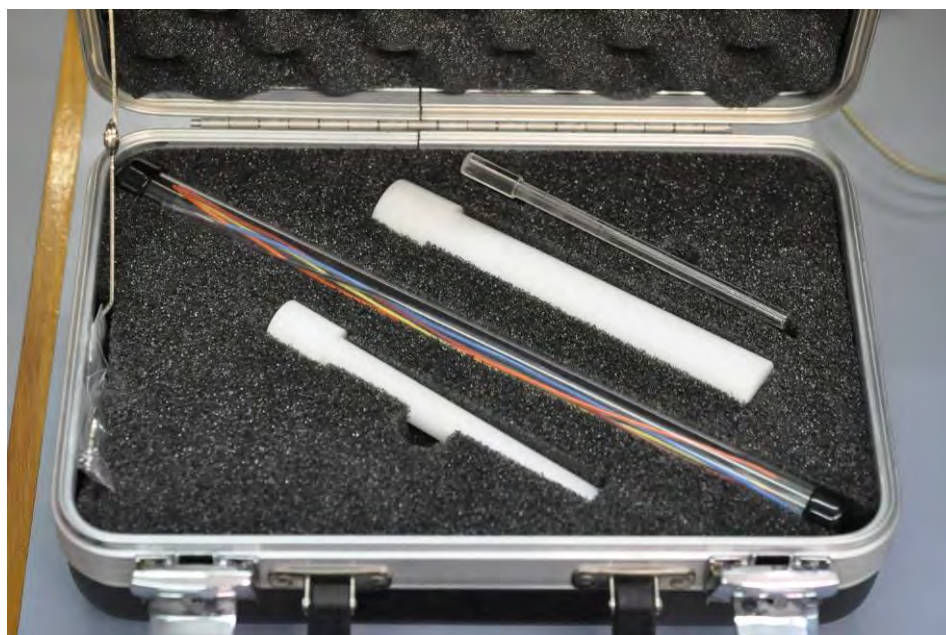
Figure 36: MetalSCAN Performance Test Kit

The FC290 manual does not specify any routine calibration of the FC290 [15] and this was specifically confirmed with the OEM. However, DSTO recommend that the performance of the FC290 sensor be routinely checked to ensure accurate operation. This can be easily achieved in-situ using the MetalSCAN Performance Test kit (Figure 36) that has been provided by DSTO with both RAAF FC290 instruments. MetalSCAN is the name of the sensor used in the FC 290. The test kit contains five colour-coded test straws each containing a spherical particle of known size and composition (Table 11, Figure 37). Each straw is passed through the sensor (Figure 38) to confirm that the sensor identifies the particle and that the particle is recorded in the appropriate size bin. The straw must be inserted and retrieved from the lower sensor port due to lack of access to the upper port; this means that for every insertion two particles should register (one for the upward pass and one for the retrieval pass). The sensor is sensitive to the velocity of the particle and several attempts are usually required to ascertain a suitable straw velocity. As the size bins are not specifically used in the RAAF T56 application, the particle detection (i.e. count) is all that is required. If the instrument fails the in-situ performance check then the OEM must be notified for corrective action (note that there is currently no agent for this equipment in Australia). Appendix L contains a pro-forma developed to aid the performance check process.

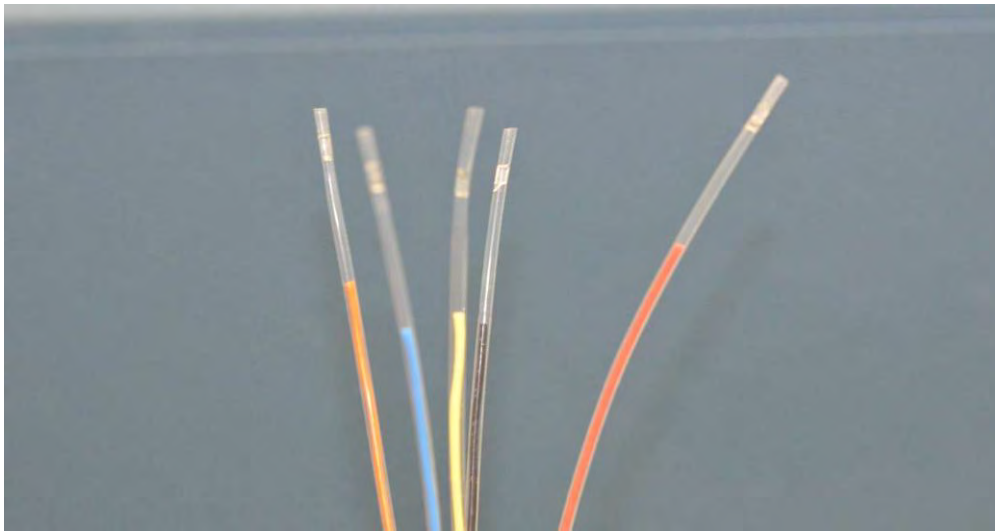
Figure 37: Test straws showing embedded particles of known size
