Australian Government Department of Defence Defence Science and Technology Organisation

Fatigue Crack Initiation from Pitting Introduced during the Anodising Process

DSTO-TR-2729

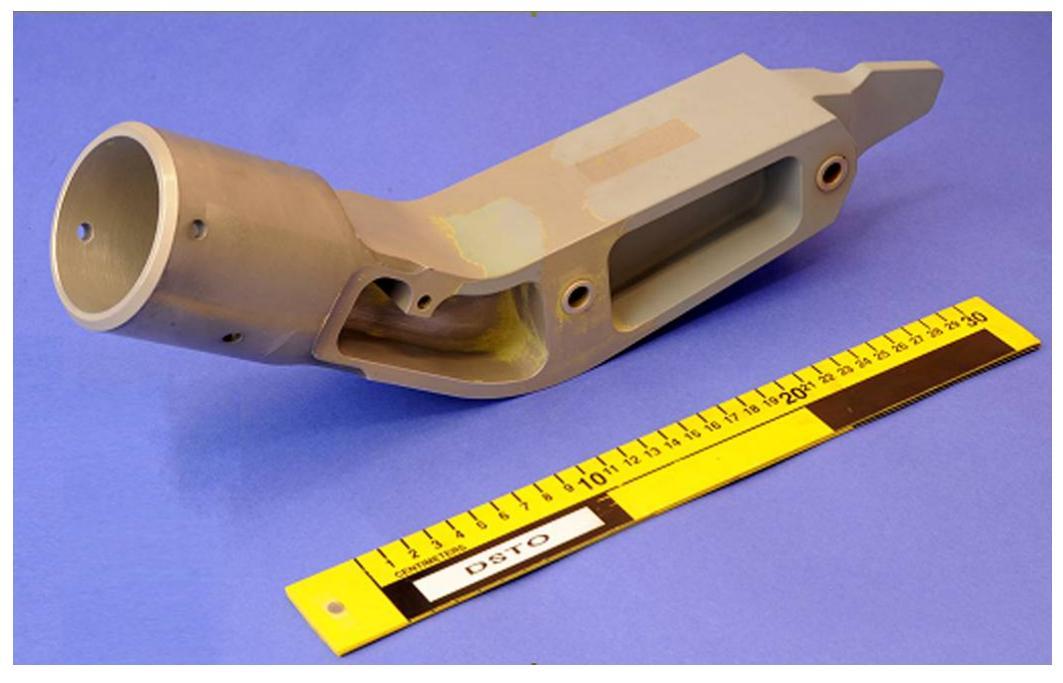
During routine inspection, pitting was observed on a new rescue hoist arm for an ADF rotary wing aircraft [11]. An in-service rescue hoist arm, from the same manufacturing batch, was also inspected and found to have similar pitting. The rescue hoist arm, shown in Figure 20, was manufactured from aluminium alloy 7075–T73 with a chromic acid anodising surface treatment.

Figure 20. Photograph of the rescue hoist arm as received. The rescue hoist arm consisted of a tubular end section and a H-profile body.
